EQUESTRIAN BARN AT AVENEL

CONDITION ASSESSMENT REPORT

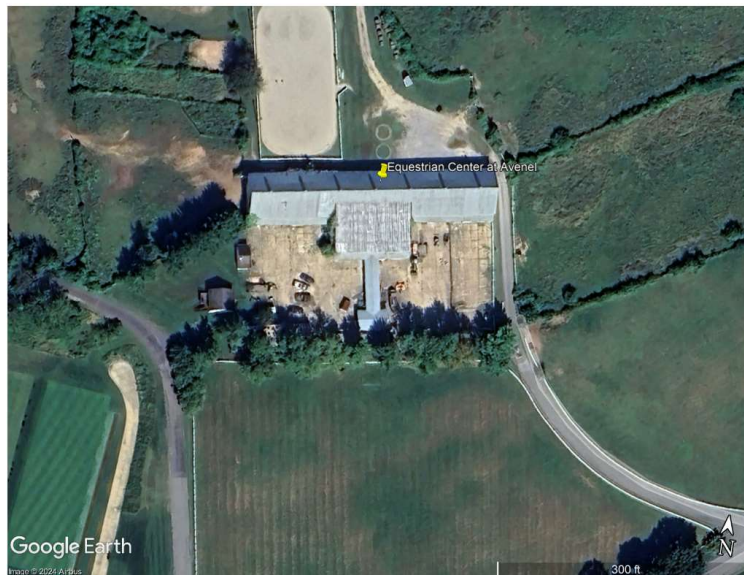
ES Figure 1 – Google Earth Image of Barn

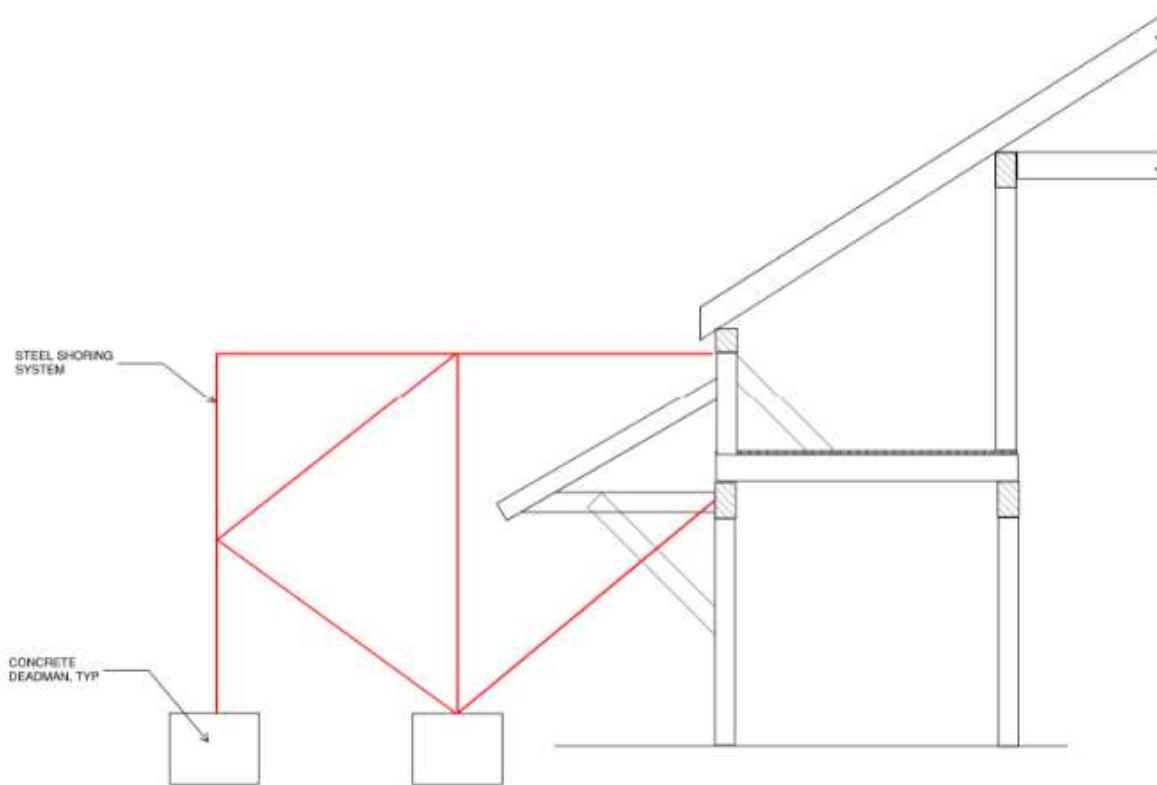
ES Figure 2 – Conceptual Exterior Building Bracing Scheme (cross section)

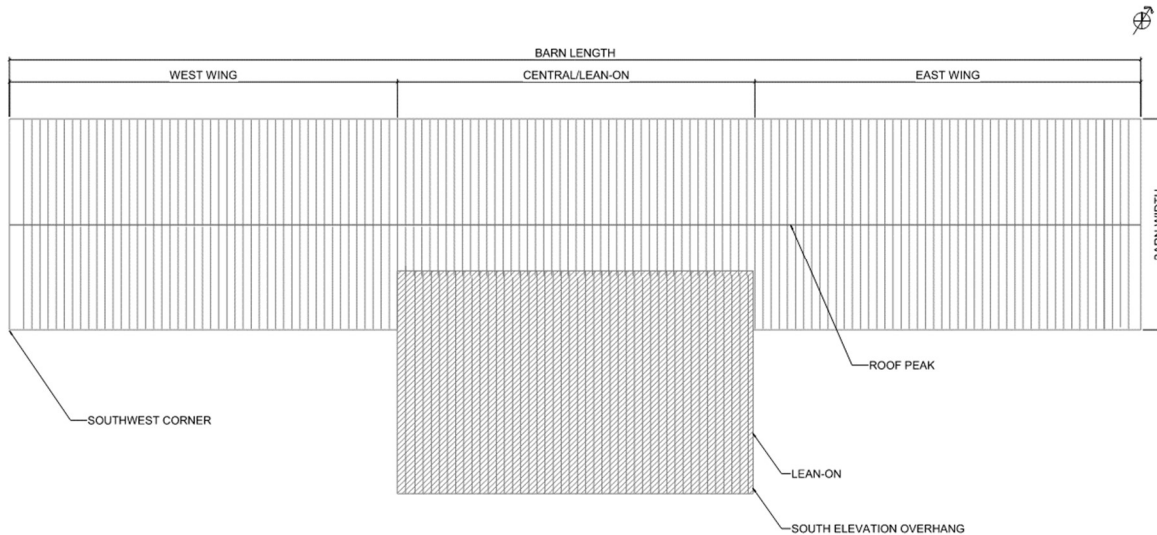
The Equestrian Center at Avenel will be referred to as 'barn' or 'the barn' hereafter for ease of communications. Due to the level of damage to the southern projection of the barn, the area to the south is called the 'lean on' area'. It appears both the barn and lean on area were constructed at the same time. The barn will remain the term for the overall structure.

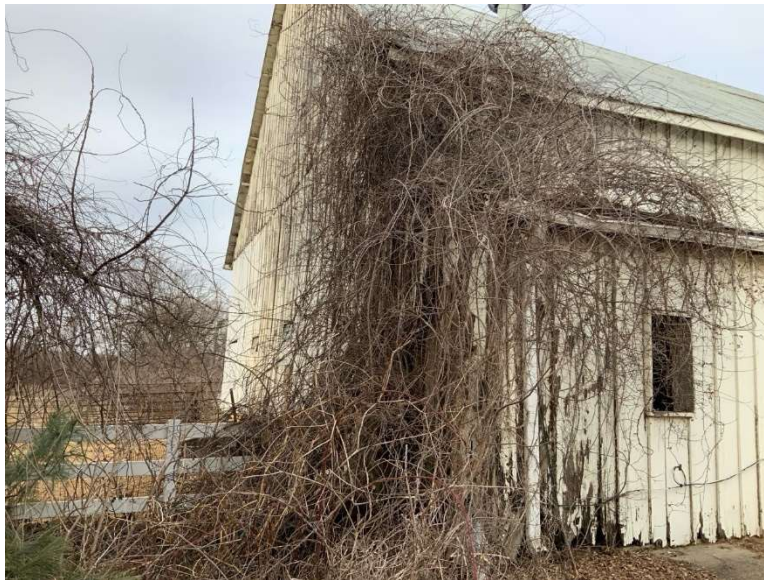
ES Photo 2: Heavy Vegetation pushing up roof deck along southwest corner (REF Photo S113)

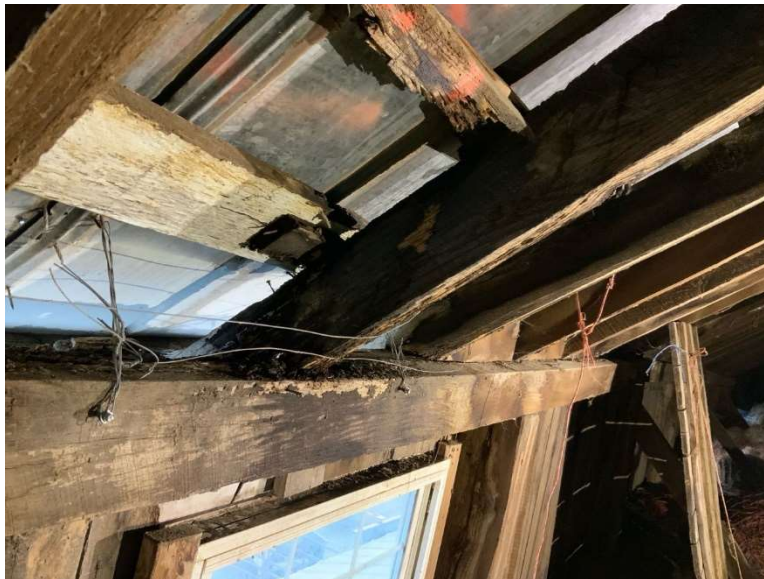
ES Photo 3 Rotting rafters (REF Photo S10 – Appendix B2)

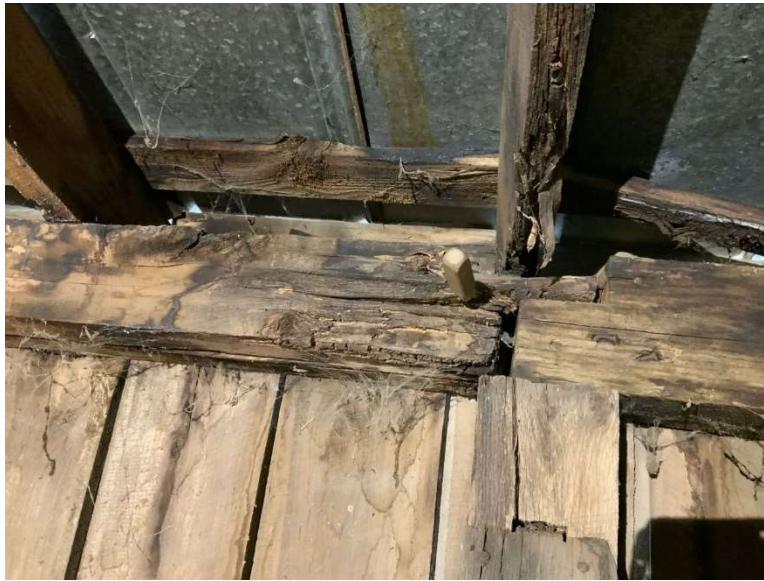
ES Photo 4 – Perimeter Roof Rot (REF Photo S21 – Appendix B2)

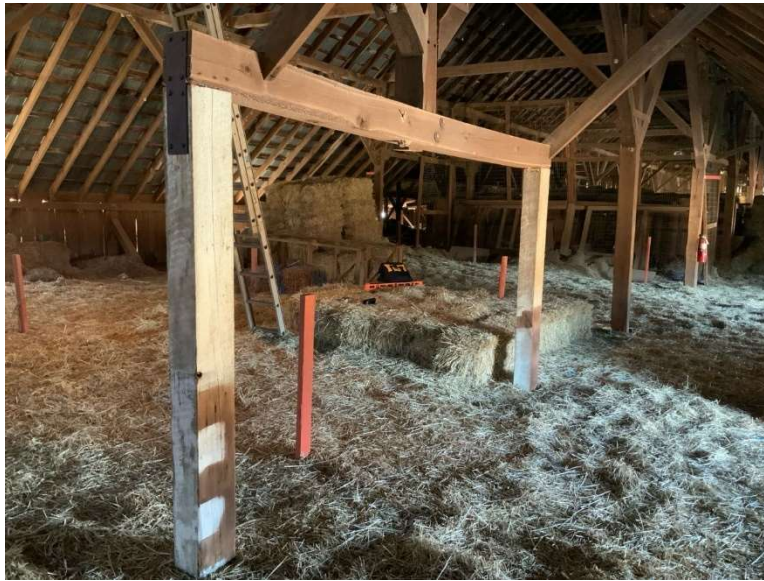
ES Photo 5 – General view of the load spreader beam structures in hayloft (REF Photo G10 – Appendix B1)

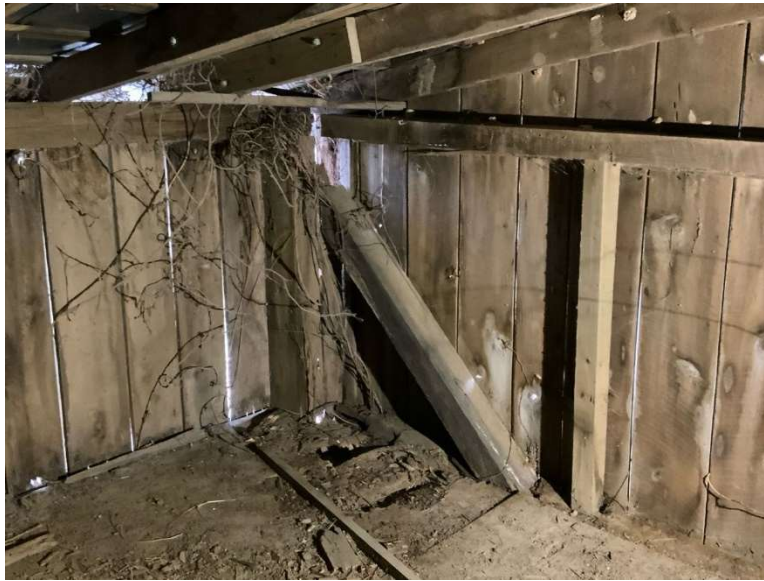
ES Photo 6 – Hayloft looking southwest – post has been added to east existing column., north brace and wind girt are not connected to the post and the east brace is missing. The floorboards adjacent to the column are rotting. (REF Photo S42- Appendix B2)

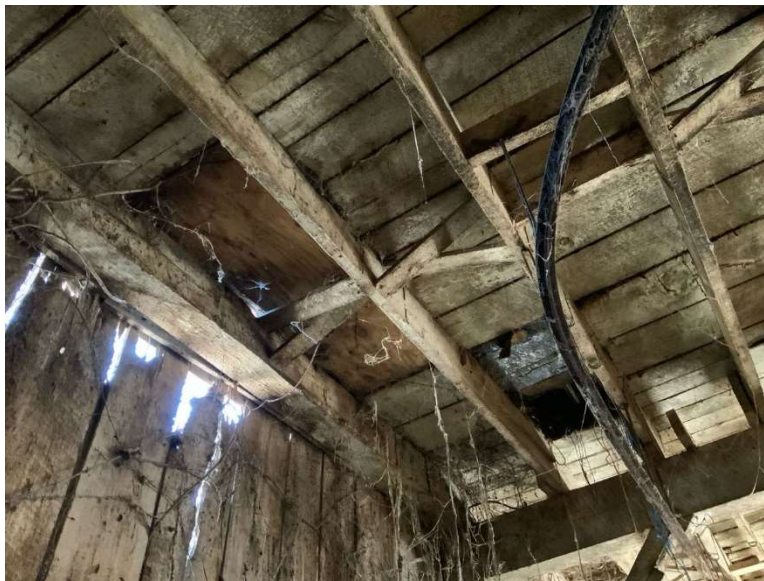
ES Photo 7 – Hayloft from below – typical rotting/broken/missing floorboards – Lean on structure (REF Photo S68 – Appendix B2)

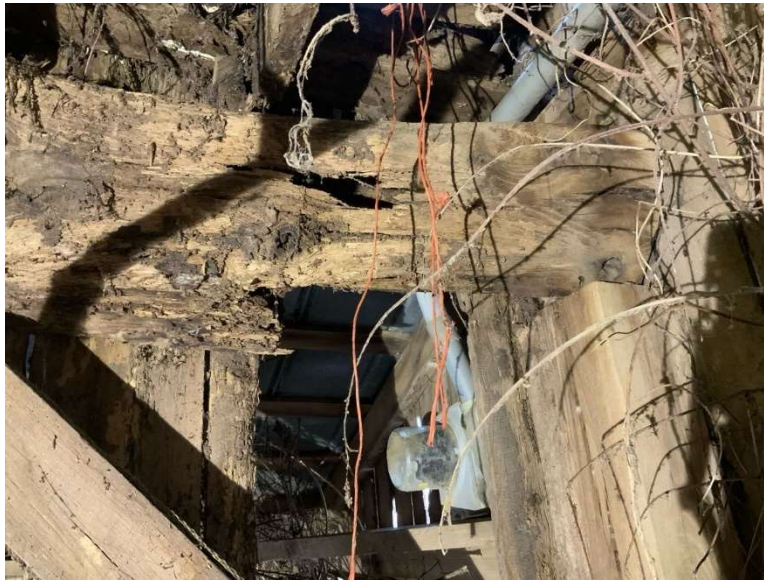
ES Photo 8 – Critical finding at hayloft floor beam – west end of beam has approximately 90% section loss – (REF Photo S81 – Appendix B2)

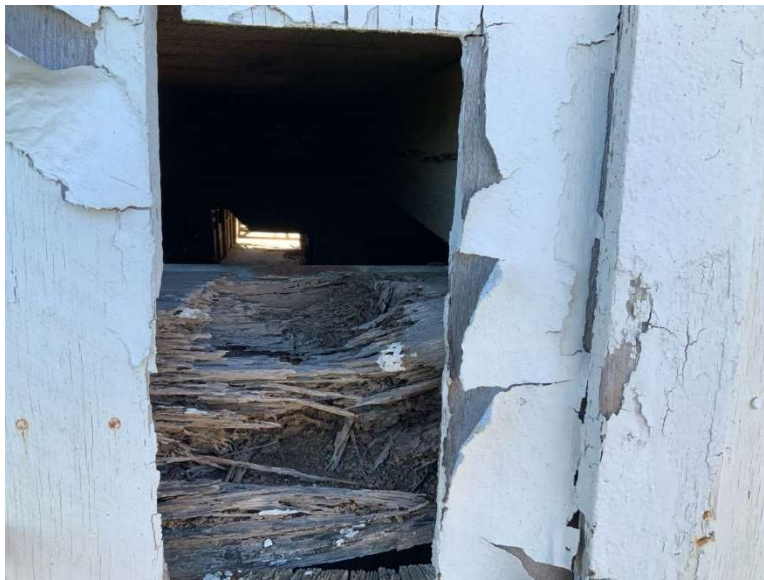
ES Photo 9 – Severe rot at floor beam – west end has significant section loss – (REF Photo S82 – Appendix B2)

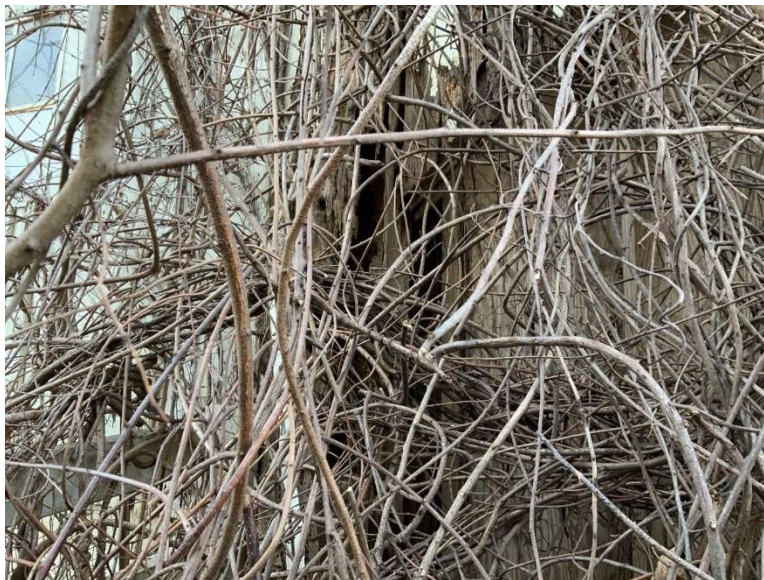
ES Photo 10 – Siding at southwest corner has holes – column appears to be rotting throughout its height – heavy vegetation (REF Photo S114 – Appendix B2).

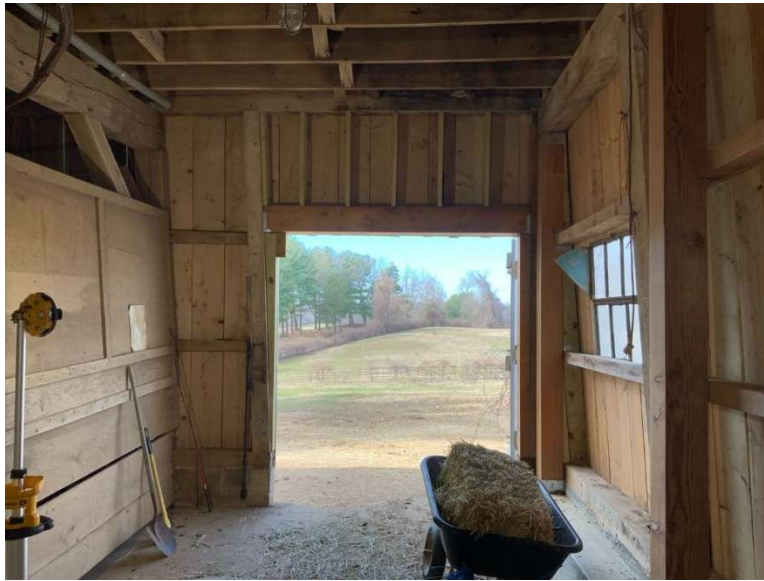
ES Photo 11 – New repairs on Northwest corner (REF Photo S100 - Appendix B2)

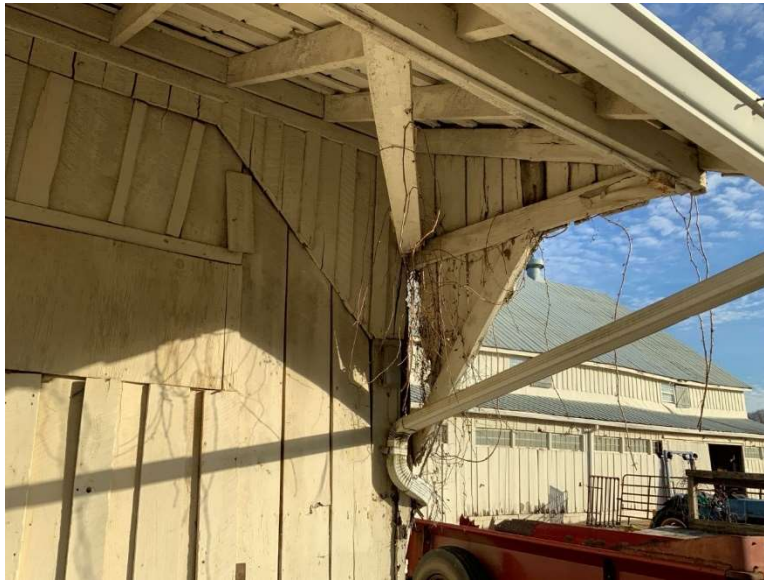
ES Photo 12 – Overhead support diagonal is disconnected at the base and overhang is leaning (REF Photo S140 Appendix B2)

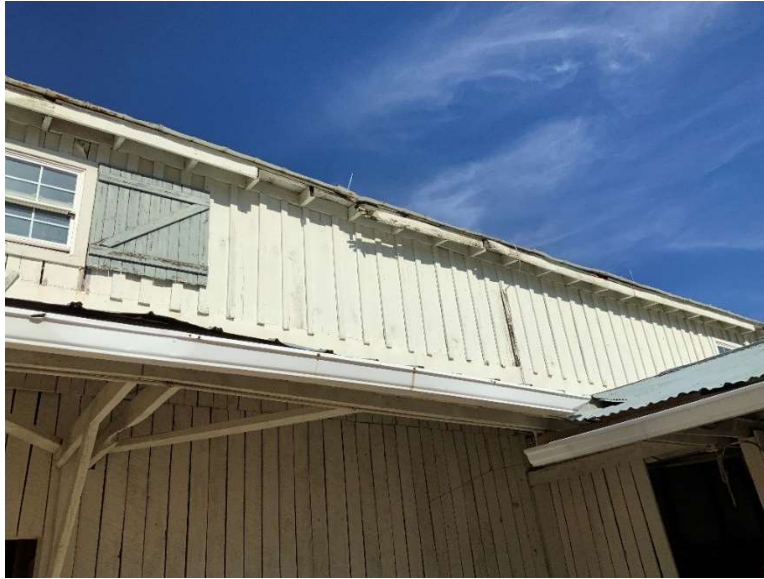
ES Photo 13 – Sections of lifted metal roof panels and missing fascia boards (REF Photo A3- Appendix B3)

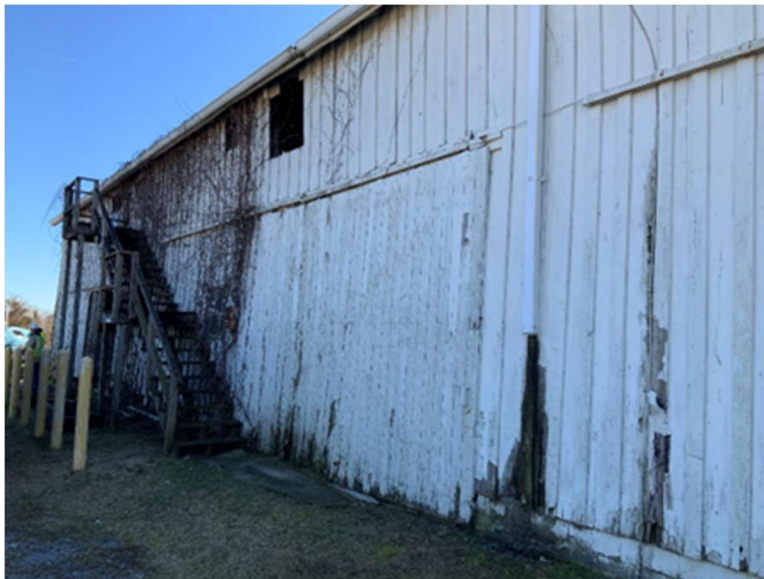
ES Photo 14 – Gutter clogged with vegetation, deteriorated boards and discontinuous rain leader (REF Photo A14 – Appendix B3)

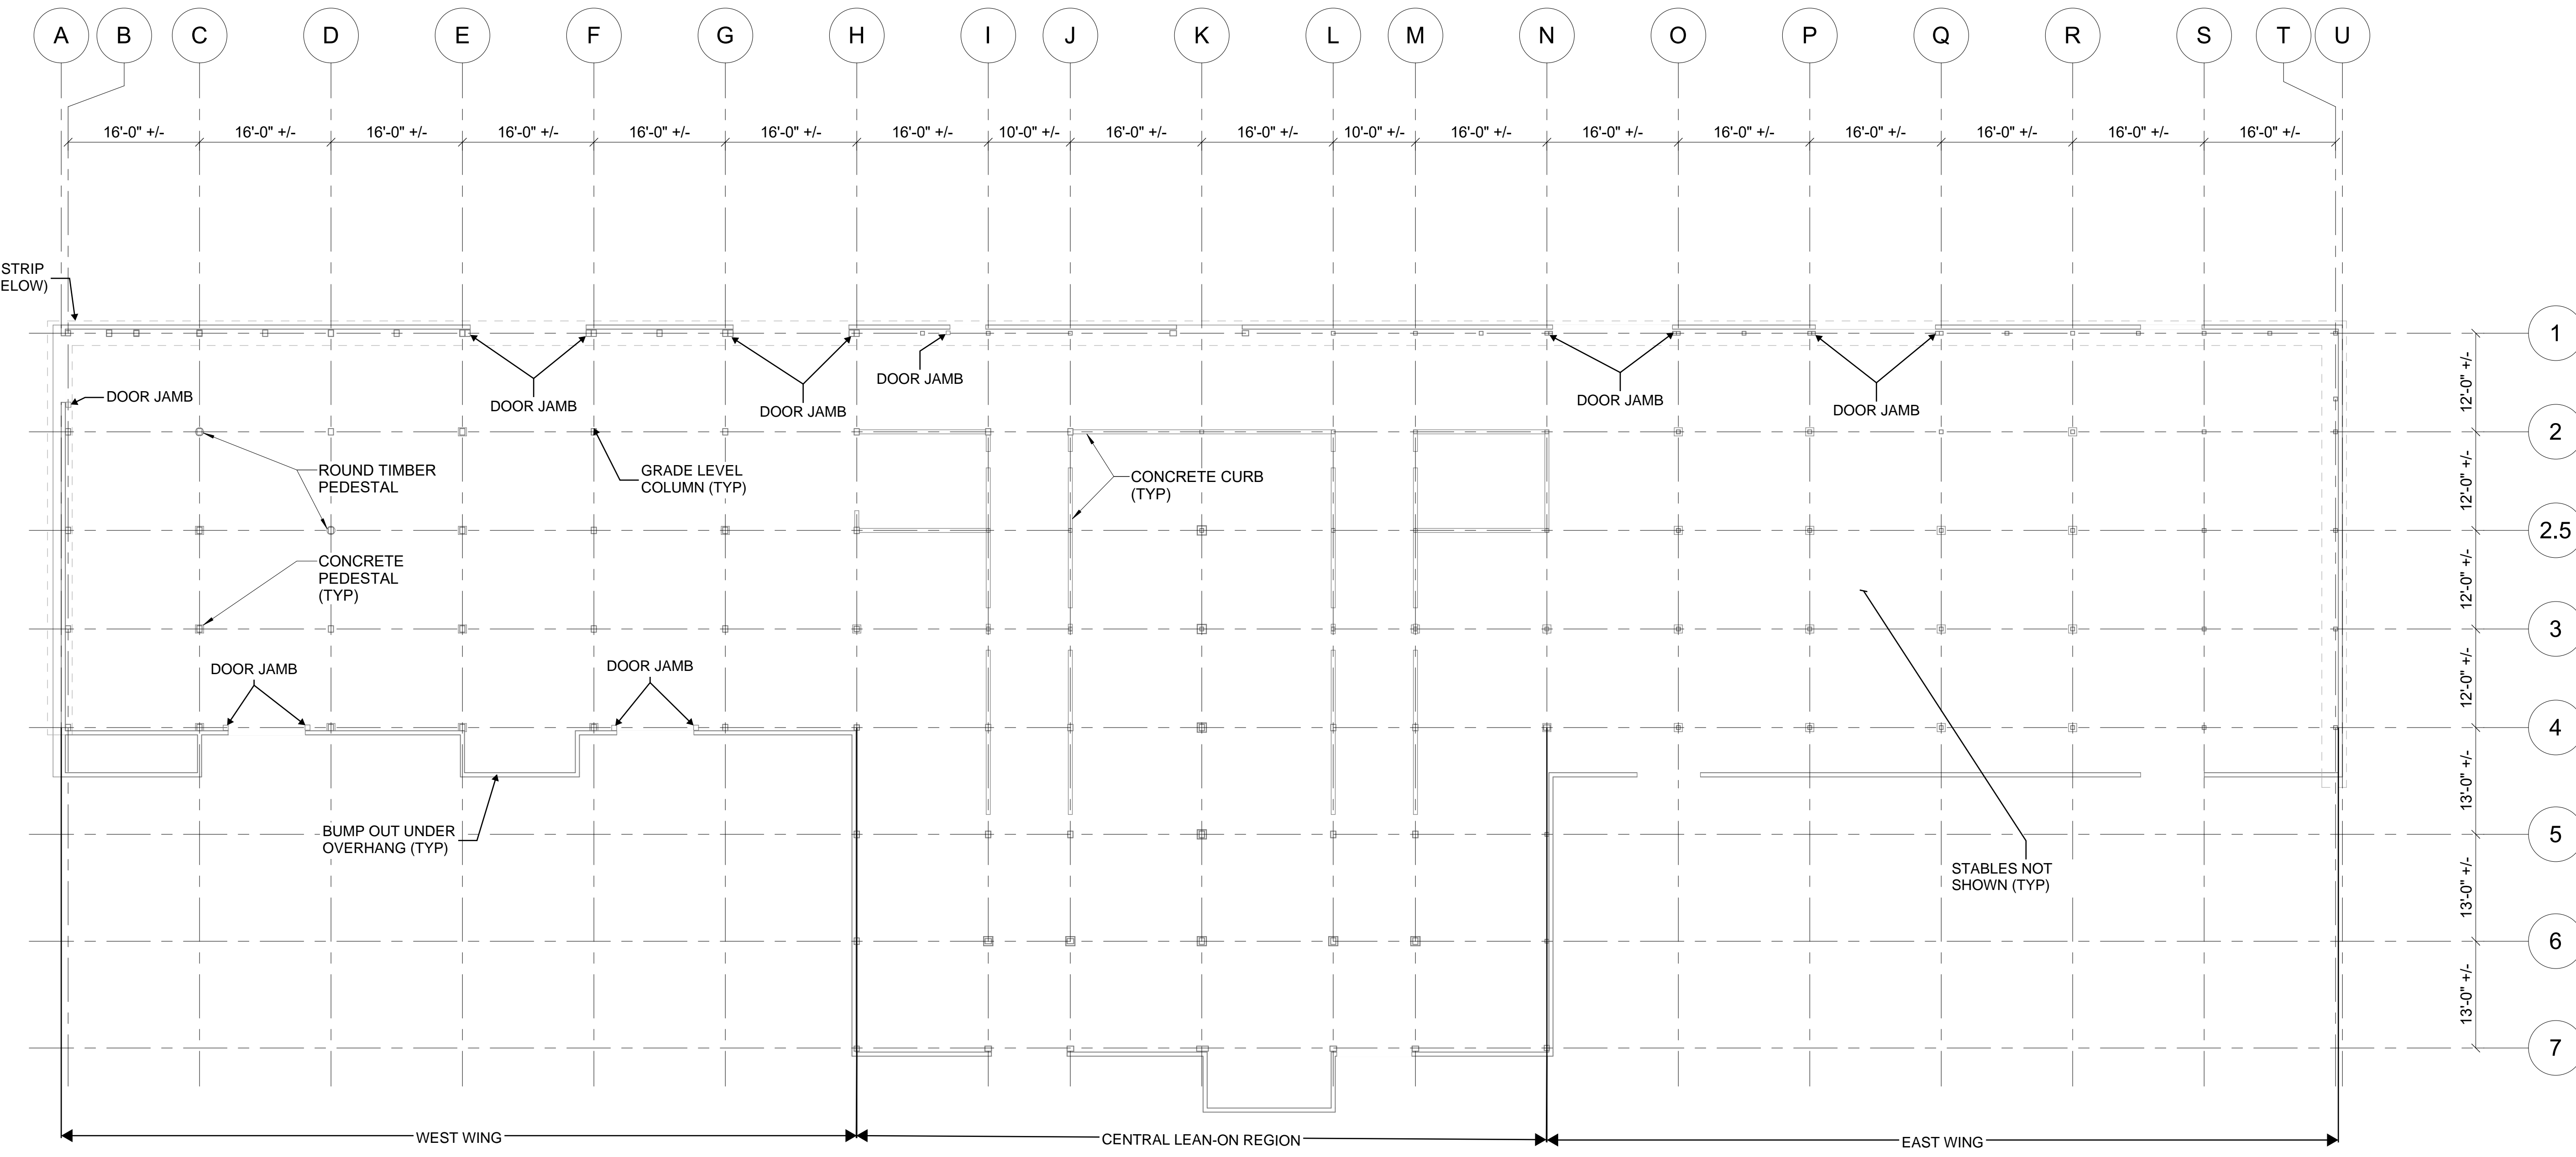
1 OVERALL FOUNDATION PLAN
 SCALE: 3/32" = 1'-0"

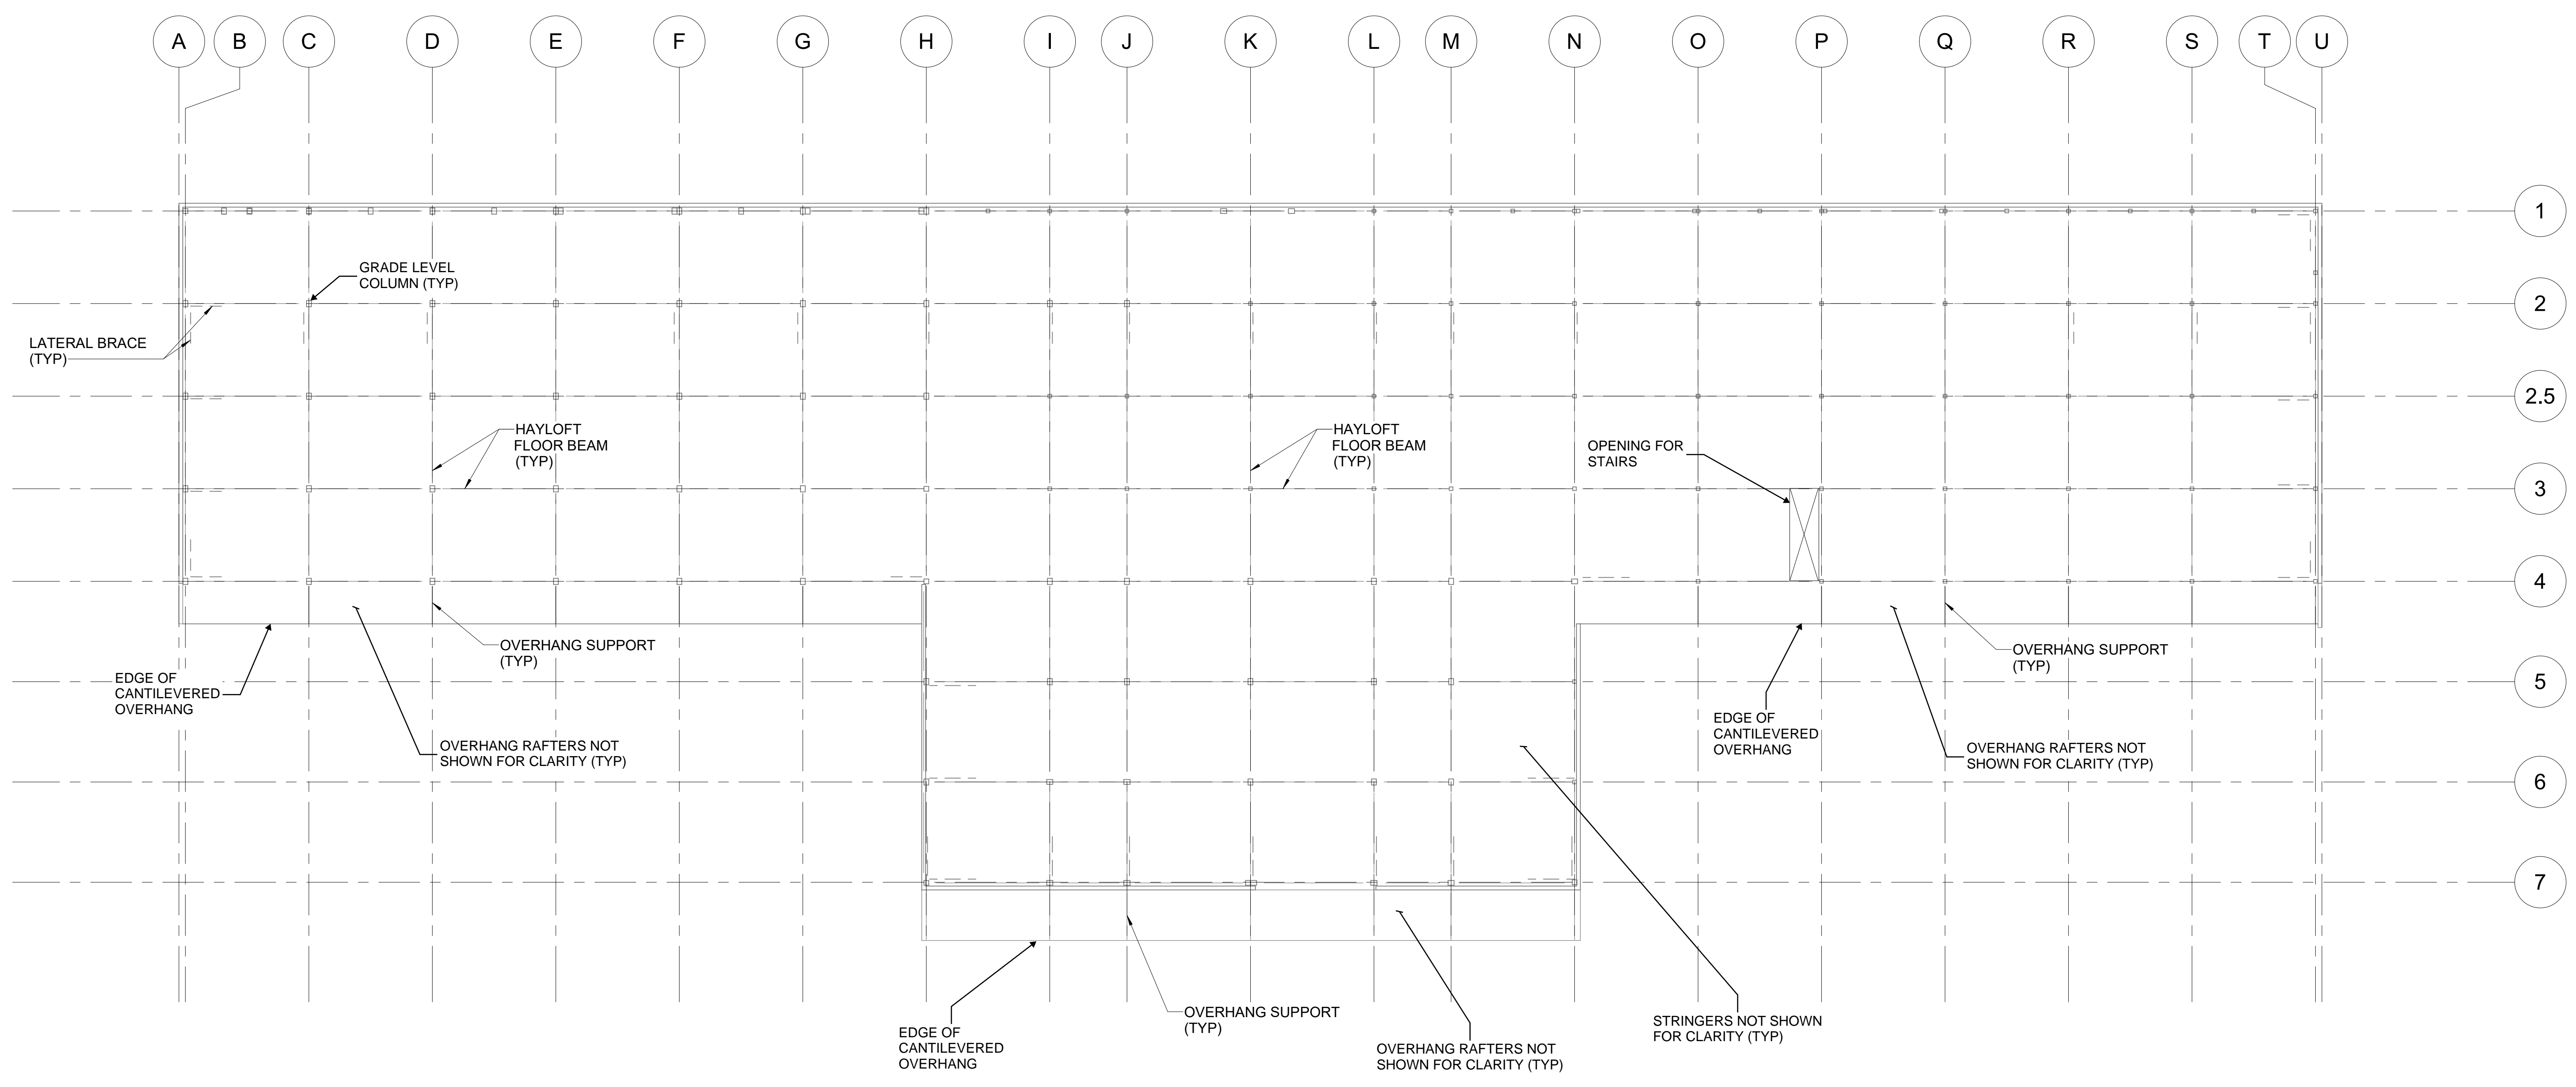
1 OVERALL HAYLOFT FRAMING PLAN
 SCALE: 3/32" = 1'-0"

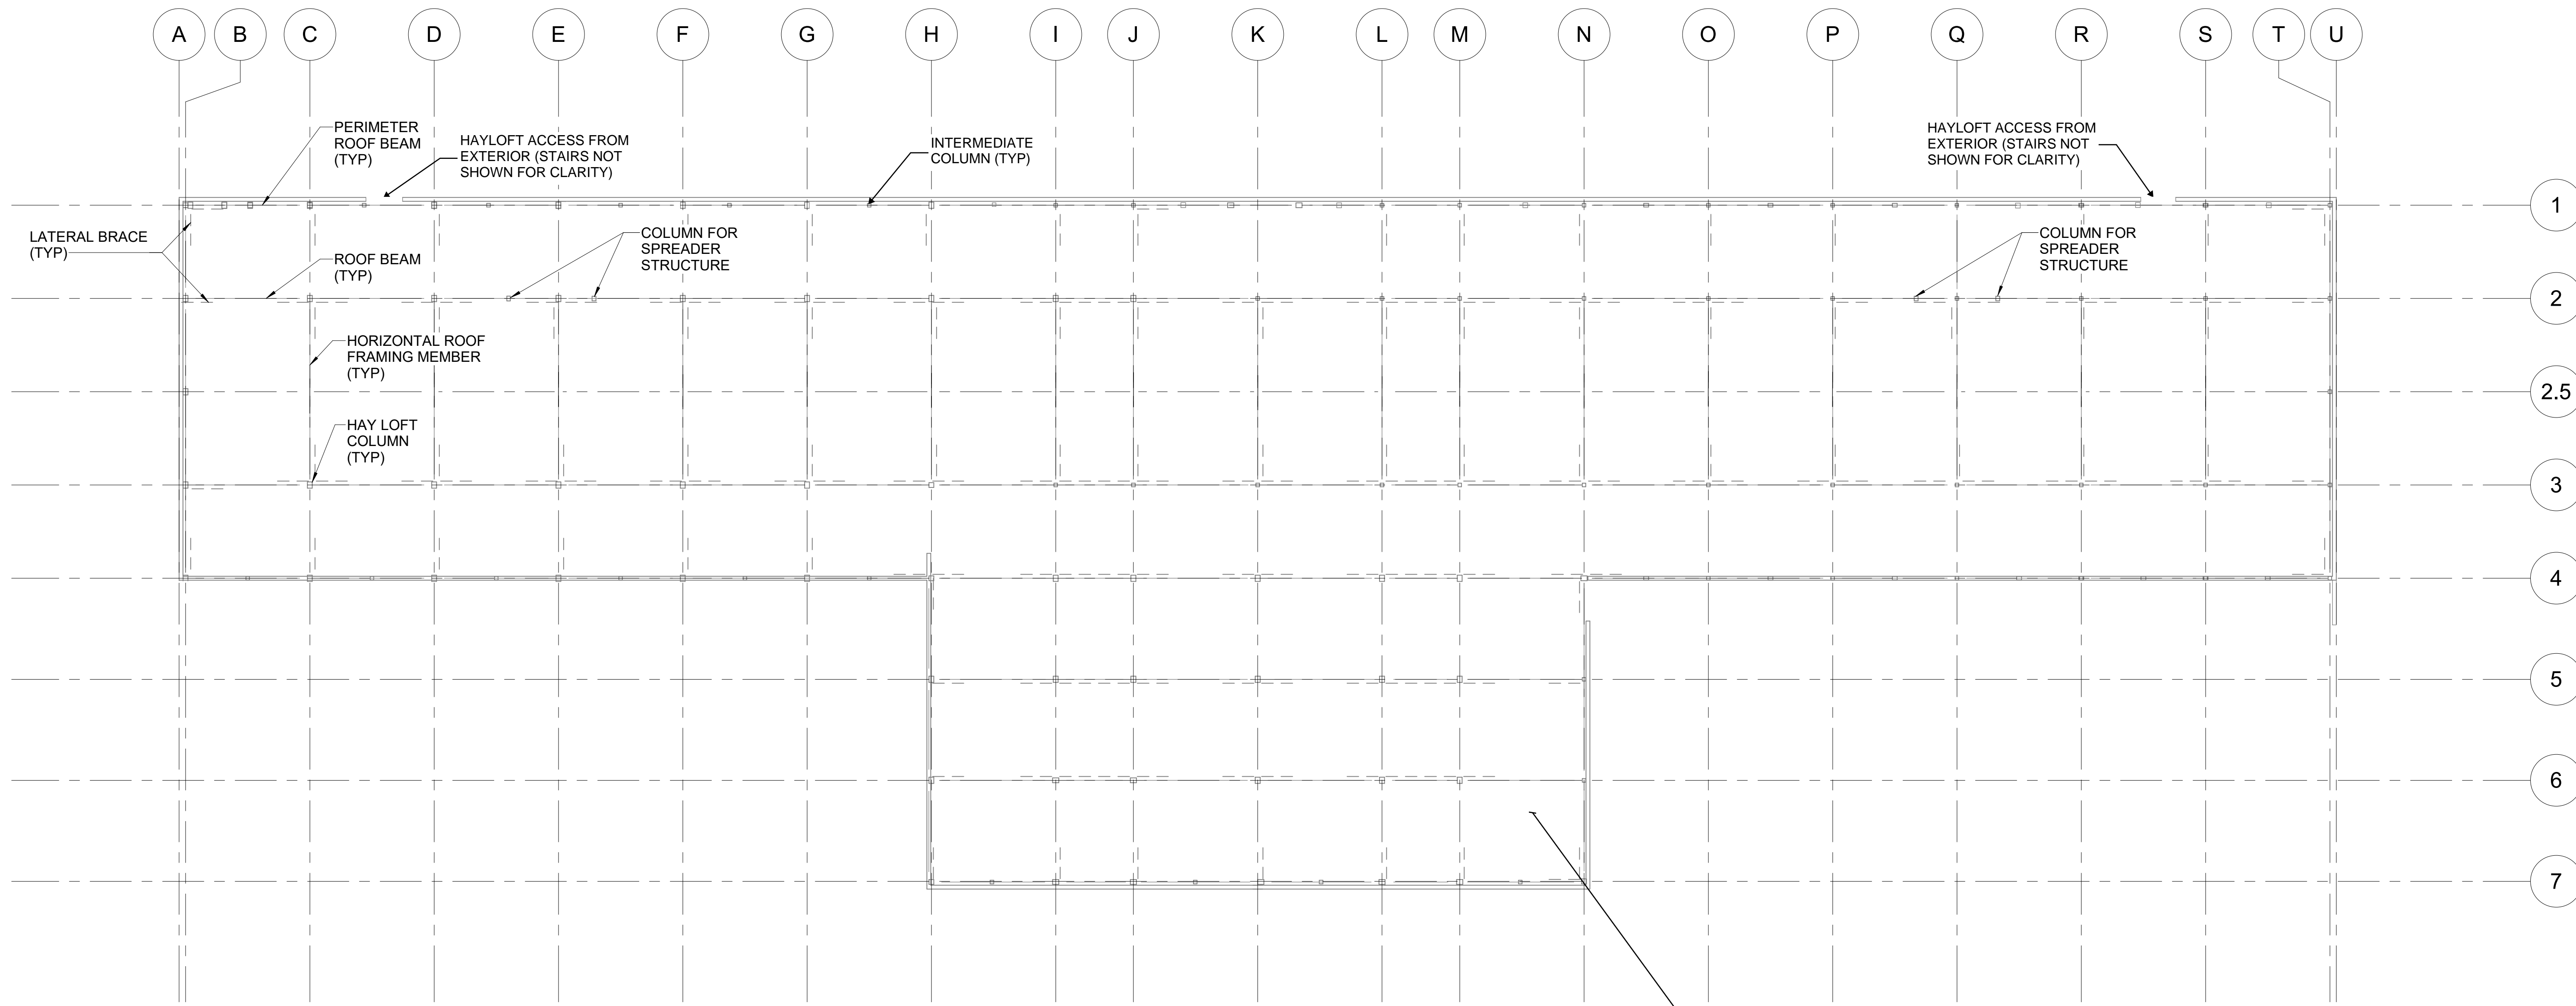
1 OVERALL ROOF SUPPORT PLAN
 SCALE: 3/32" = 1'-0"

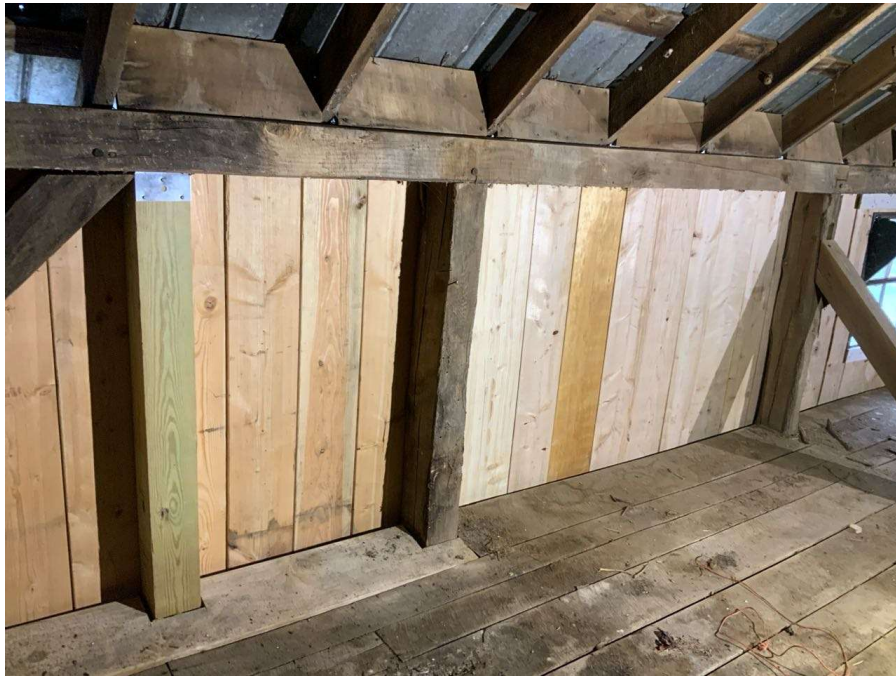
Photo G-9: General view of an intermediate column supporting a roof beam along the perimeter in the hayloft. Intermediate column between Columns B/1 and C/1 shown looking northeast. Note an additional intermediate column was added at this location during a previous repair.

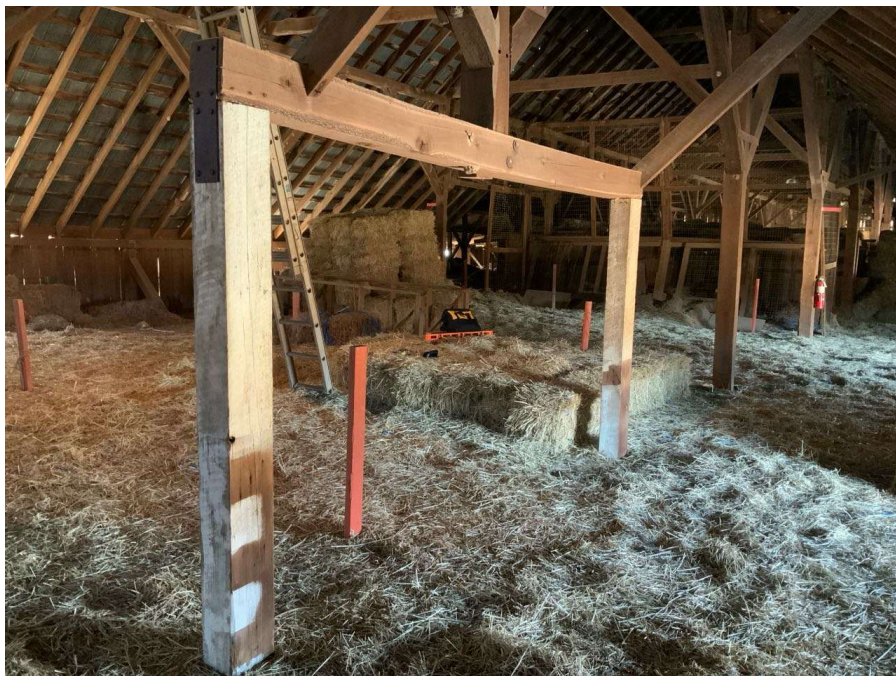
Photo G-10: General view of a load transfer spreader beam structures in the hayloft. Structure at Column Q/2 shown looking southwest.

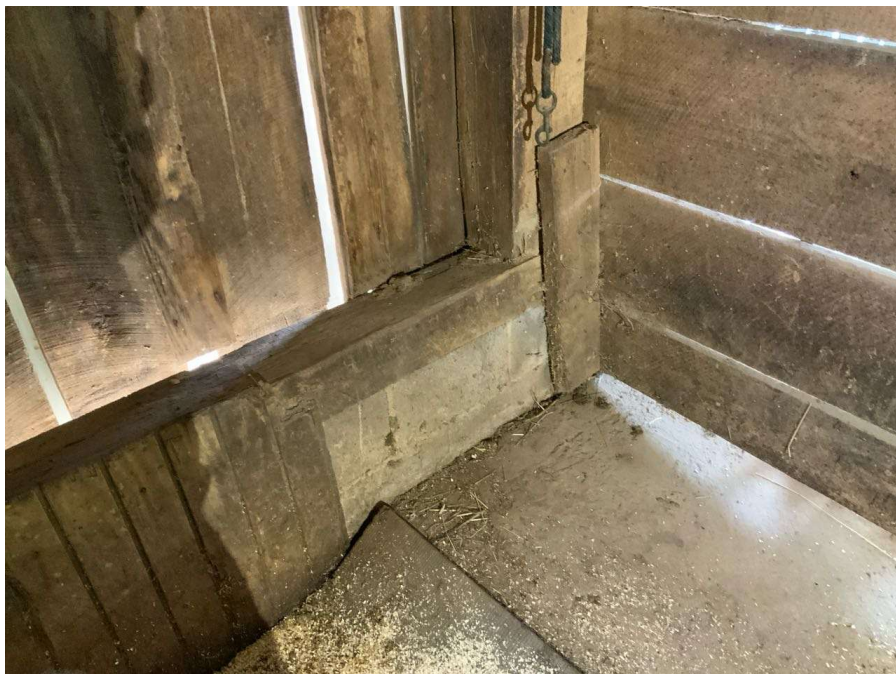
Photo G-20: General view of a perimeter grade level column supported by timber sill plate and CMU foundation wall. Column B/1 shown looking northwest.

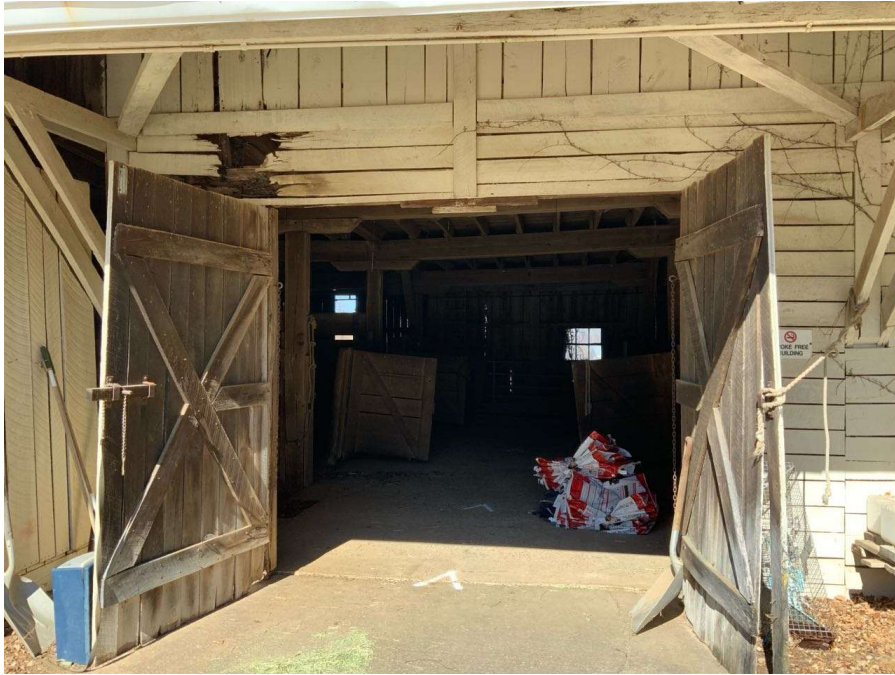
Photo G-21: General view of the concrete slab-on-ground walkway within the aisles of the barn. Walkway at the west wing between Gridlines F and G shown looking north.

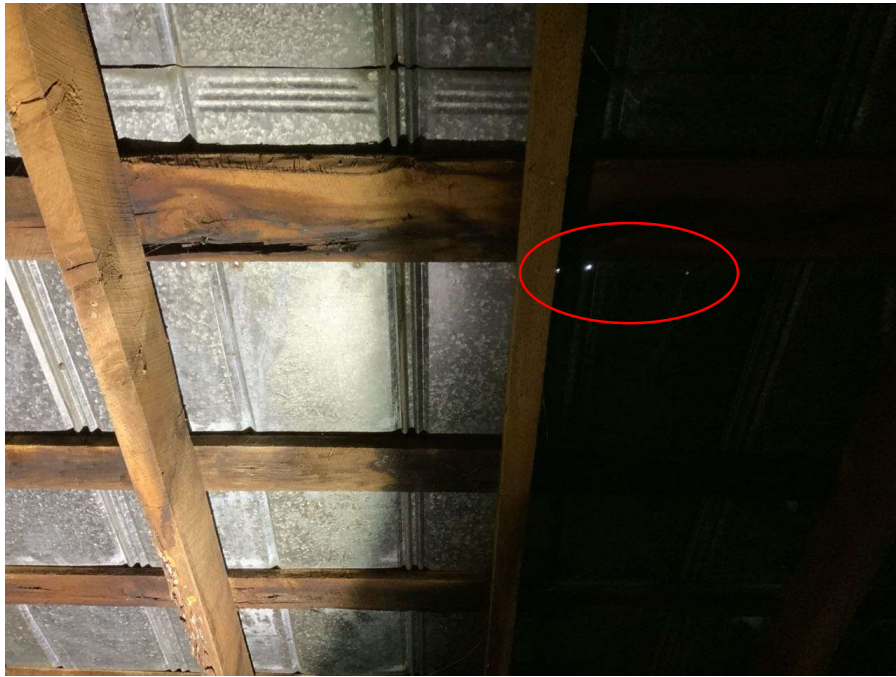
Photo S-1: Typical pinhole leak in roof metal deck. Deck near Column L/6 shown.

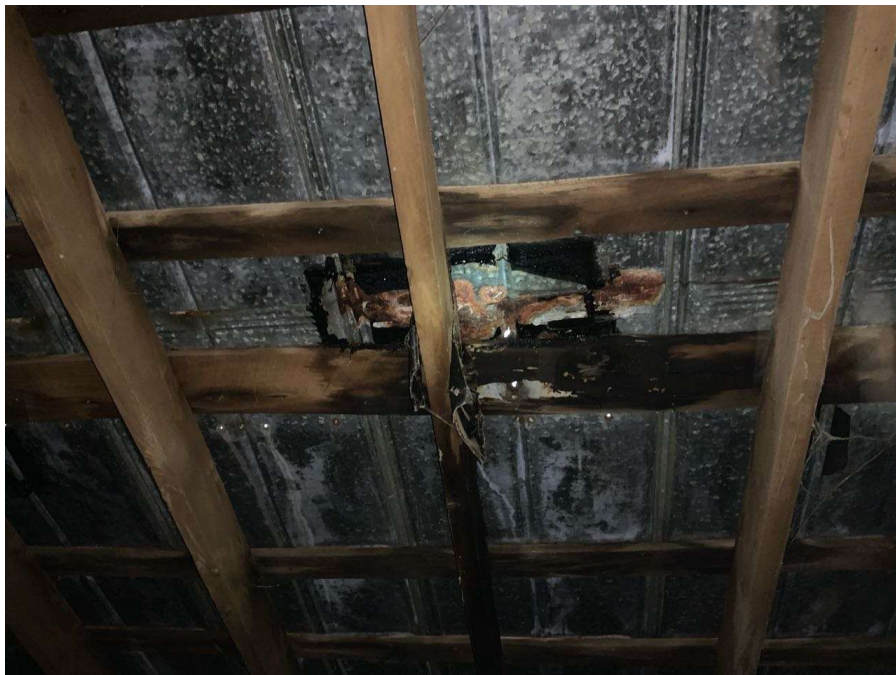
Photo S-2: Typical area of rusted roof deck and failing patch. Deck near Column L/6 shown.

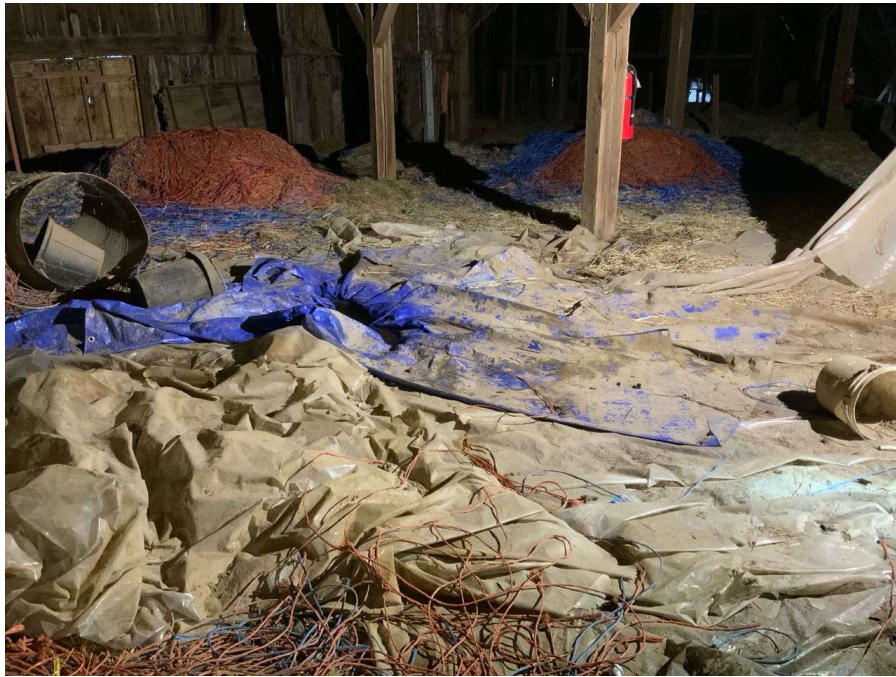
Photo S-3: Tarps with standing water on the hayloft flooring underneath the lean-on region of the structure. Floor shown looking northwest along Gridline 6.

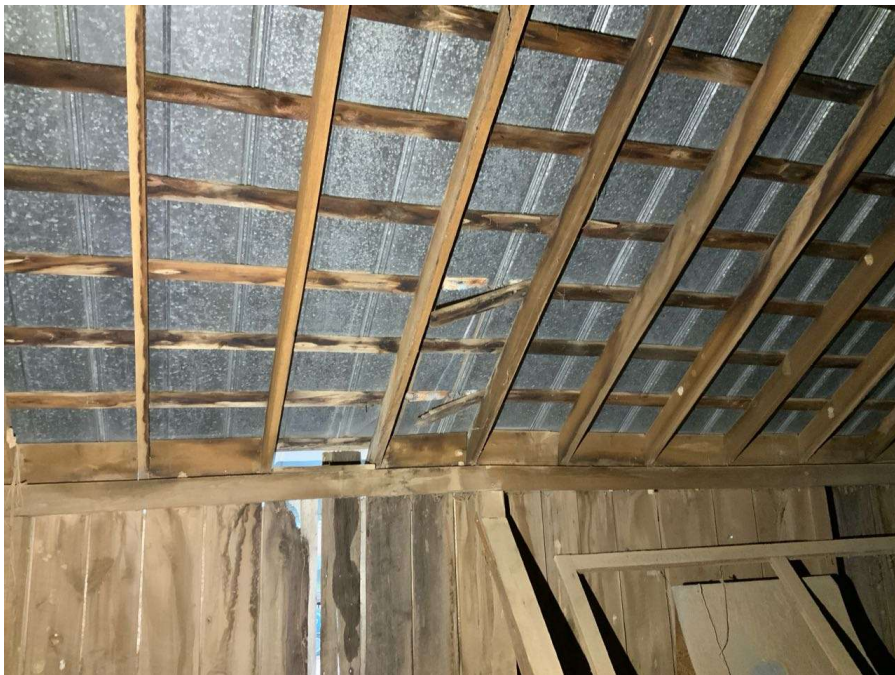
Photo S-8: Typical water saturated and broken roof purlins. Roof near Column F/4 shown looking southwest.

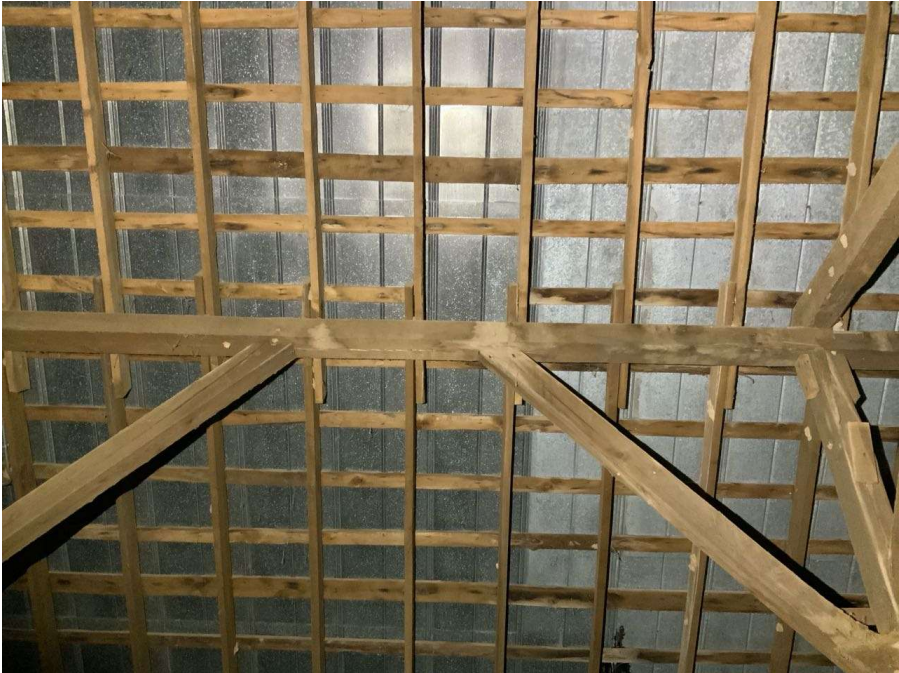
Photo S-9: Broken/missing roof purlin. Roof deck near Column L/2 shown looking north.

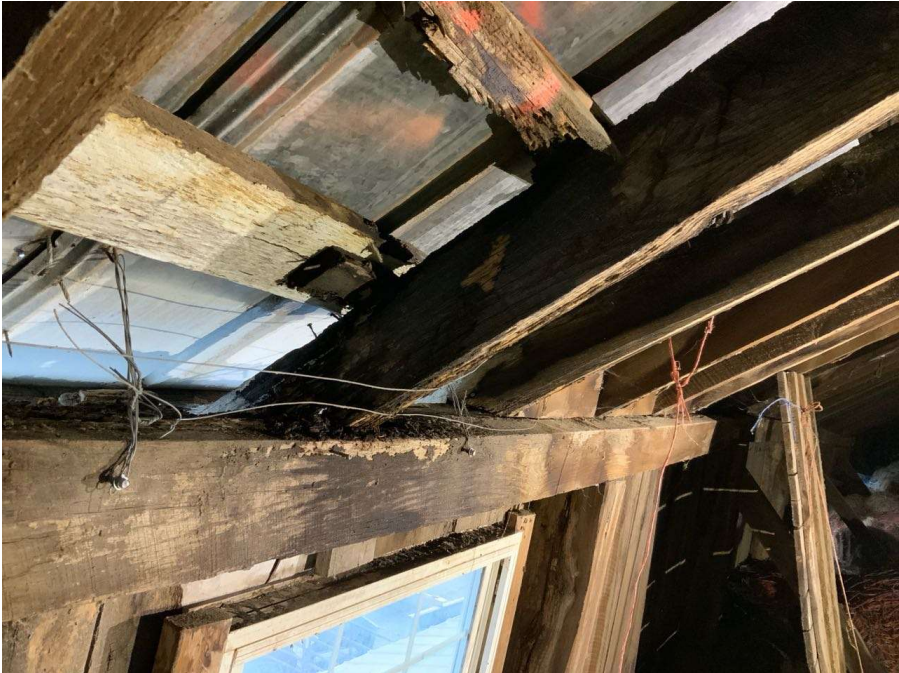
Photo S-10: Rotted rafters with full icepick penetration along Gridline 4 between Gridlines R and S.
