EQUESTRIAN BARN AT AVENEL

CONDITION ASSESSMENT REPORT

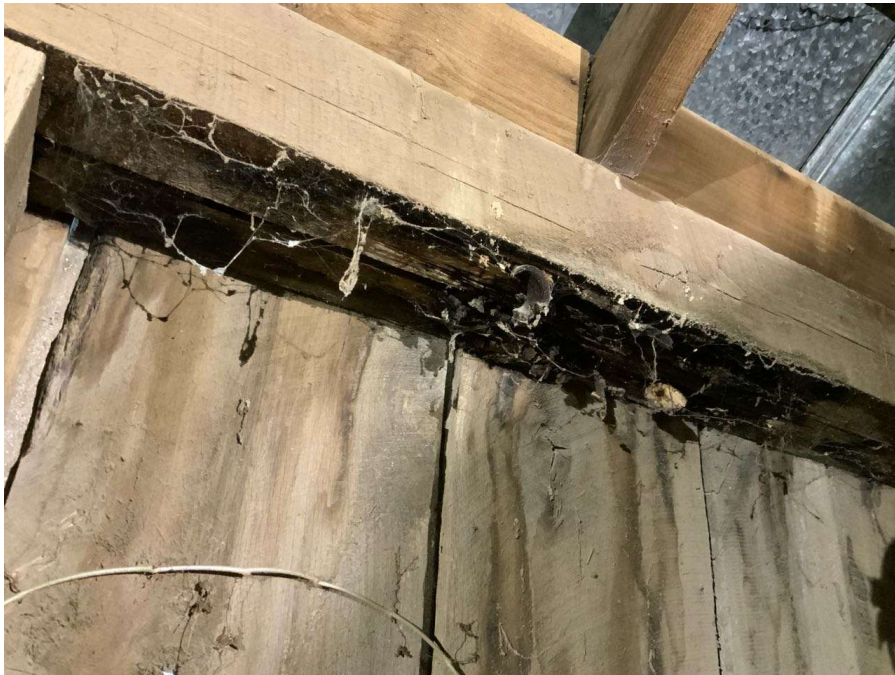
Photo S-20: Roof beam between Columns D/4 and E/4 exhibits rot with full icepick penetration.

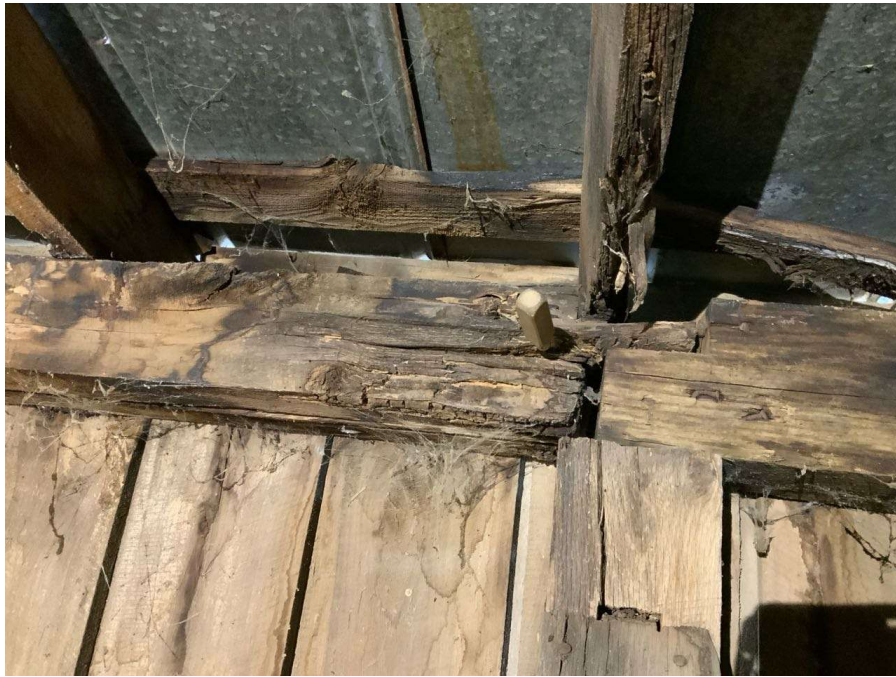
Photo S-21: Roof beam between Columns I/7 and J/7 exhibits rot with full ice pick penetration at west bearing.

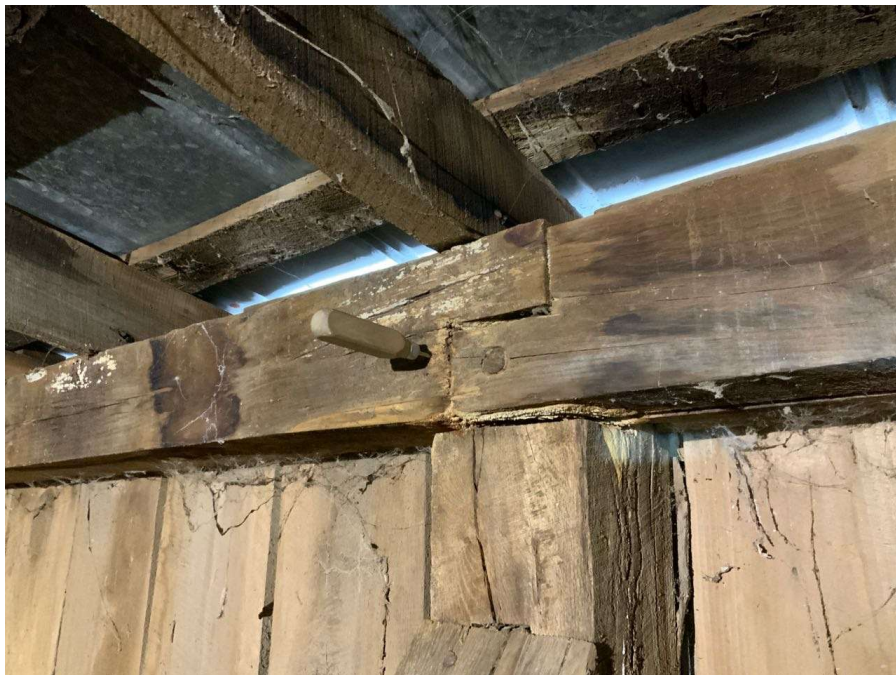
Photo S-22: Roof beam between Columns K/7 and L/7 exhibits rot with up to 4" deep ice pick penetration at west bearing.

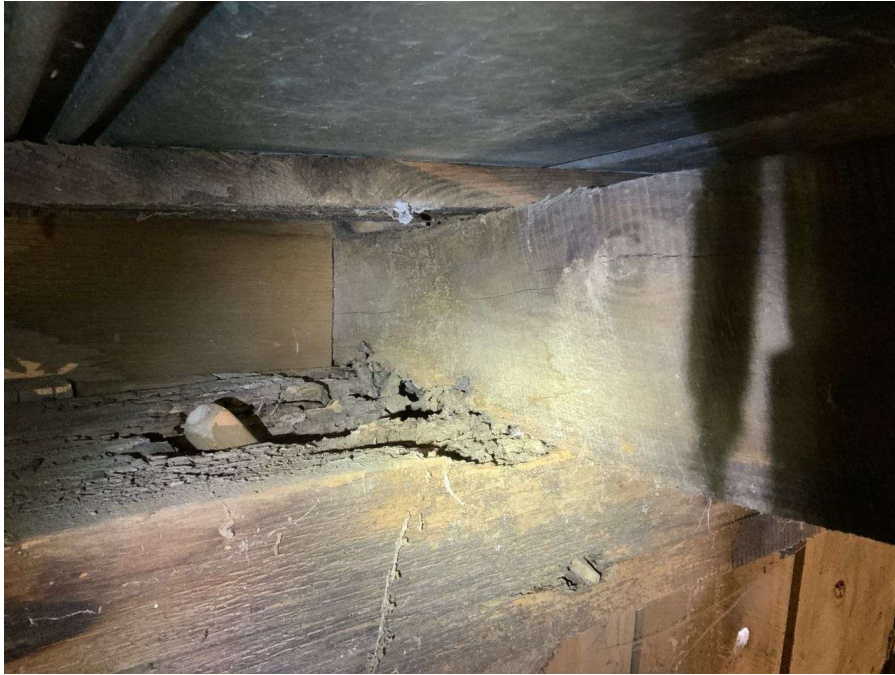
Photo S-23: Roof beam between Columns M/7 and N/7 exhibits rot with significant section loss under roof stringer. Note the icepick is fully inserted in top of beam.

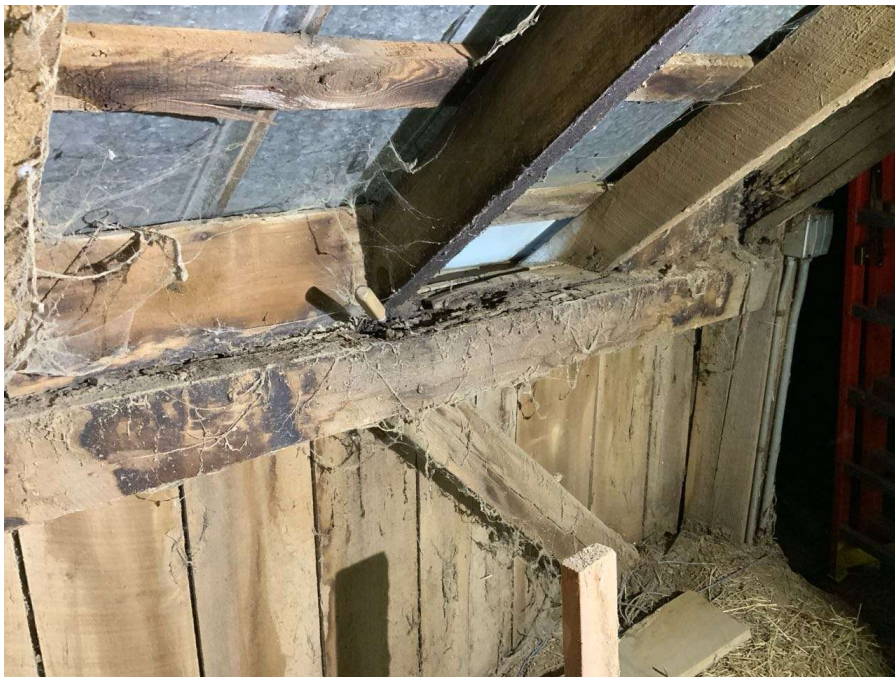
Photo S-24: Roof beam between Columns N/4 and O/4 exhibits rot with up to full icepick penetration in top face at west bearing over a 6ft length.

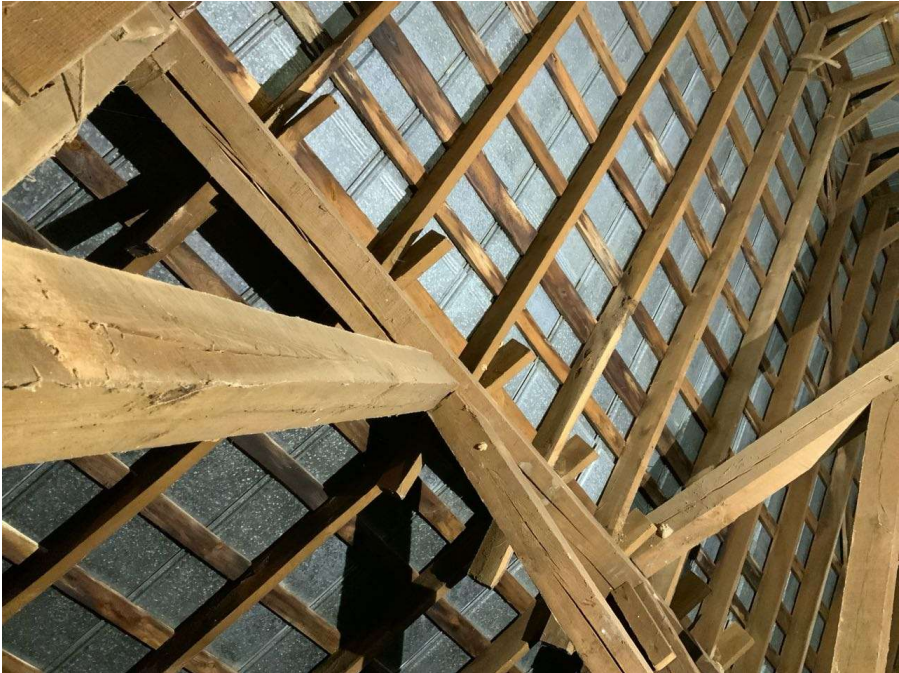
Photo S-25: Typical check on bottom face of interior roof beam. Roofbeam between Columns I/3 and J/3 shown.

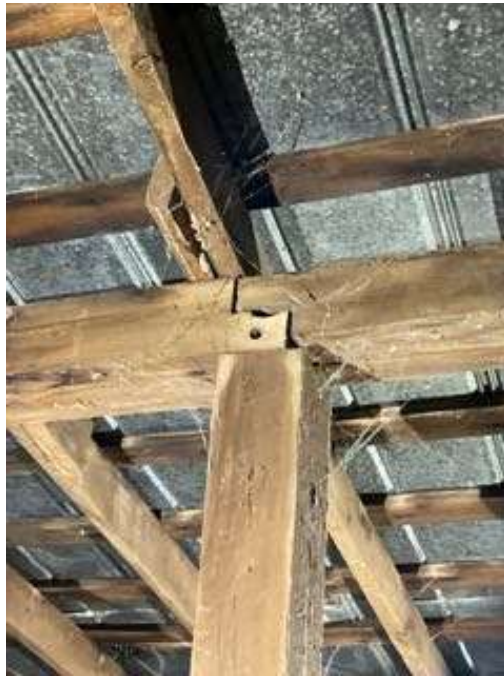
Photo S-29: Roof beam dowel is deteriorated/missing at Column M/5 (looking south).

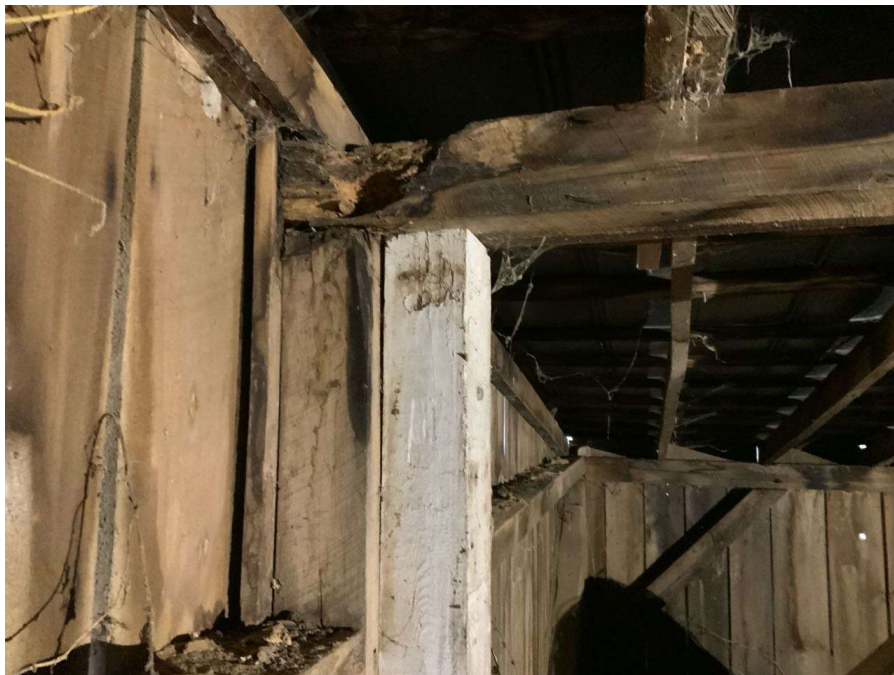
Photo S-30: Beam between Column M/6 and N/6 exhibits rot with full pick penetration at east bearing. A 5.25" x 5.25" post has been added to the west side of the column to help support the beam.

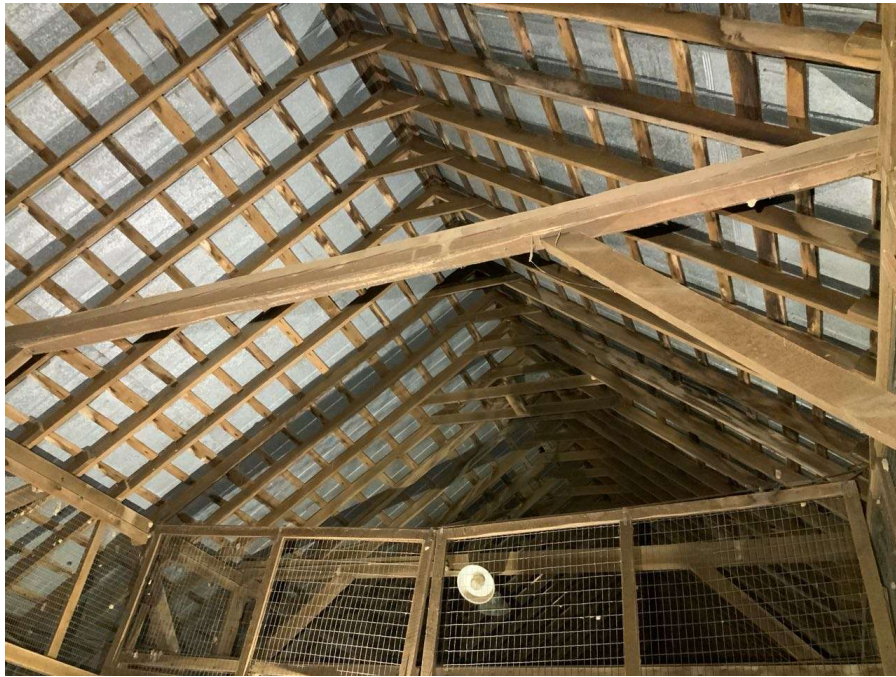
Photo S-31: Potential split at horizontal frame member between Columns G/2 and G/3 in the hayloft (looking east). The member appears to have excessive deflection compared to other similar members.

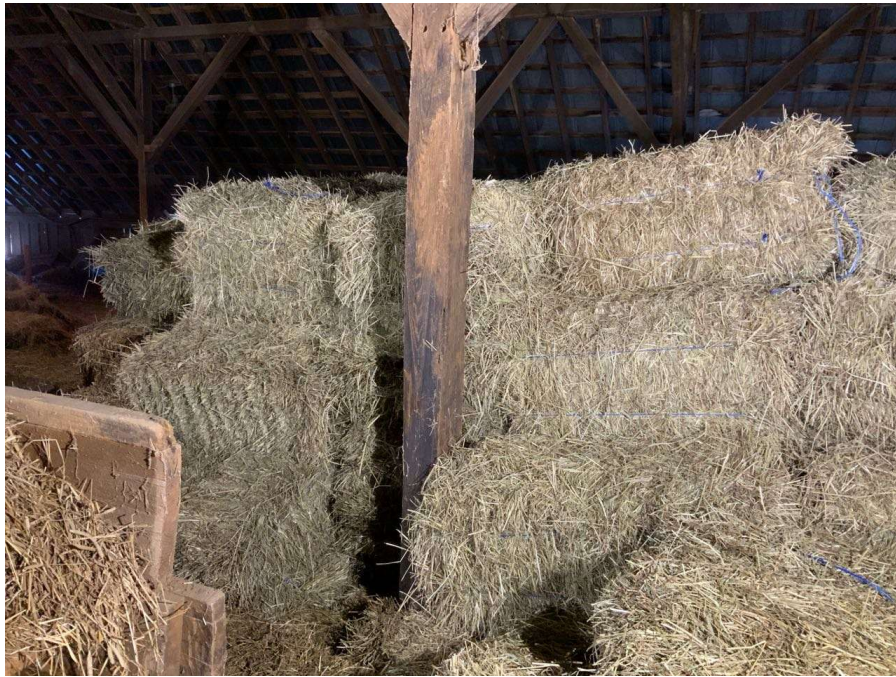
Photo S-35: Column M/3 in hayloft exhibits water staining and soft rot with minimal ice pick penetration (looking northwest).

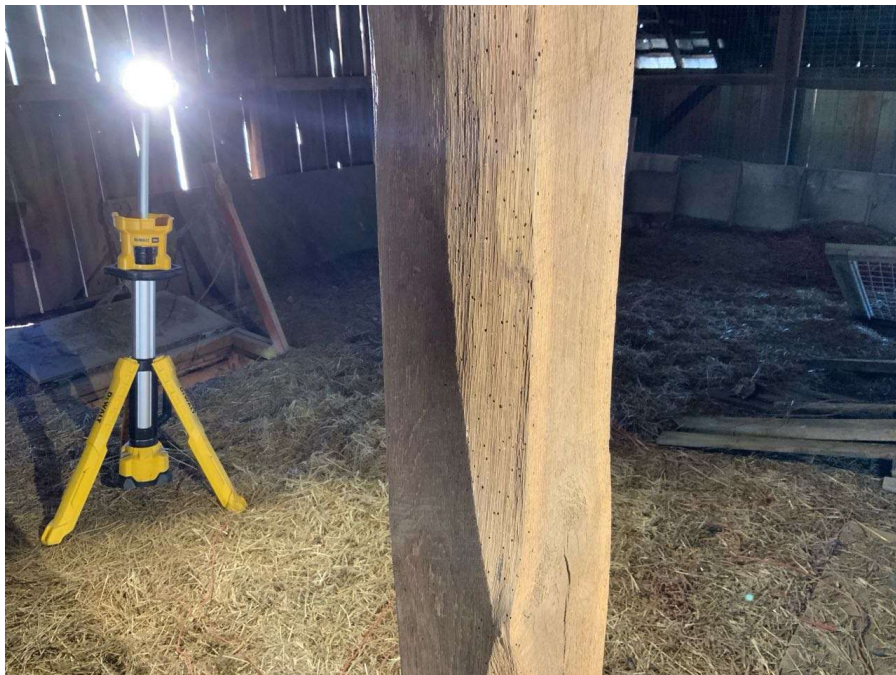
Photo S-36: Small holes at the base of the columns in the hayloft likely from insects or animals. Column C/3 looking northwest shown.

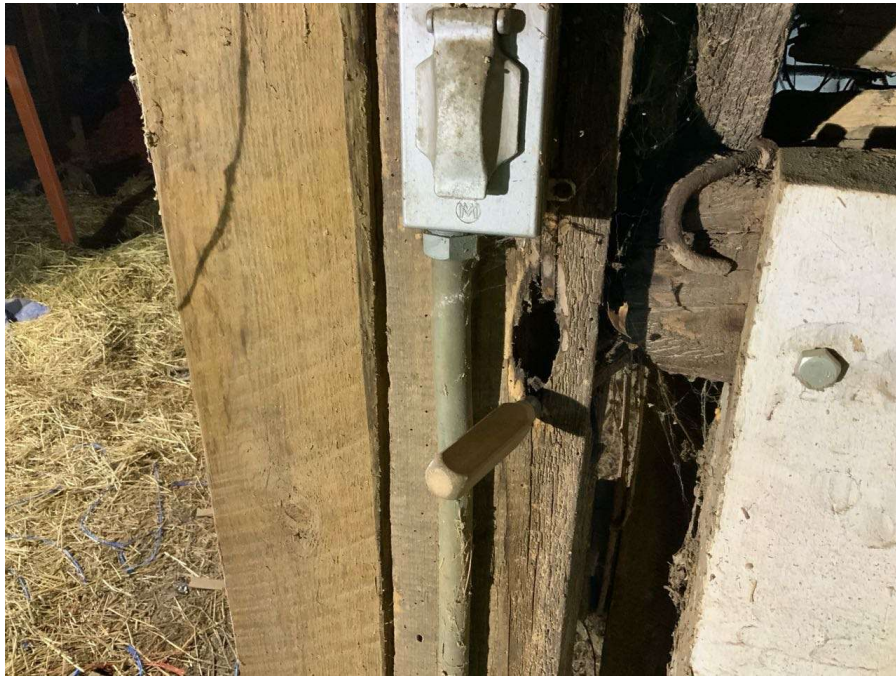
Photo S-39: Severe rot at original Column H/4 in hayloft (looking south). Note a newer column has been installed to the east of the existing column.

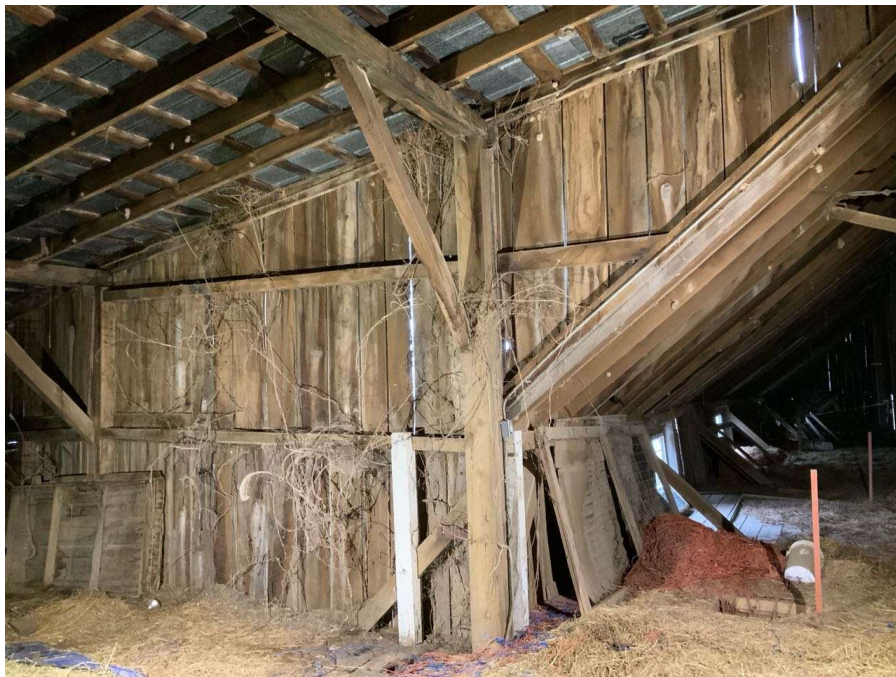
Photo S-40: New column and posts supporting wind girt and roof beam at Column H/4 in hayloft (looking southwest). Note the south brace is connected with an ineffective strap to the new column.

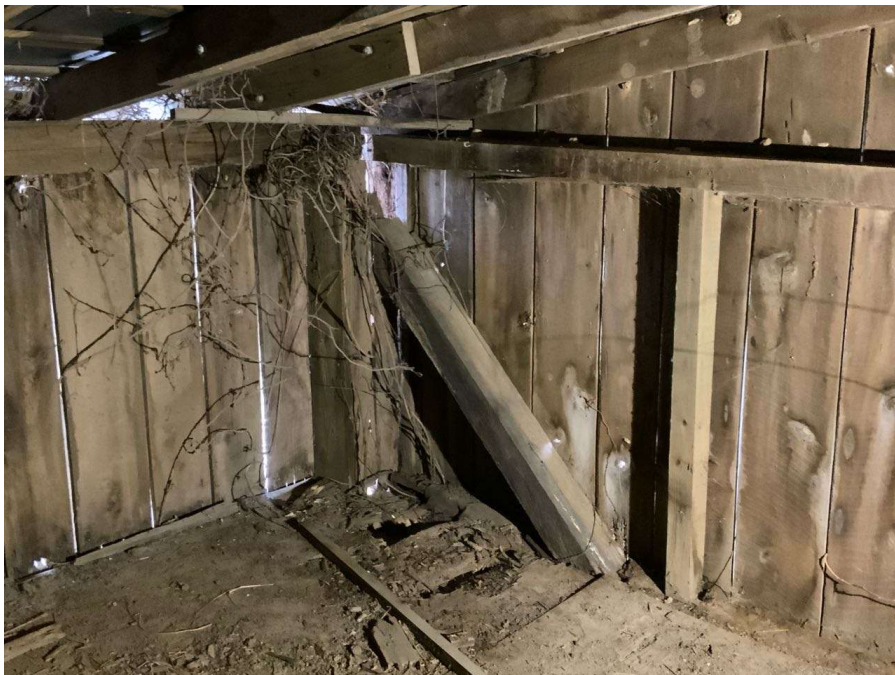
Photo S-42: Severe rot at top of original Column H/7 in hayloft (looking southwest). A new post has been installed to the east of the existing column. The north brace and wind girt are not connected to the new post and the east brace is missing. The floorboards adjacent to the column are rotting.

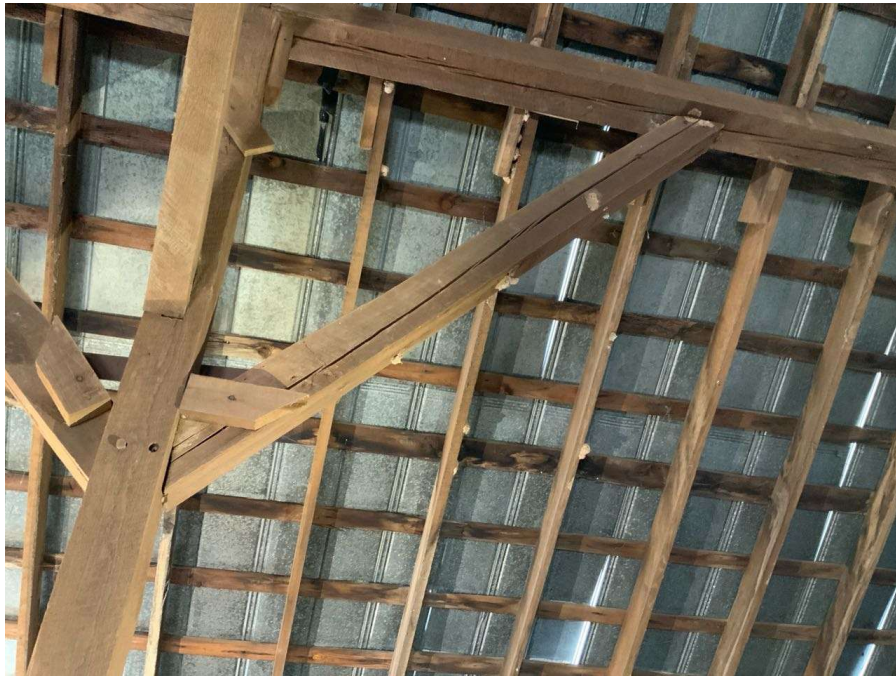
Photo S-43: Typical check in the east/west knee braces in hayloft. West brace at Column C/3 shown looking south.

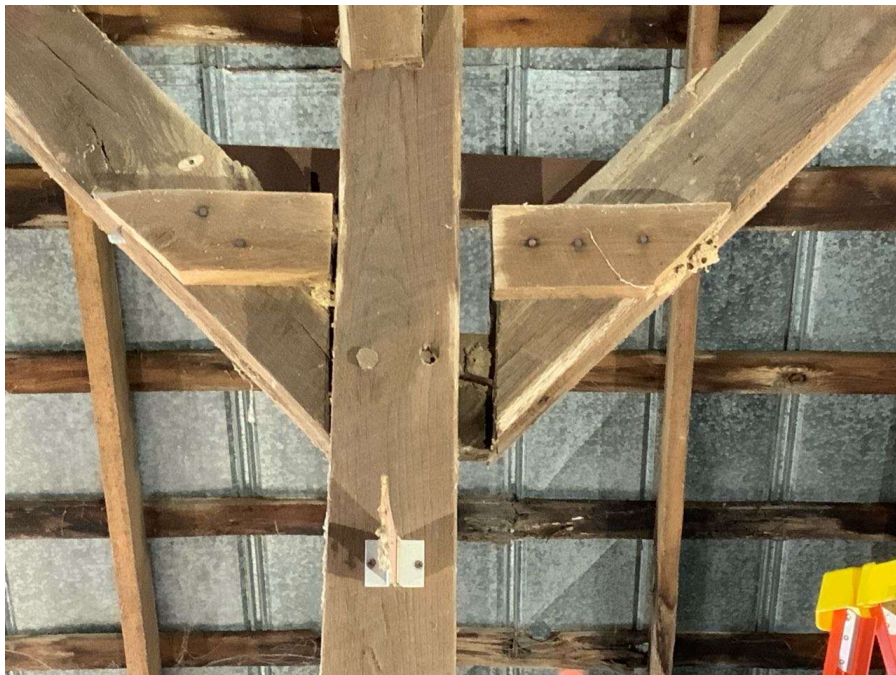
Photo S-50: The west brace at Column R/3 in hayloft is disconnected at the base connection to the column. The dowel at this connection is missing.

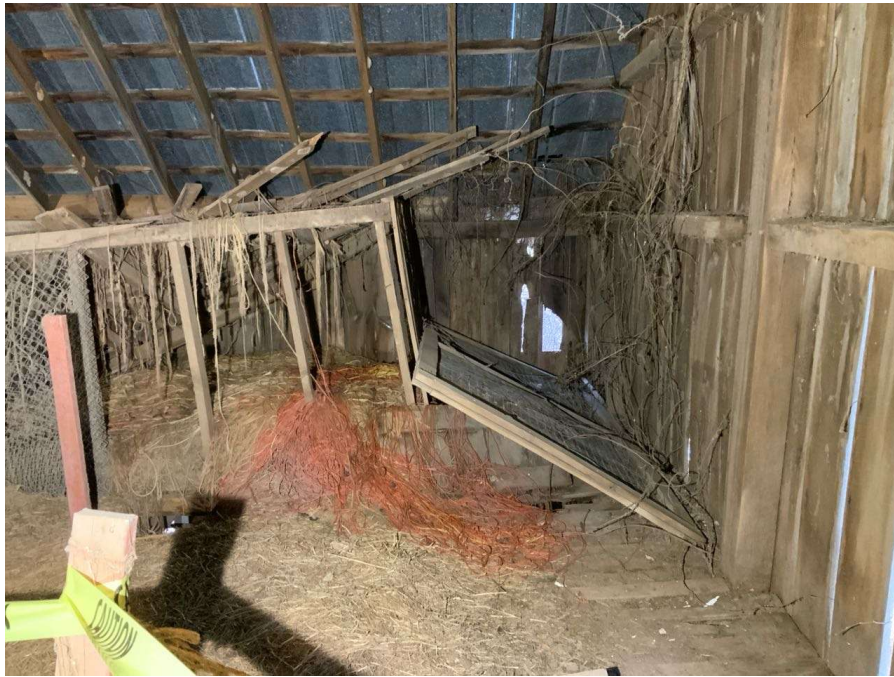
Photo S-51: The east brace at Column B/4 in hayloft appears to be missing based on similar geometry in other portions of the building (looking south).

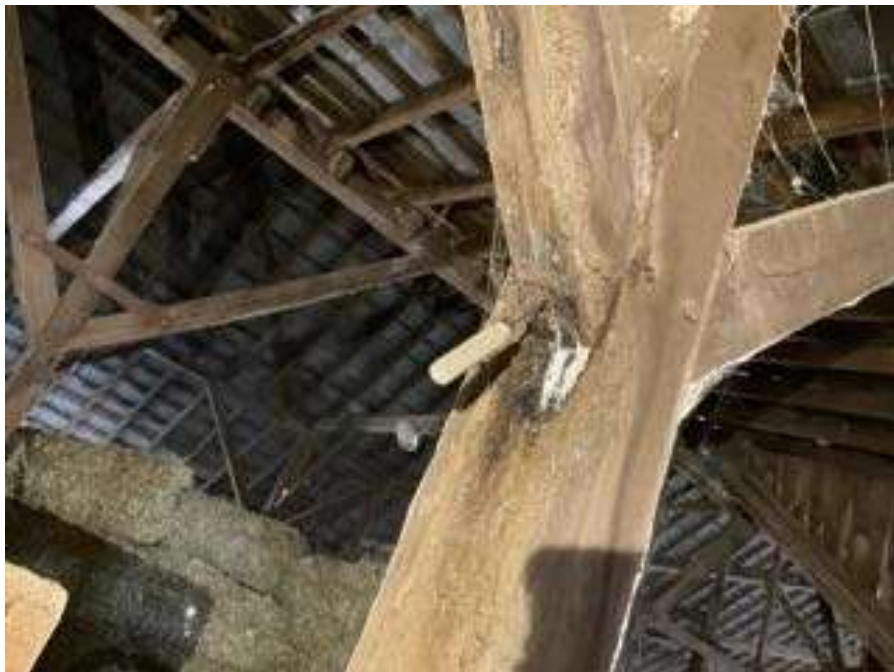
Photo S-52: The west brace at Column M/4 in hayloft exhibits rot at the base connection to the column (looking north).

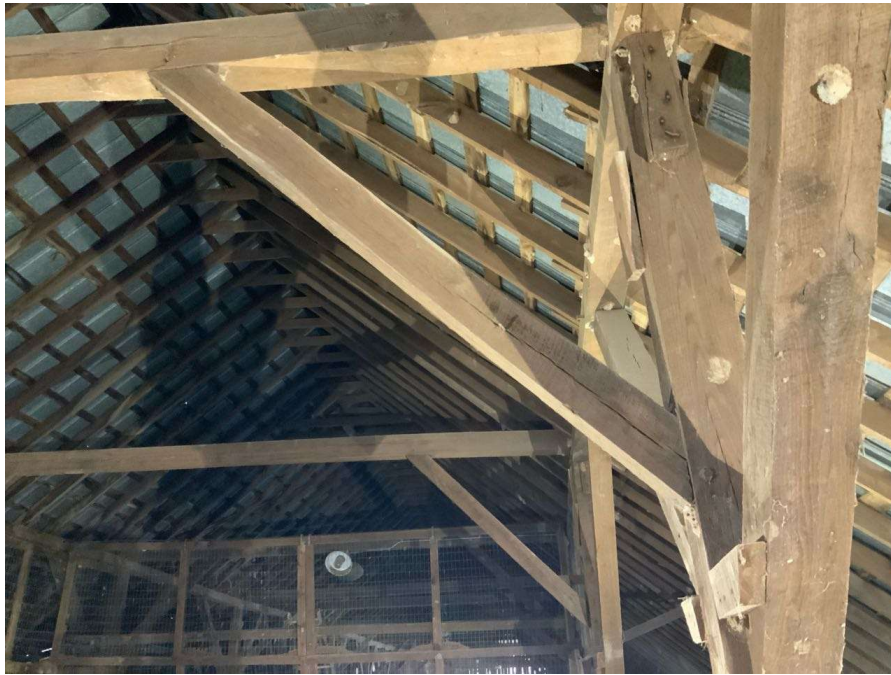
Photo S-53: Split in the south brace of Column P/2 in hayloft (looking west)

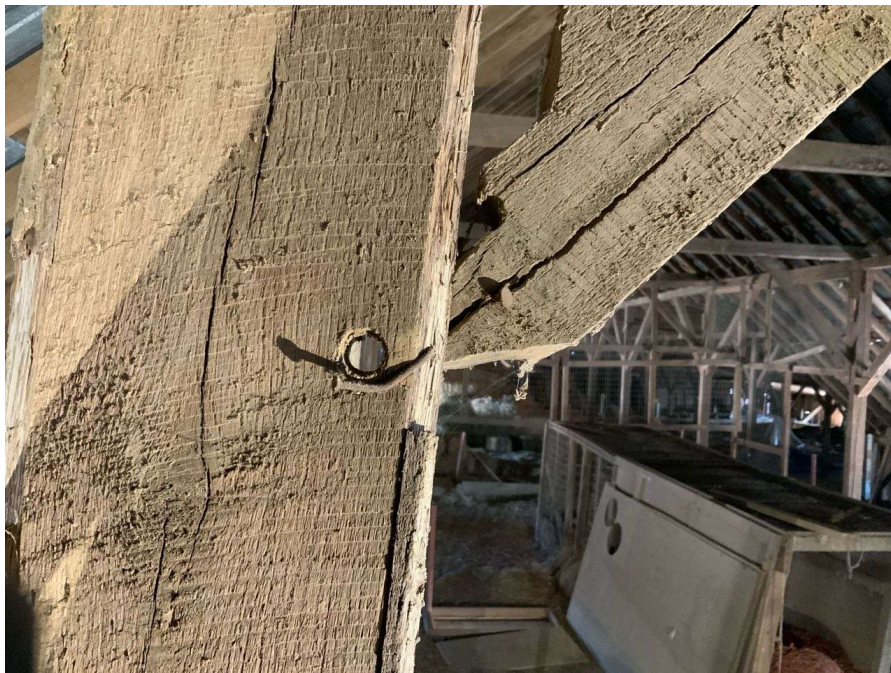
Photo S-54: South brace at Column E/2 in the hayloft is disconnected at the base connection to the column. The dowel hole is broken and only a small sliver of the brace is still within the mortise slot.

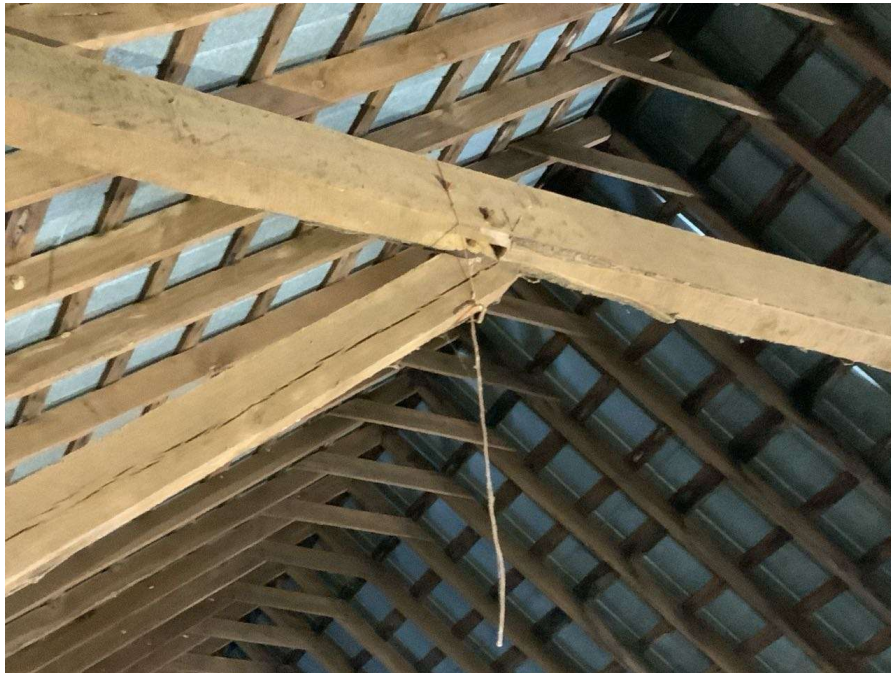
Photo S-55: South brace at Column F/2 in the hayloft is disconnected at the top connection to the horizontal frame member. The brace is no longer within the slot and held up by a single steel strap (looking east).

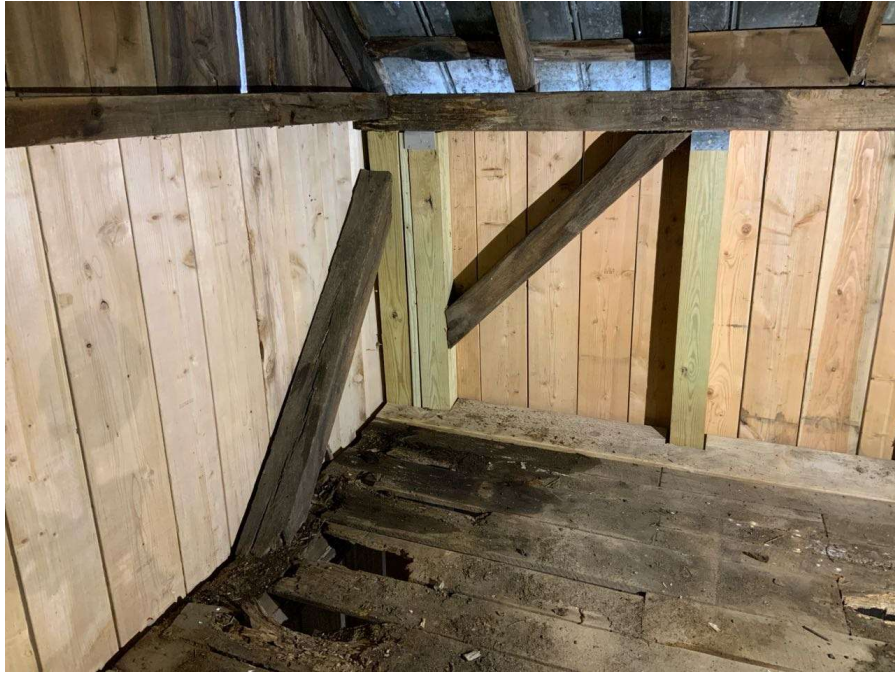
Photo S-61: South brace at Column B/1 in hayloft exhibits rot at base connection to the floor beam. The wind girt and roof beam also exhibit signs of rot at the connection interface. Note broken floorboards in the region preventing hands-on access.

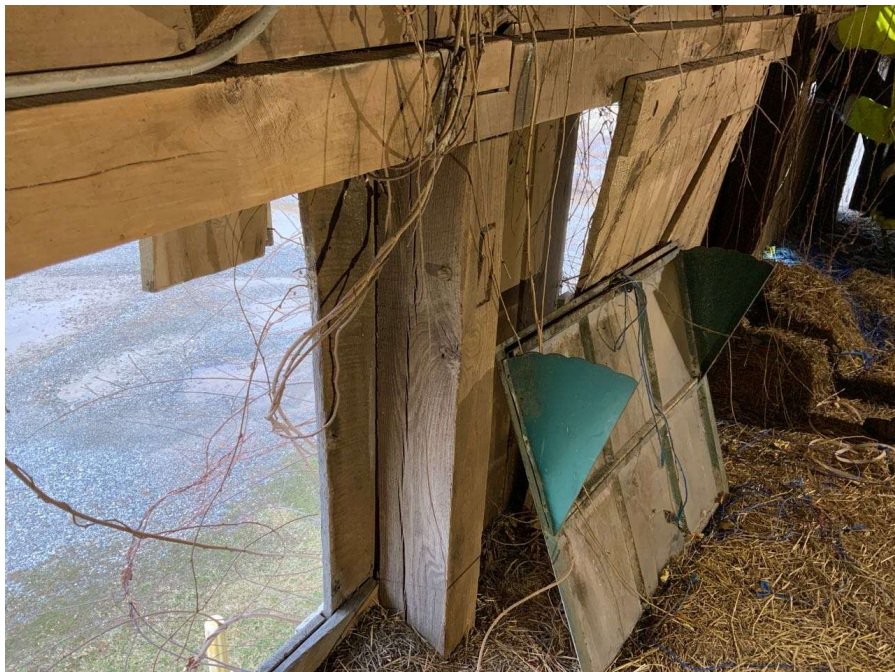
Photo S-62: South brace at Column Q/1 in the hayloft appears to have been cut off and removed, likely at the same time that the load transfer spreader structures were installed.

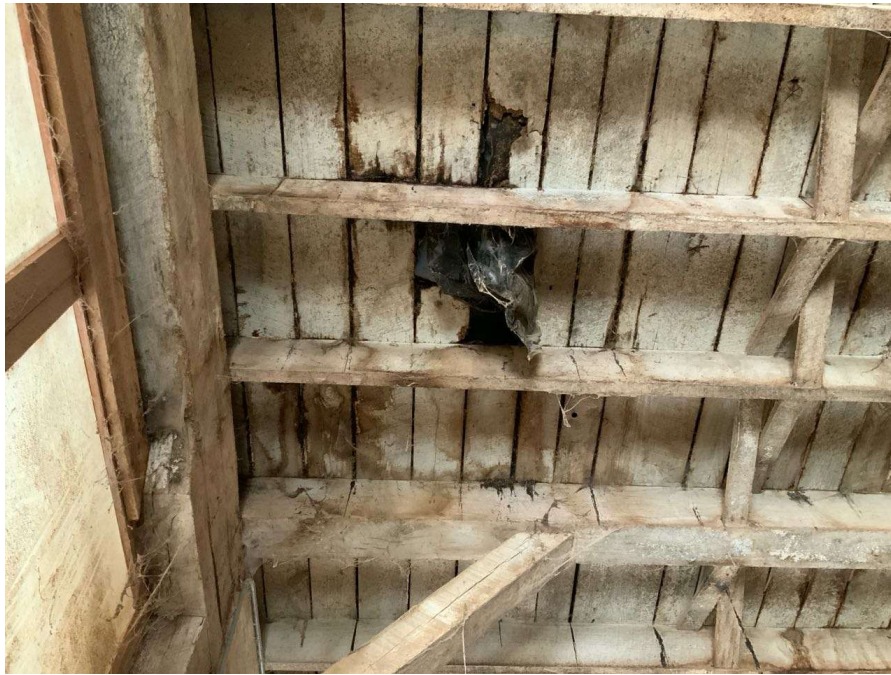
Photo S-67: Typical rotting/broken/missing floorboards. Lean-on portion of structure near Gridline 7 shown looking west.

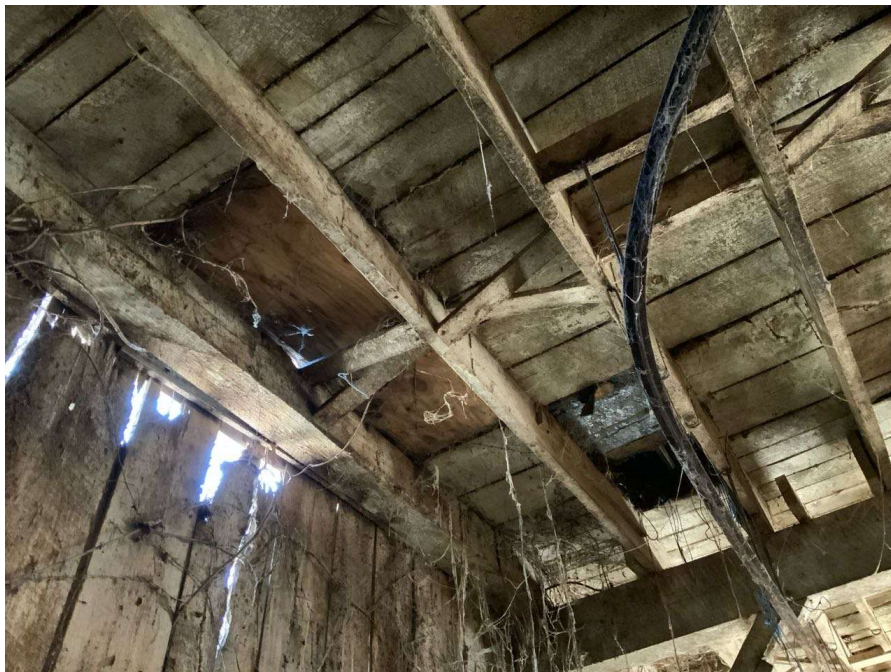
Photo S-68: Typical rotting/broken/missing floorboards. Lean-on portion of structure near Gridline N shown looking southeast. Note plywood has been installed to cover some openings.

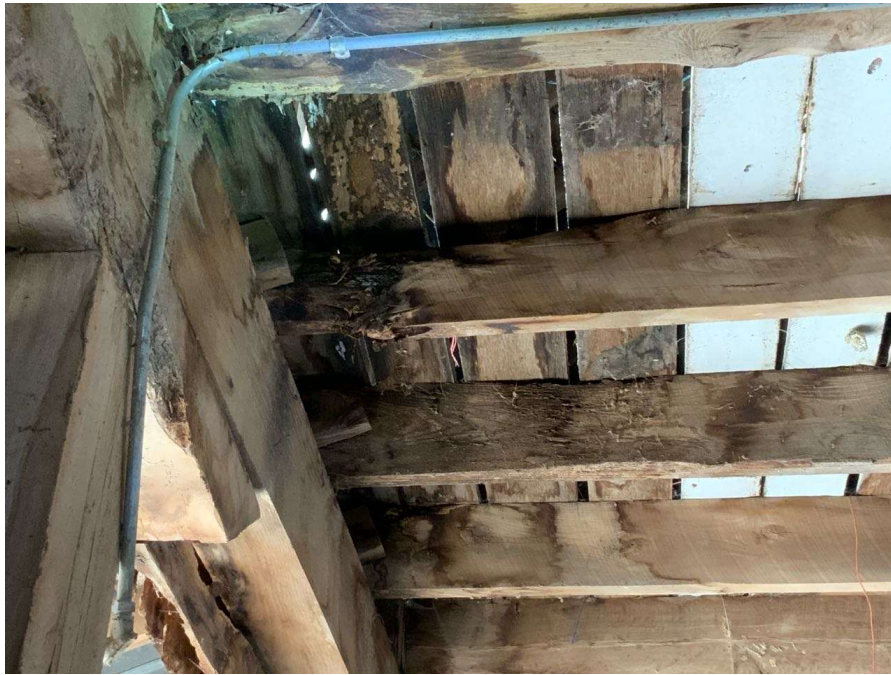
Photo S-69: Rotting floor stringer bearing on floor beam spanning between Column R/4 and S/4 (looking west).

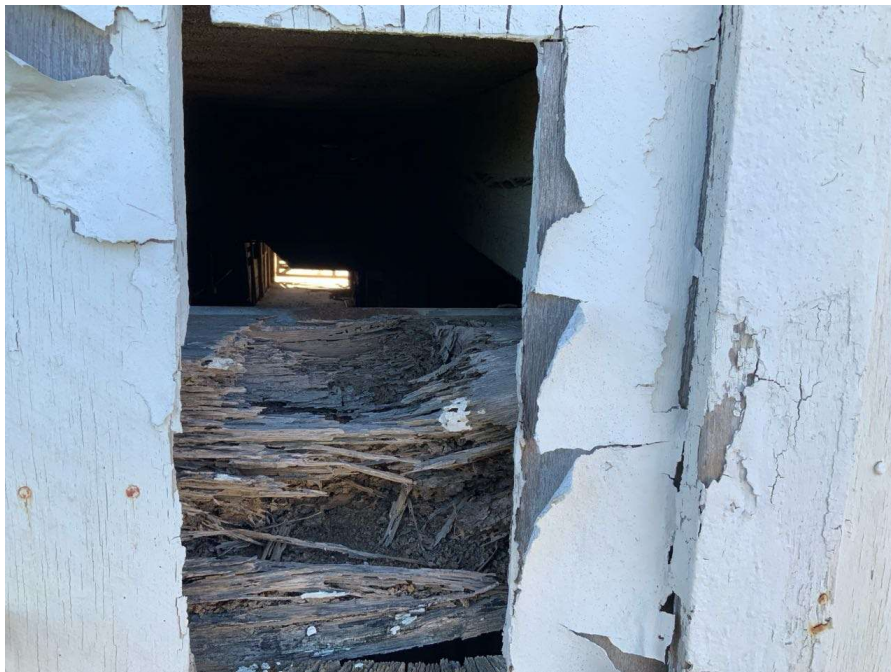
Photo S-82: Severe rot at floor beam between Columns I/1 and J/1. The west end of the beam has approximately 75% section loss.

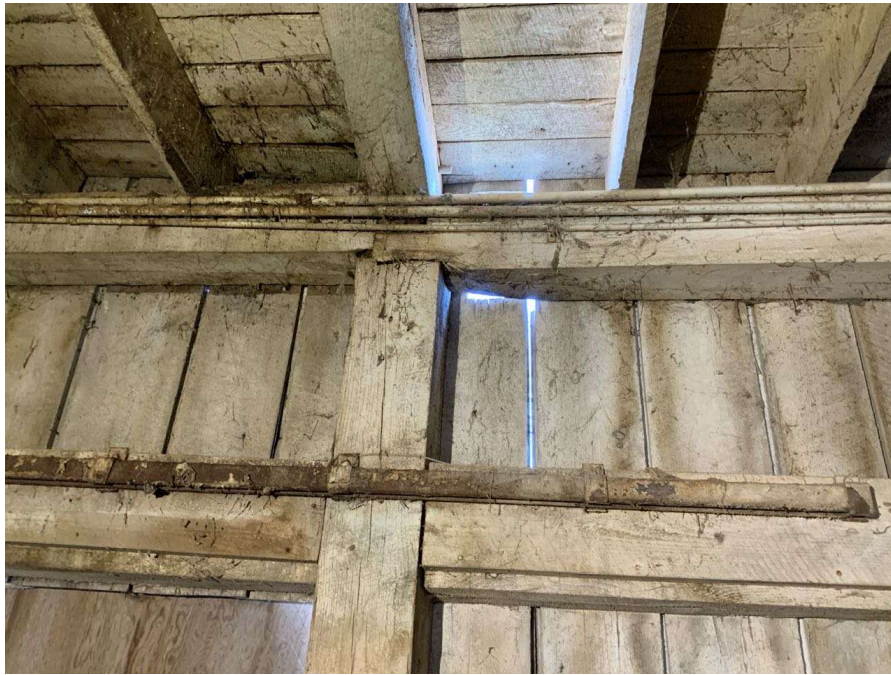
Photo S-83: Severe rot at floor beam between Columns I/1 and J/1. The west end of the beam has approximately 75% section loss. Beam crushing is observed at the bearing location.

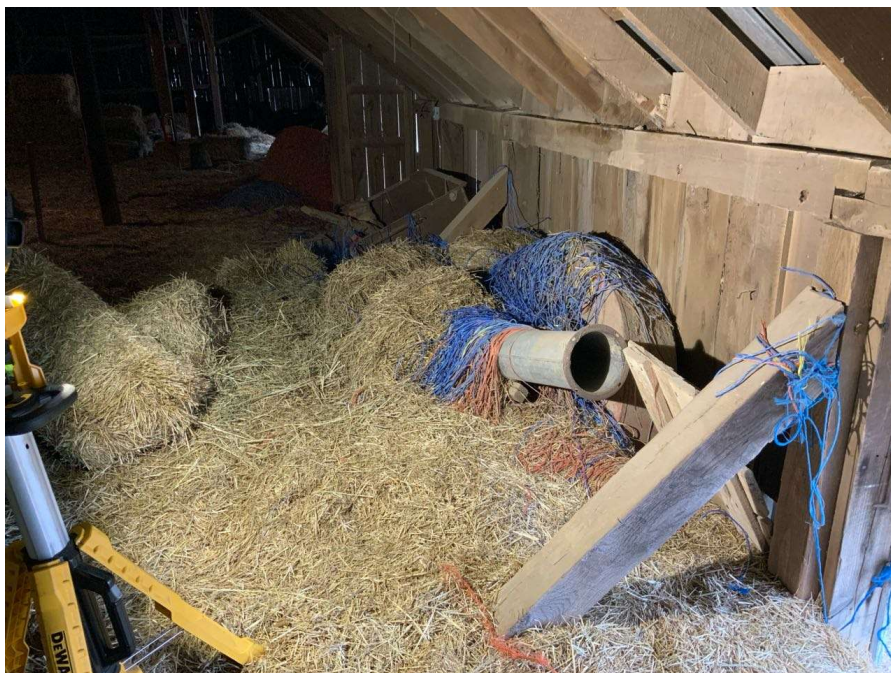
Photo S-84: Haybales and debris directly above severely rotted beam between Columns I/1 and J/1 in hayloft (looking northwest).

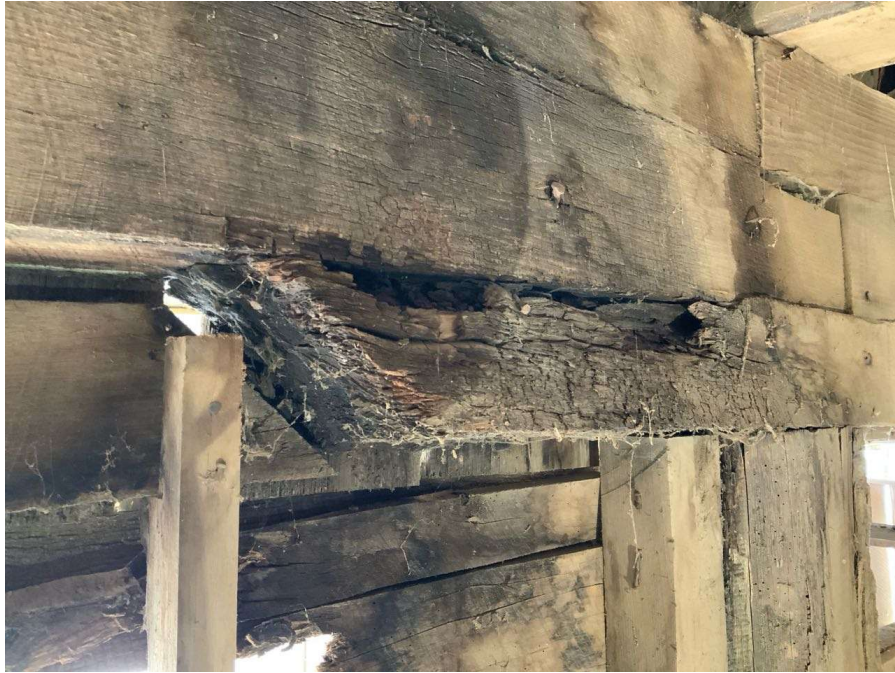
Photo S-85: Water damage and rot at west end of floor beam between Columns F/4 and G/4 (looking south). Supporting column cap at Column F/4 has severe rot.

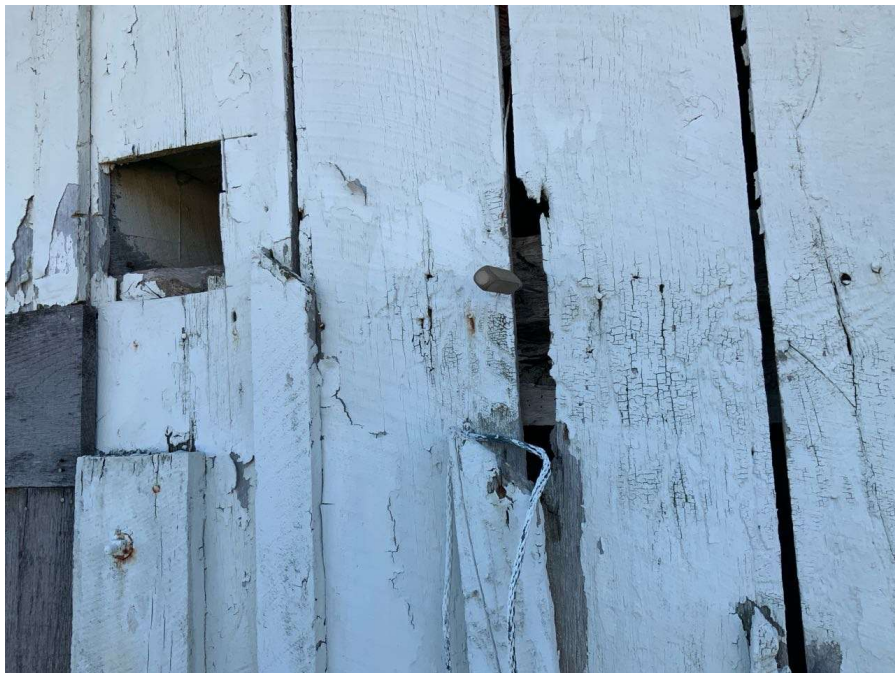
Photo S-86: Rot with 2" icepick penetration at east end of floor beam between Column J/1 and K/1 (looking south from exterior).

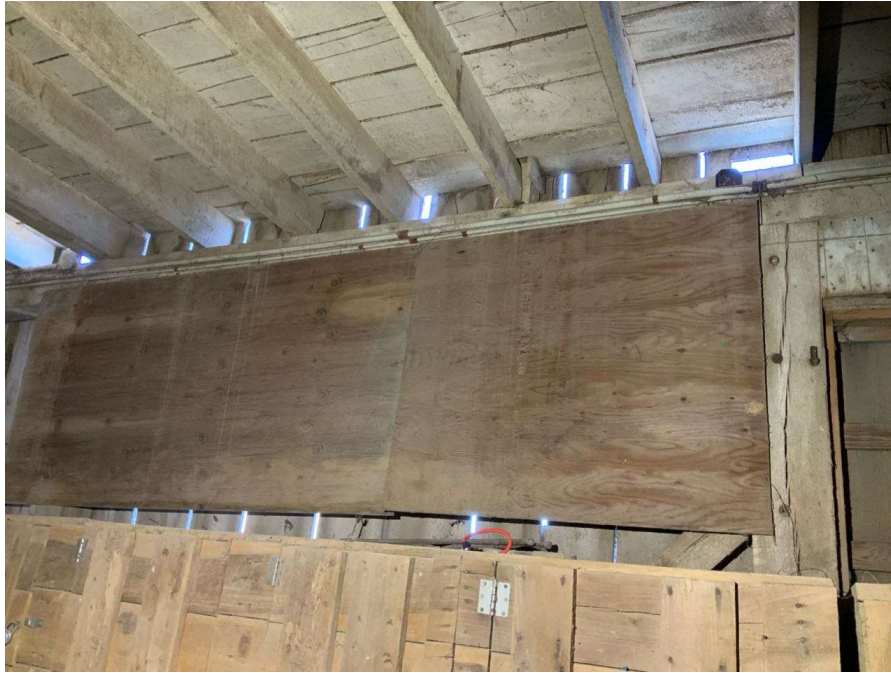
Photo S-87: Rotted floor beam between Column J/1 and K/1 could not be observed from the interior due to plywood obscuring the view (looking north).

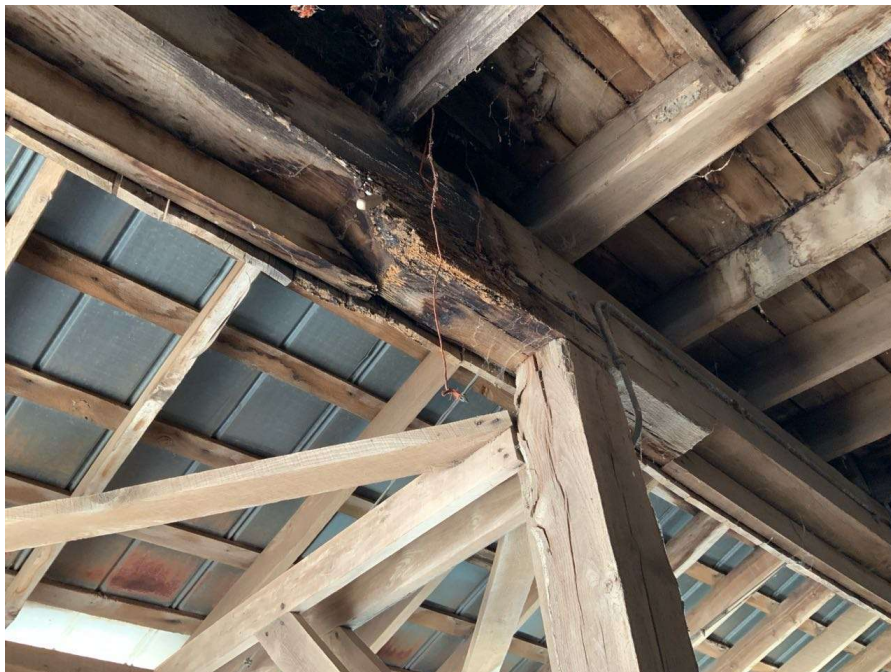
Photo S-88: Water damage and rot at west end of floor beam between Columns R/4 and S/4 (looking southwest). Supporting column cap at Column R/4 has similar rot.

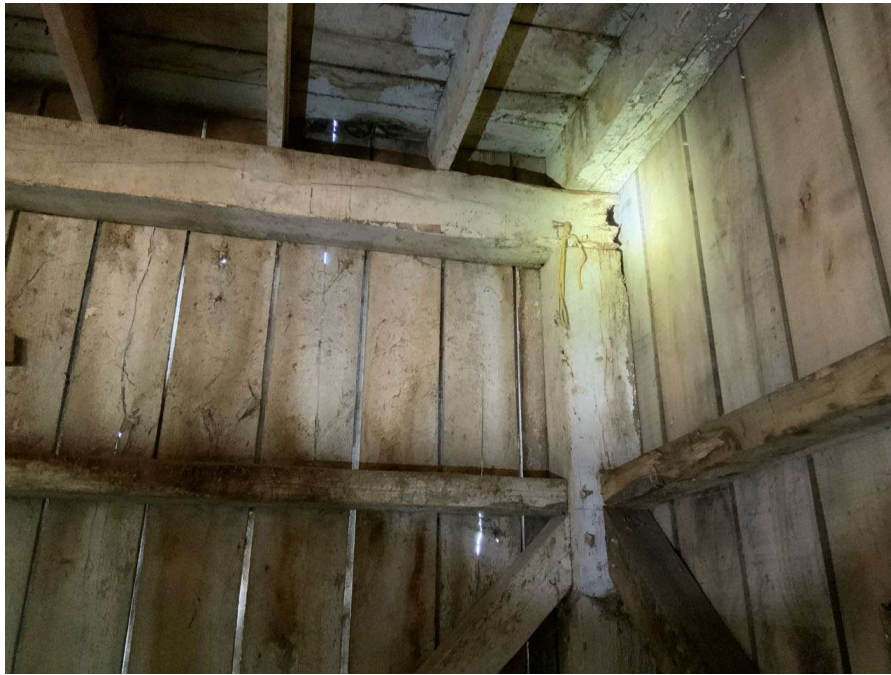
Photo S-89: Rot at east end of floor beam between Columns S/1 and T/1 (looking northeast).

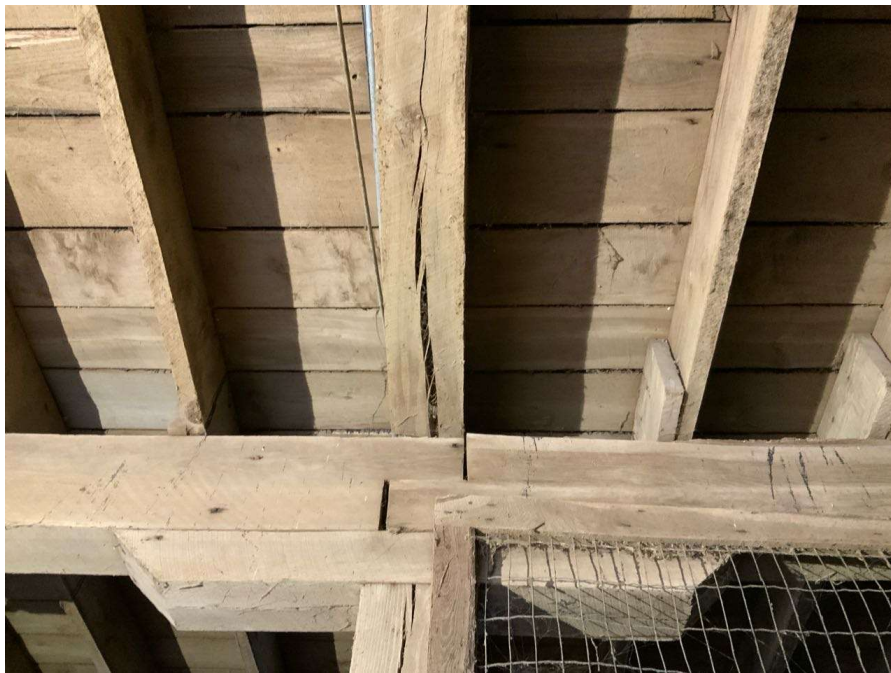
Photo S-90: Wide check on the bottom face of the north/south spanning hayloft floor beam. Beam between Columns D/2.5 and D/3 shown looking north.

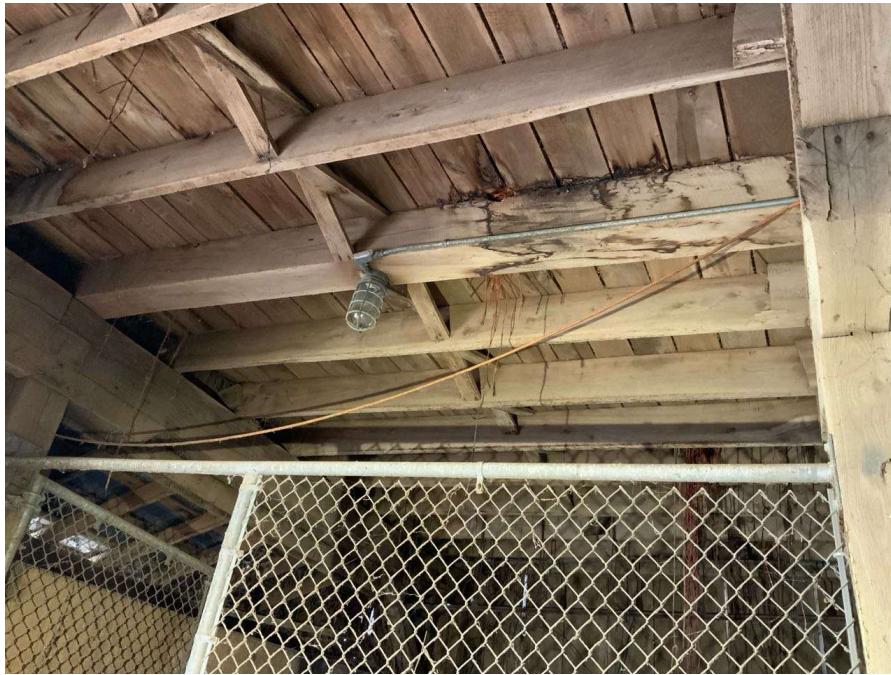
Photo S-91: Area of water damage and rot near north end of floor beam. Beam between Columns C/3 and C/4 shown looking west.
