EQUESTRIAN BARN AT AVENEL

CONDITION ASSESSMENT REPORT

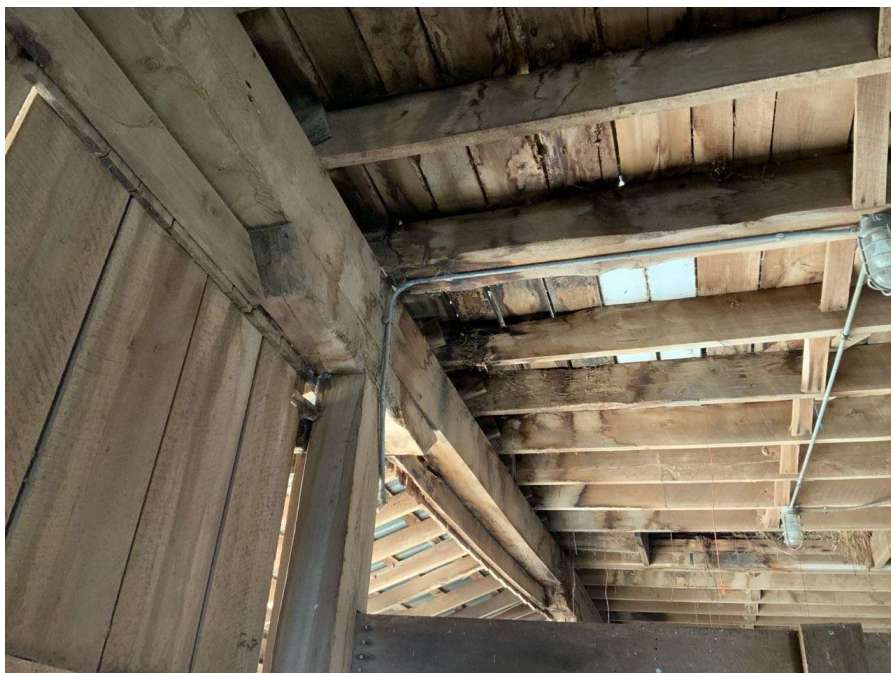
Photo S-92: Area of water damage and rot near south end of floor beam. Beam between Columns S/3 and S/4 shown looking west.

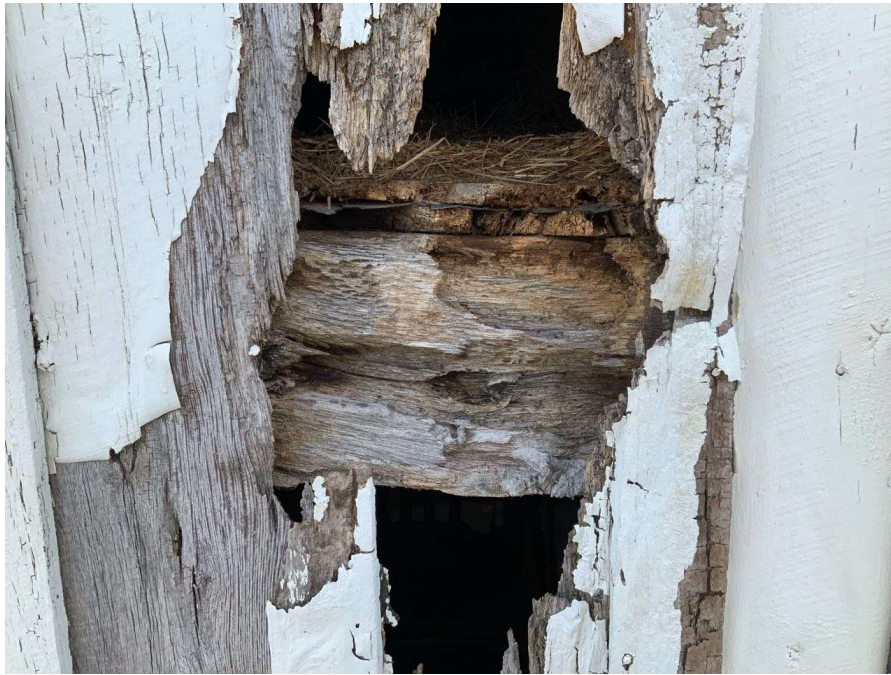
Photo S-93: Area of water damage and rot with approximately 25% section loss near north end of floor beam. Beam between Columns T/2.5 and T/3 shown looking west.

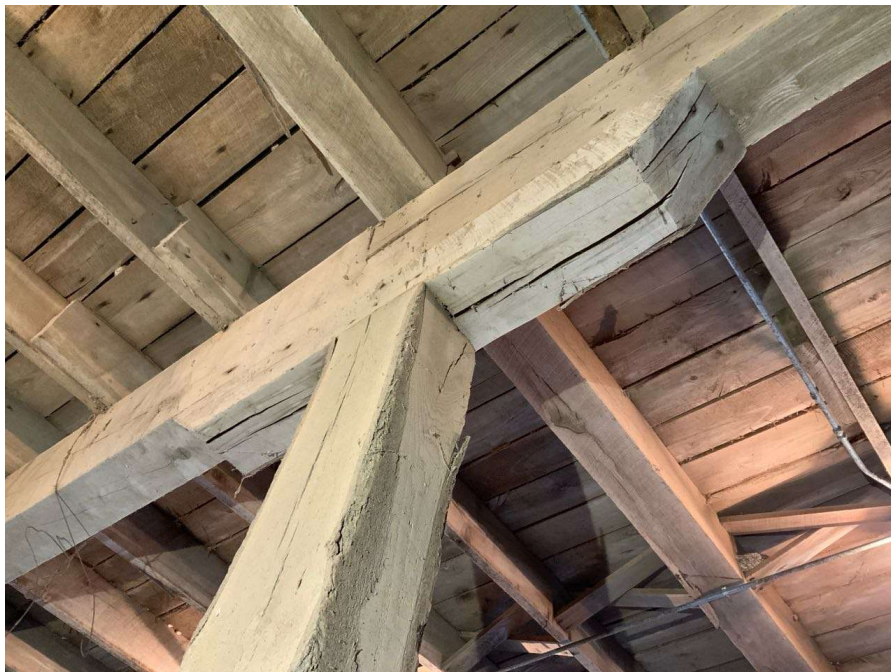
Photo S-94: Typical check in the bottom face of the at-grade column cap. Column O/3 shown.

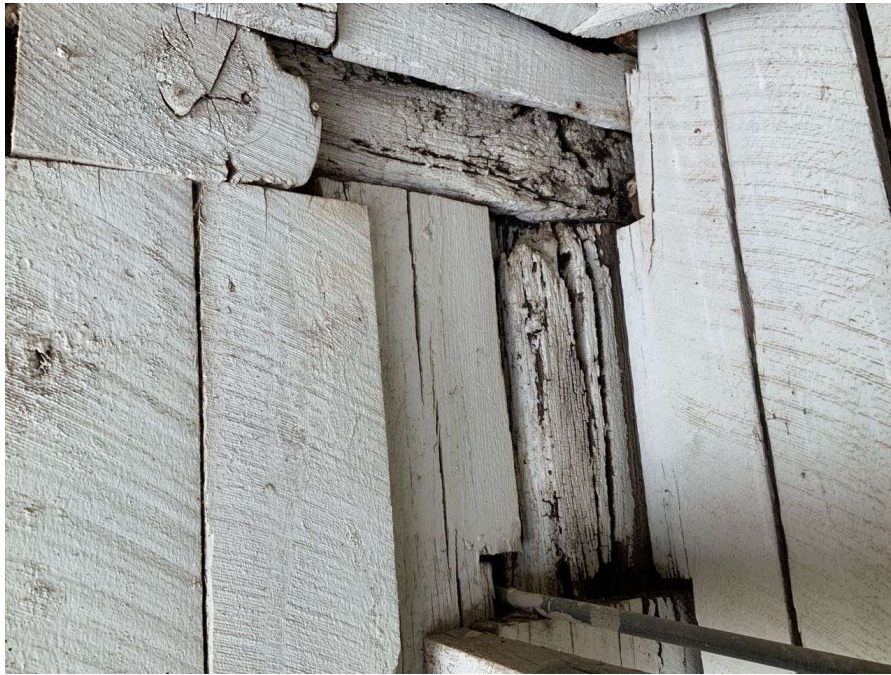
Photo S-97: South face of the at-grade column cap at Column K/7 is exposed to exterior and has soft rot with up to 1.5" icepick penetration.

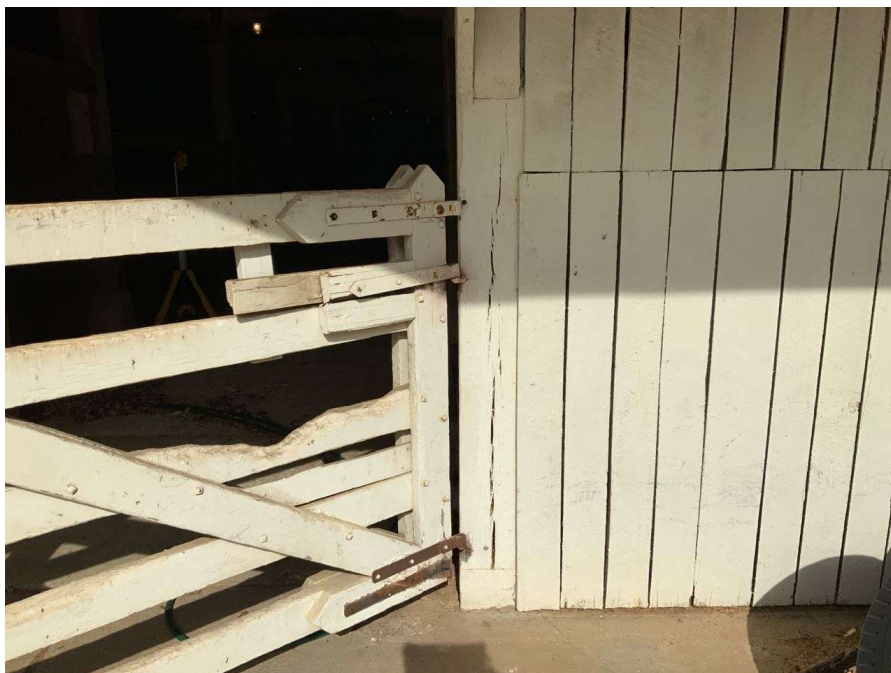
Photo S-98: Split in Column J/7 at grade level (looking north).

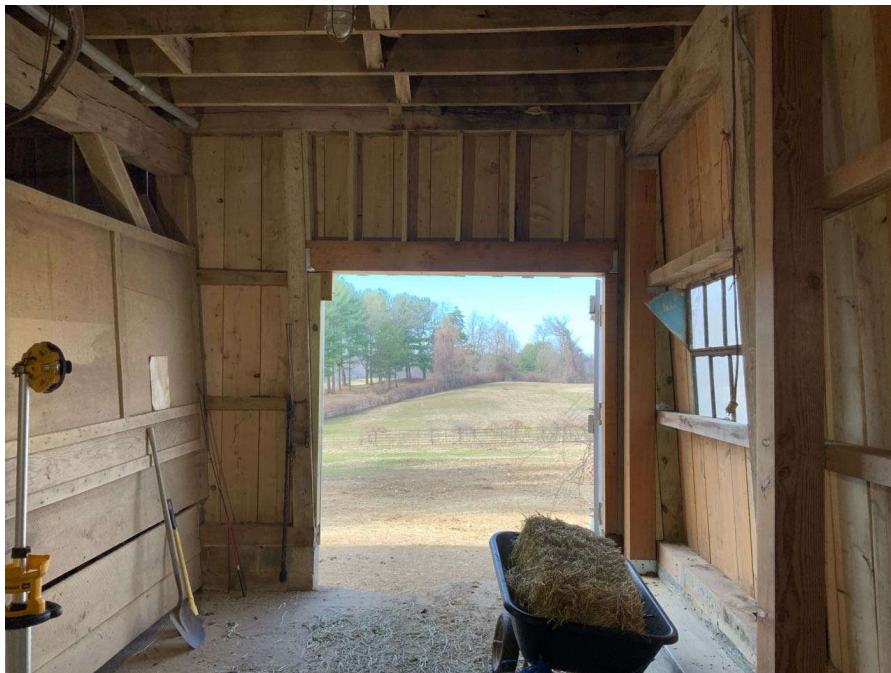
Photo S-100: View looking west down Gridline 1 in the west wing at the newly repaired northwest corner of structure. The new columns are plumb. The original columns are leaning up to 5 degrees to the south.

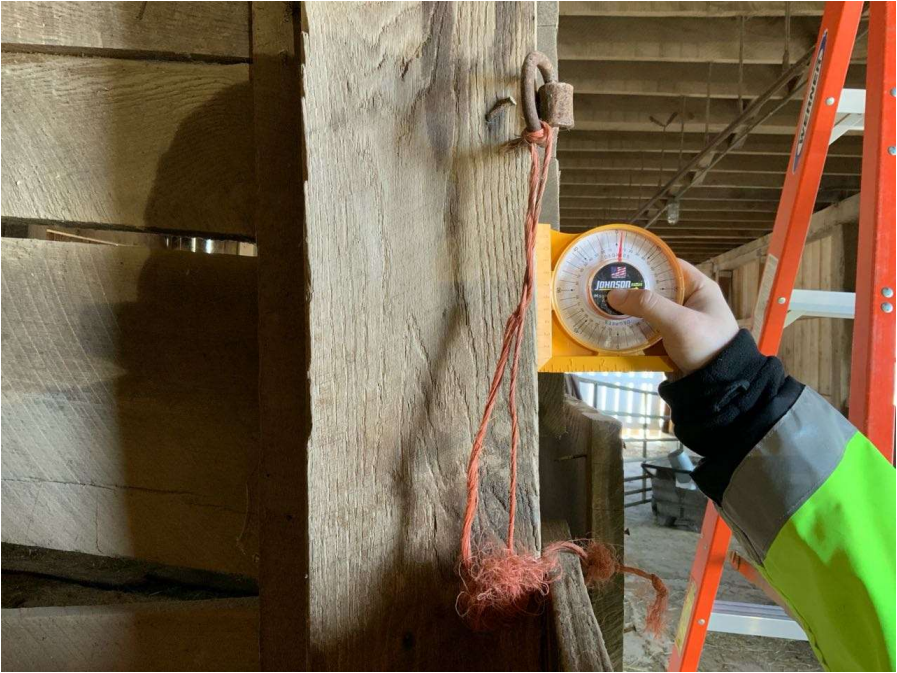
Photo S-101: Column E/2 at grade level is leaning up to 6 degrees towards the south.

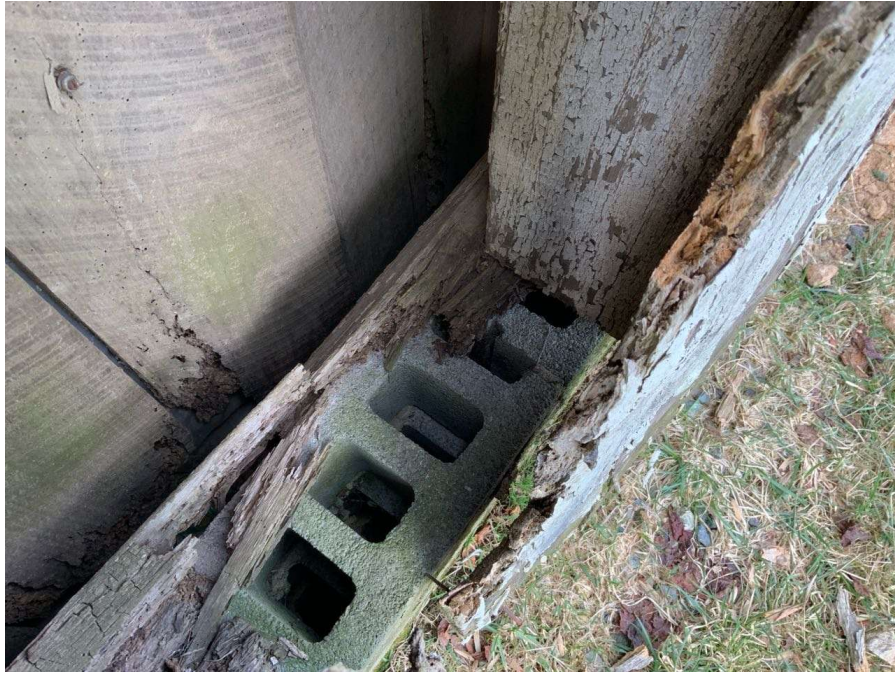
Photo S-111: Bearing loss at Column J/1 at grade level. The column has approximately 30% section loss. The sill plate is completely deteriorated under and to east of column and the column is sitting directly on the CMU foundation wall.

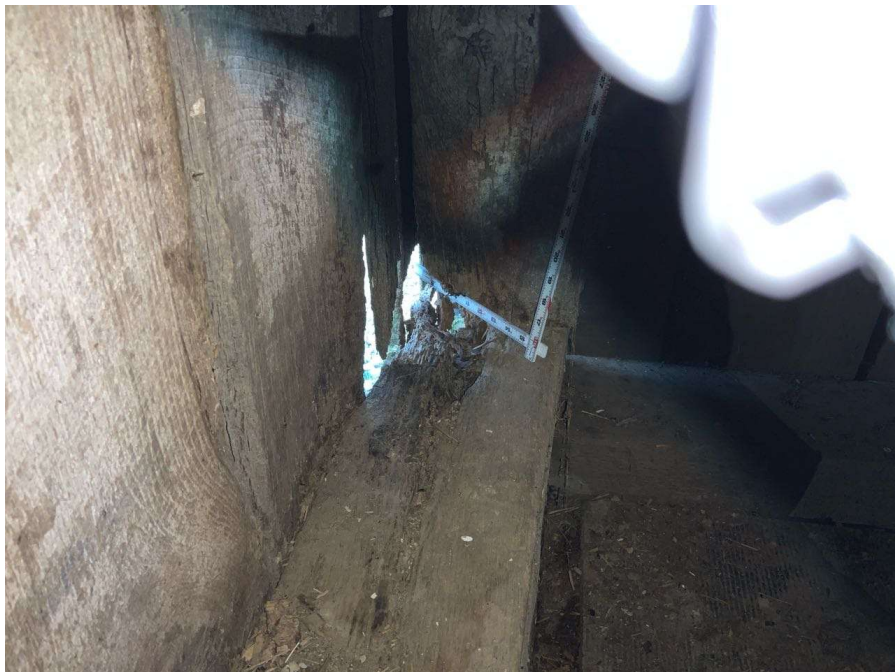
Photo S-112: Bearing loss at Column T/1 at grade level. The column has 50-75% section loss. The sill plate is deteriorated and rotting under the column.

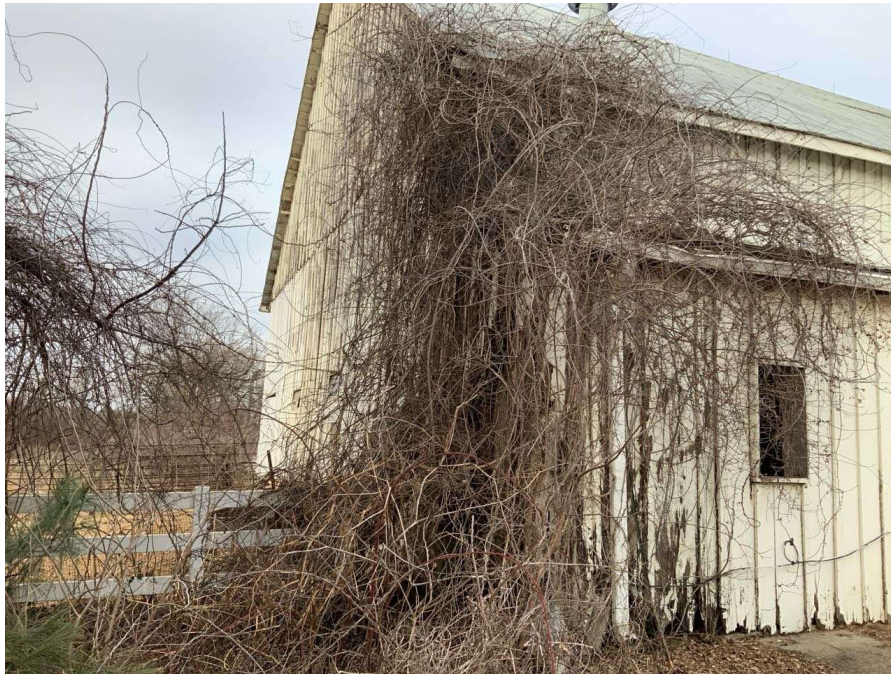
Photo S-113: Heavy vegetation on southwest corner of structure preventing access to Column B/4.

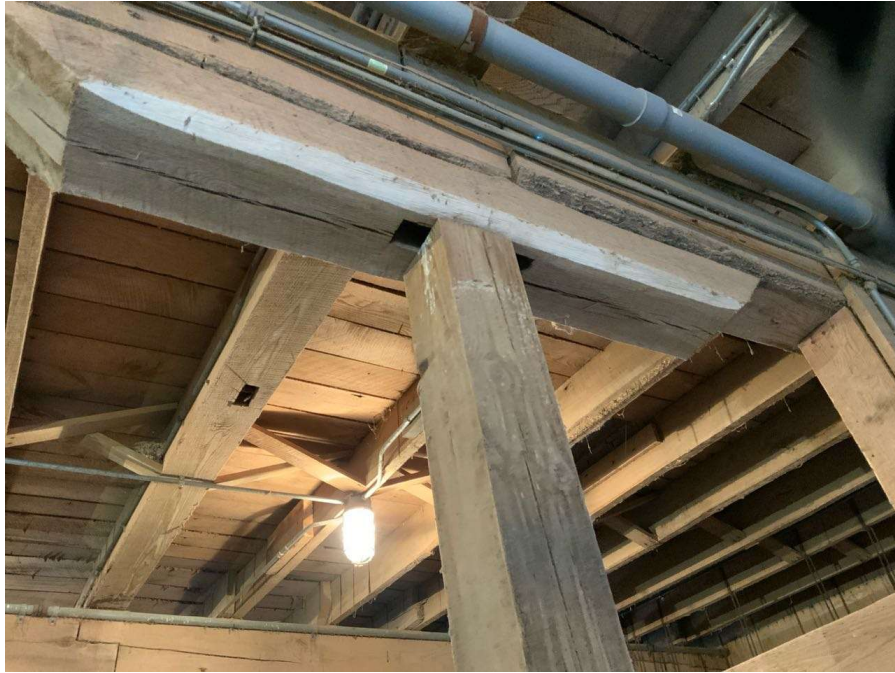
Photo S-115: Replaced column at Column O/2 at grade level has no positive connection to the cap at the top. Note the empty mortise slot in the floor beam indicating that the brace for this column is missing.

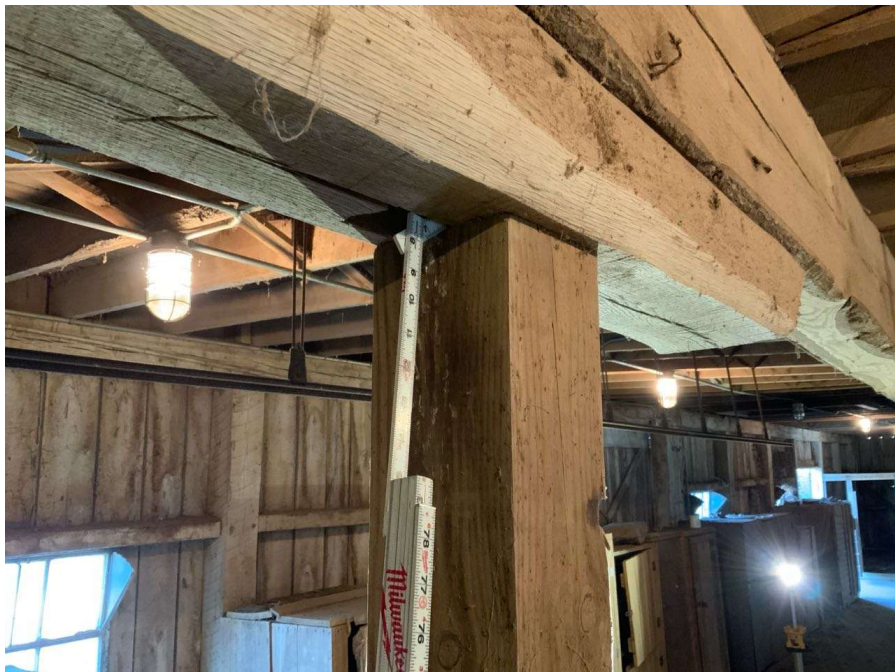
Photo S-116: Replaced column at Column O/2 at grade level has no positive connection to the cap at the top.

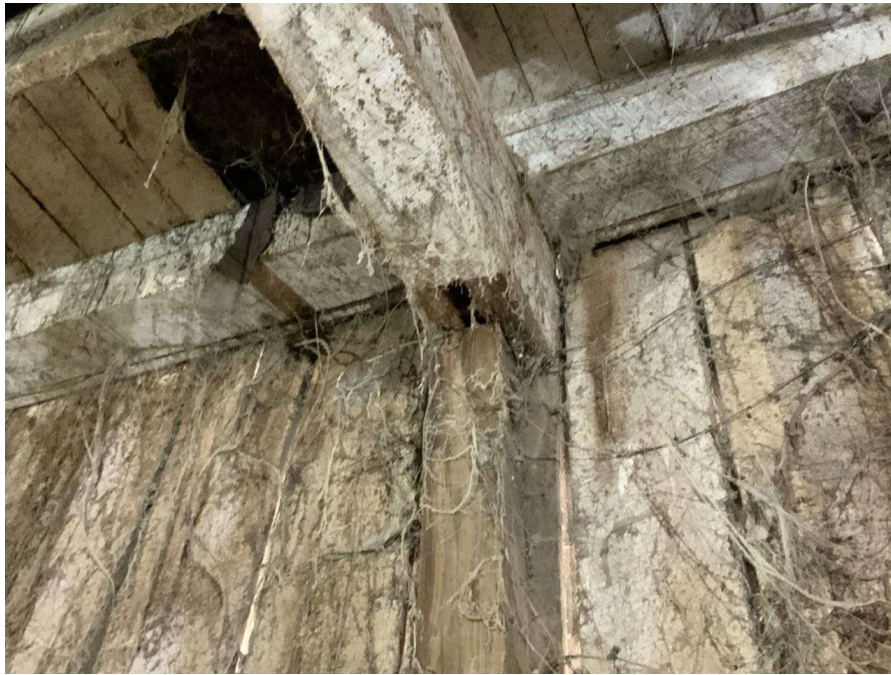
Photo S-117: The replaced column at Column N/5 at grade level has no positive connection to the cap at the top. Note the west brace is missing.

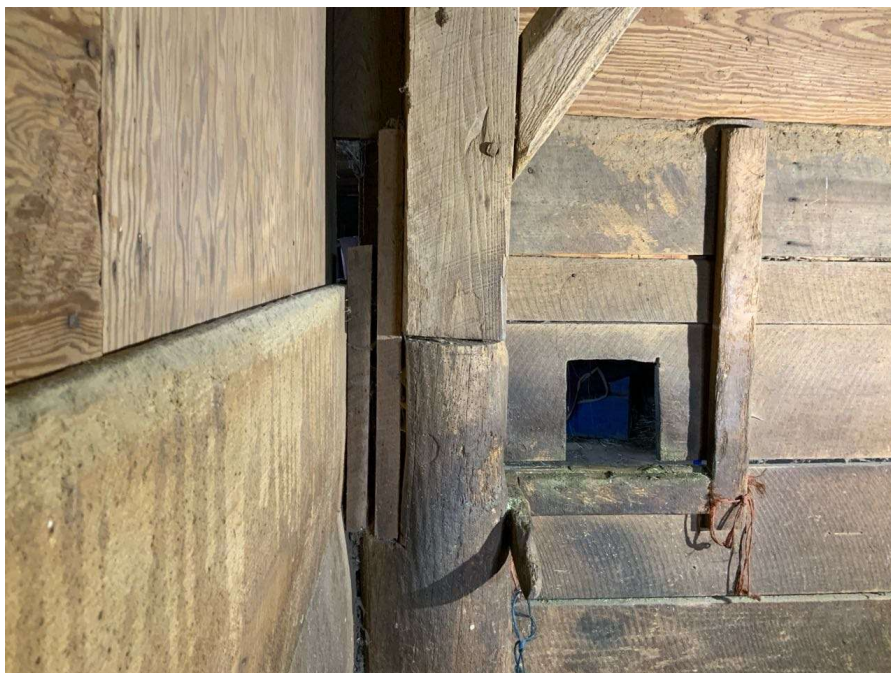
Photo S-118: The bottom portion of Column C/2 at grade level consists of a round post spliced to the original column using timber boards.

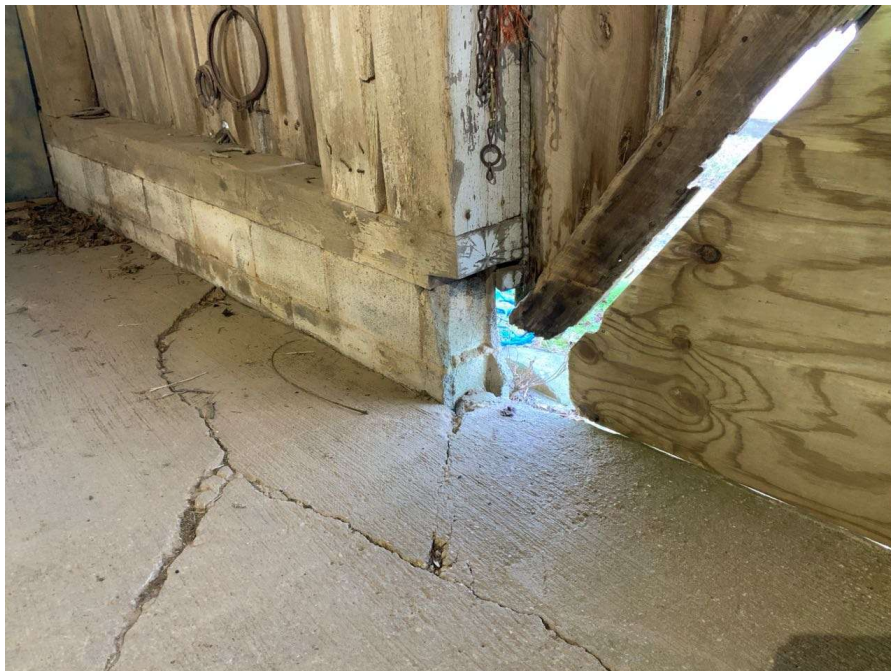
Photo S-122: Chipped out masonry foundation wall indicating door was likely installed or widened after the original construction. Door between Columns E/1 and F/1 shown.

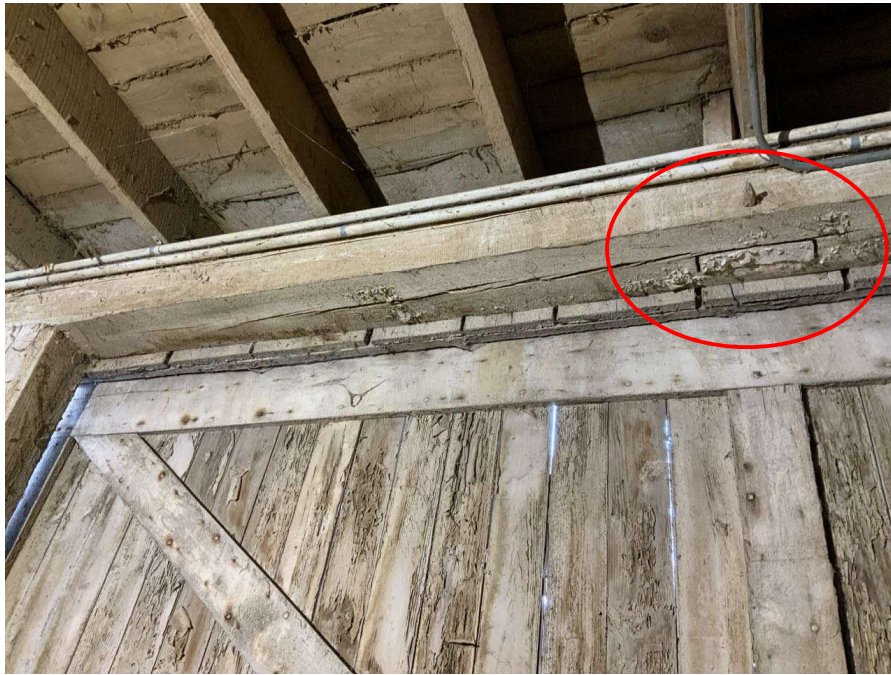
Photo S-123: Cut portion of intermediate column still in mortise slot with dowel. Door between Columns G/1 and H/1 shown.

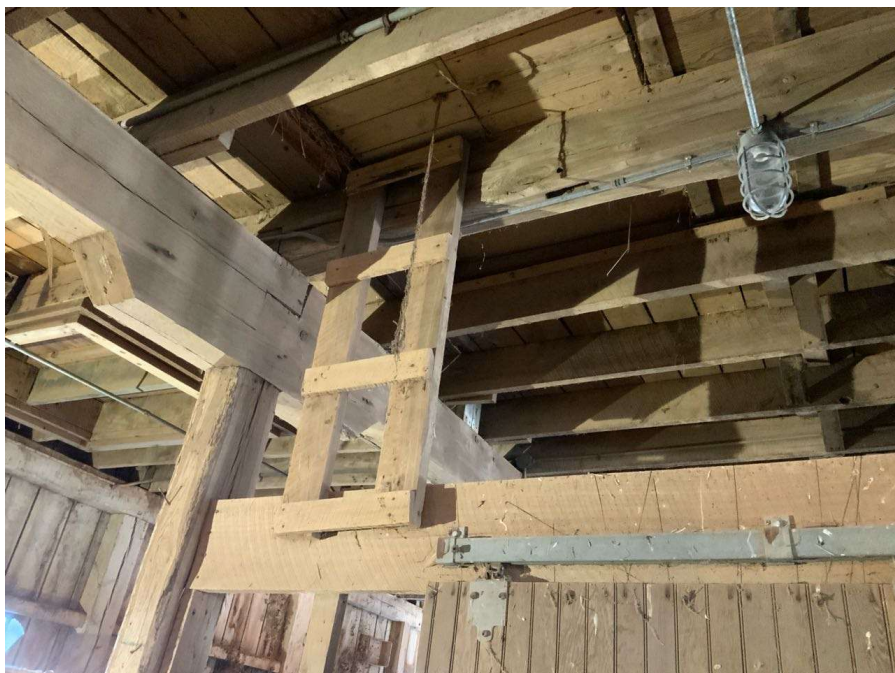
Photo S-134: Missing brace at Column Q/2 at grade level. Note the empty mortise slot in the floor beam above. A ladder to a hatch is in the place where the brace should be located.

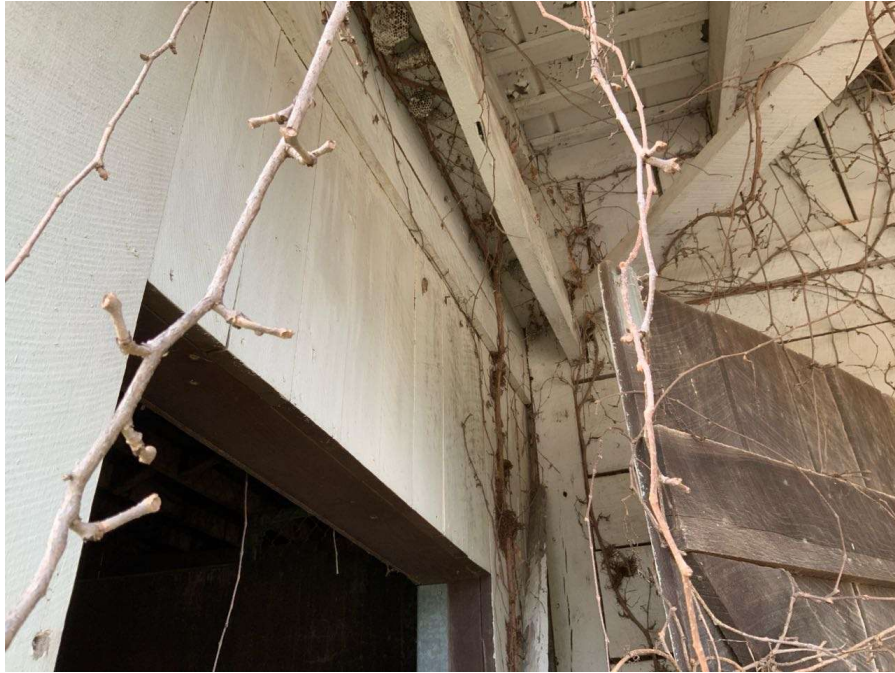
Photo S-135: Missing overhang diagonal supports at Column C/4.

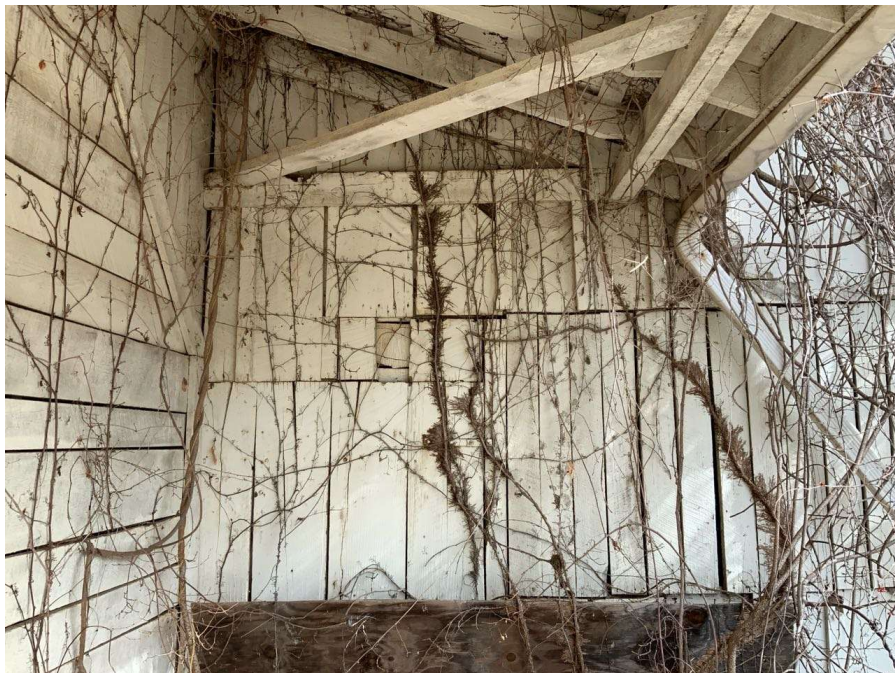
Photo S-136: The overhang at Column H/4 does not have any diagonal support but the wall of the lean-on structure appears to be supporting the overhang instead.

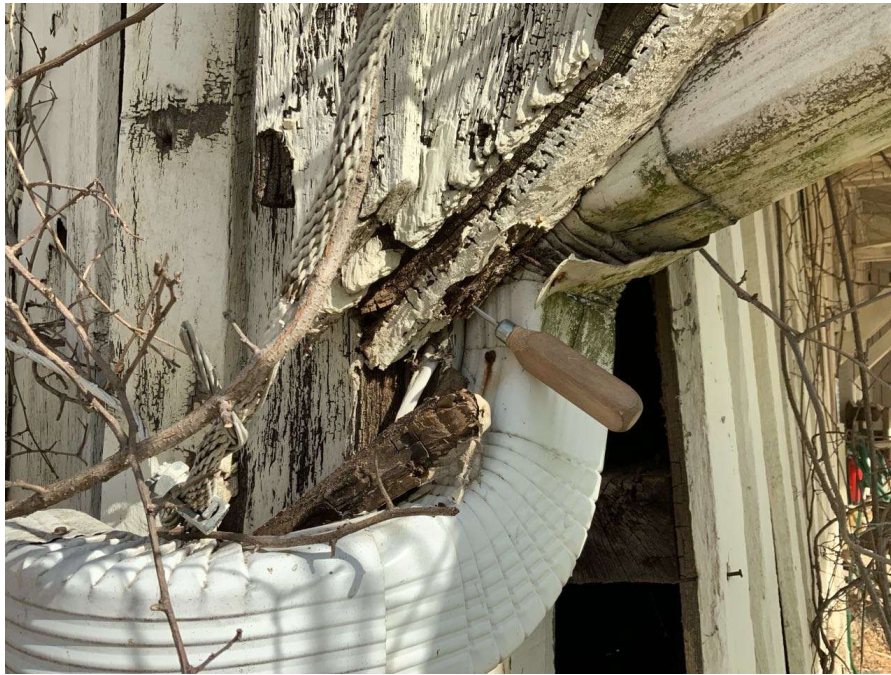
Photo S-137: The overhang support diagonal at Column H/7 exhibits rot at base connection with up to 4" deep icepick penetration. The diagonal is not fully connected to the column.

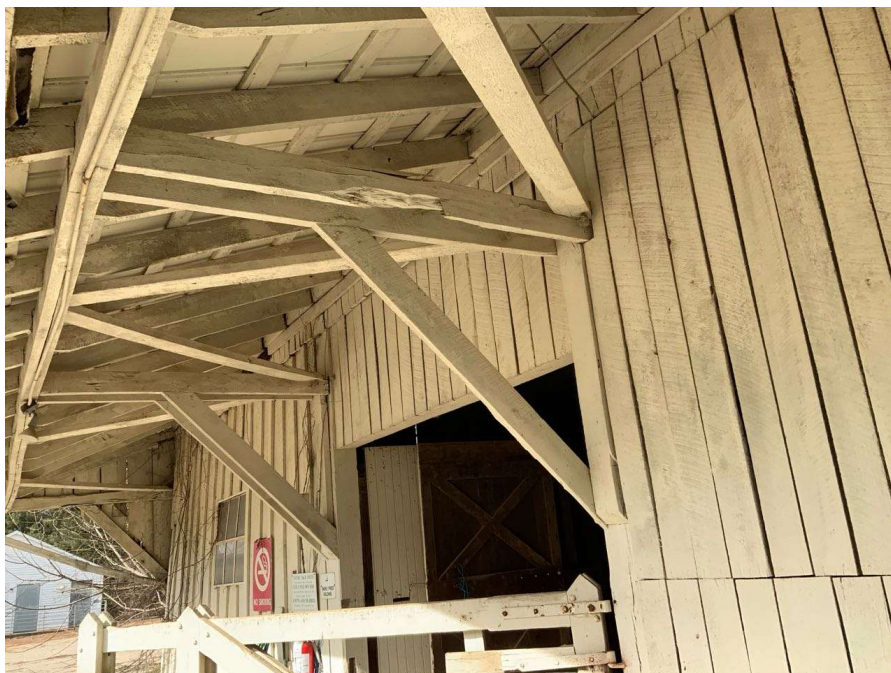
Photo S-138: The east overhang support diagonal is missing, and the horizontal member is damaged at Column J/7.

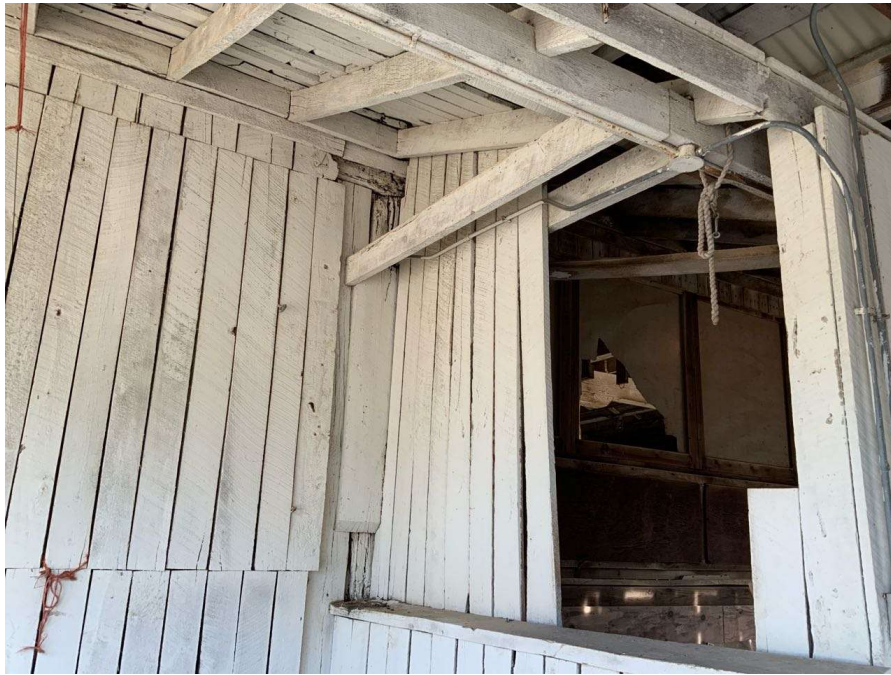
Photo S-139: The west overhang support diagonal is missing at Column K/7.

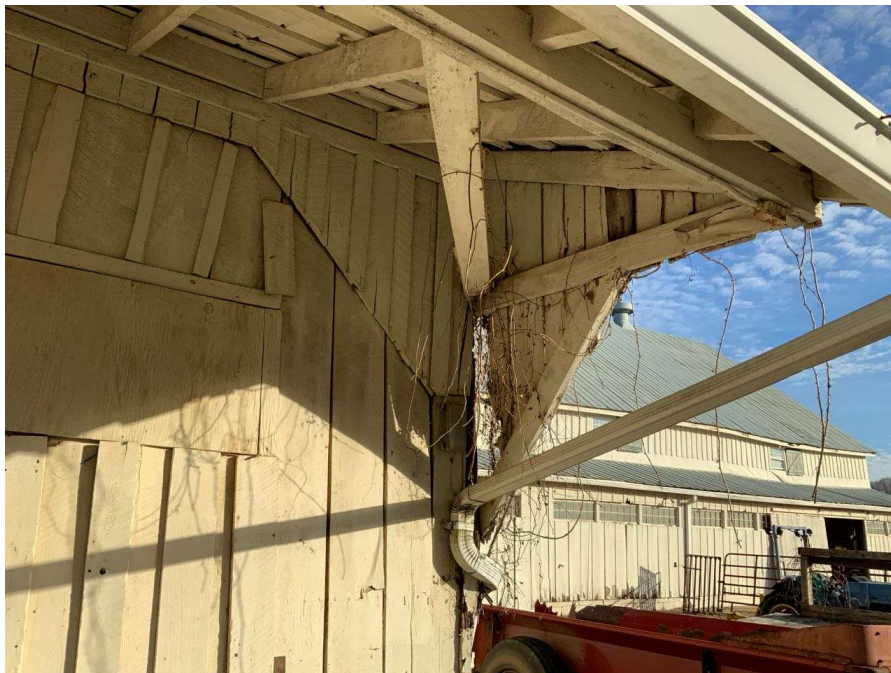
Photo S-140: The overhang support diagonal is disconnected at the base connection to Column N/7.

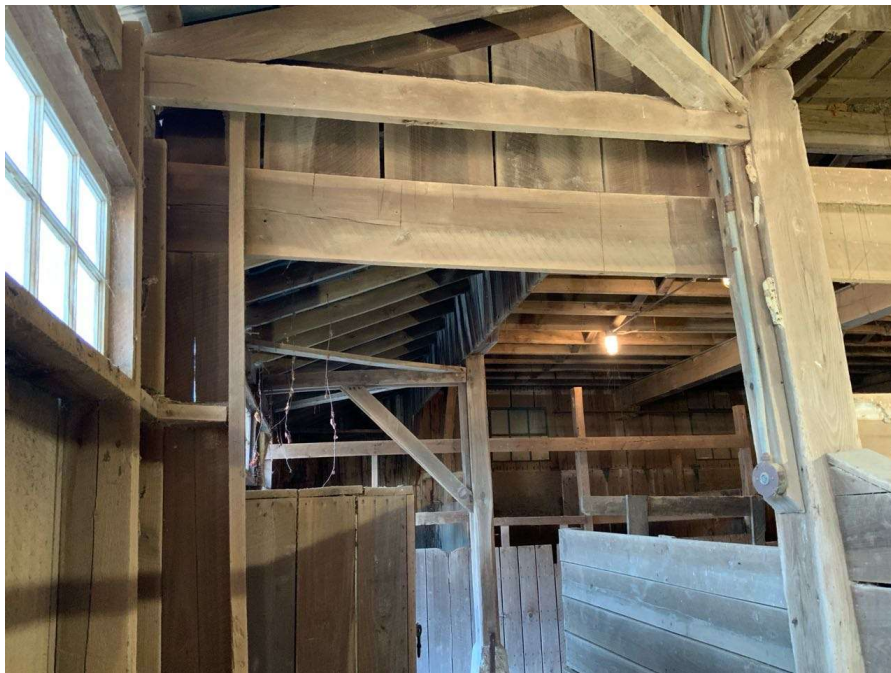
Photo S-142: Both overhang support diagonals and the west horizontal member is missing at Column P/4.

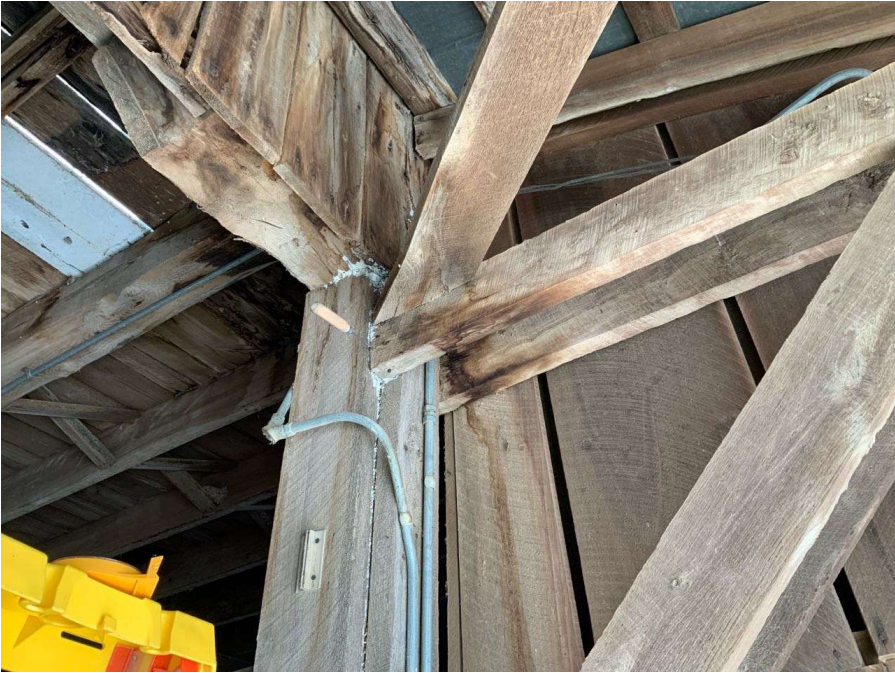
Photo S-143: Rot at the overhang support horizontal member connection to Column S/4.

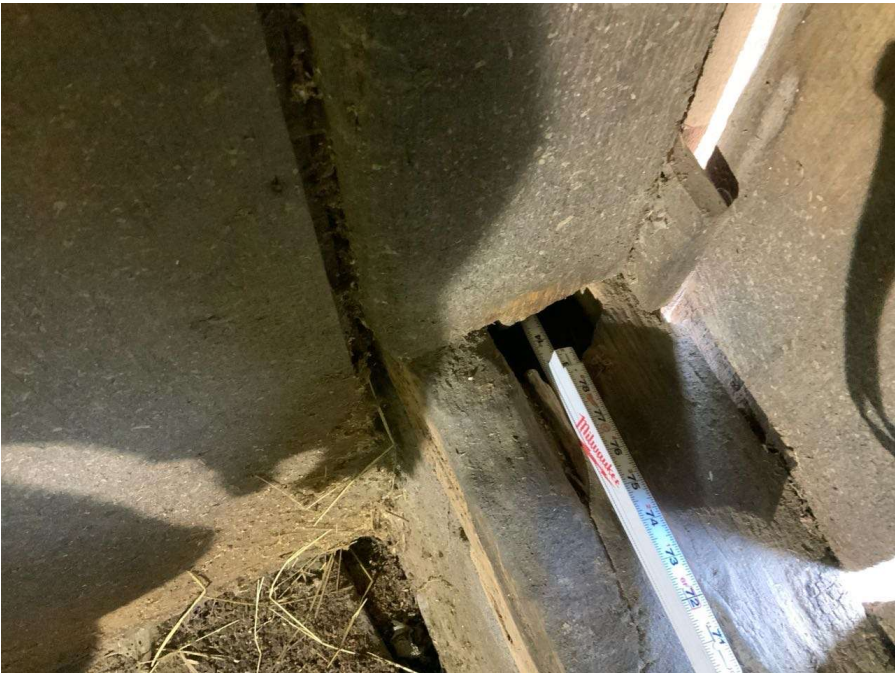
Photo S-144: Rot with section loss in the sill plate below Column B/2.5 at grade level.

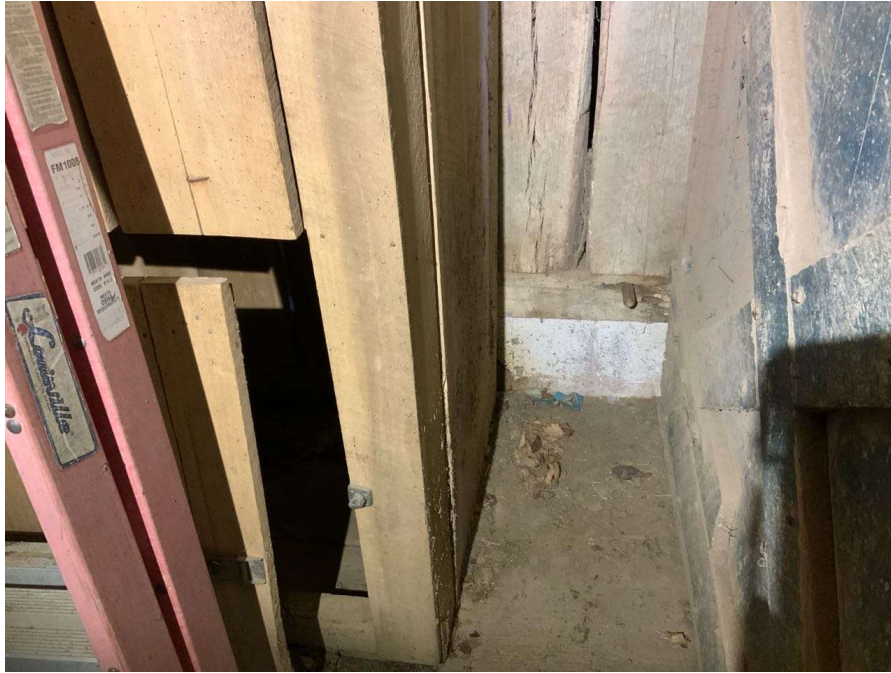
Photo S-145: Rot with full icepick penetration in the sill plate below Column H/1 at grade level.

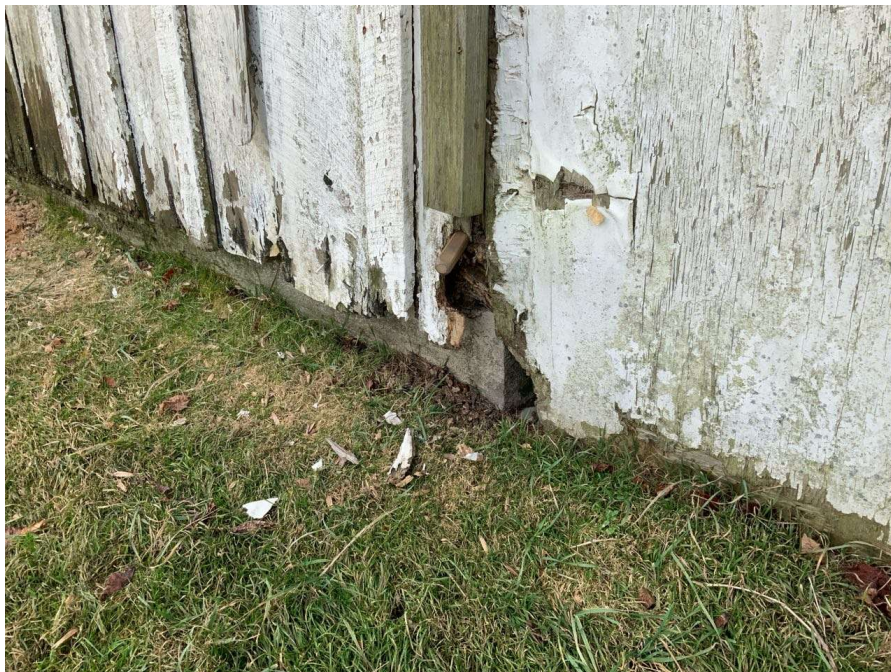
Photo S-146: Rot with full icepick penetration in the sill plate below Column I/1 at grade level.

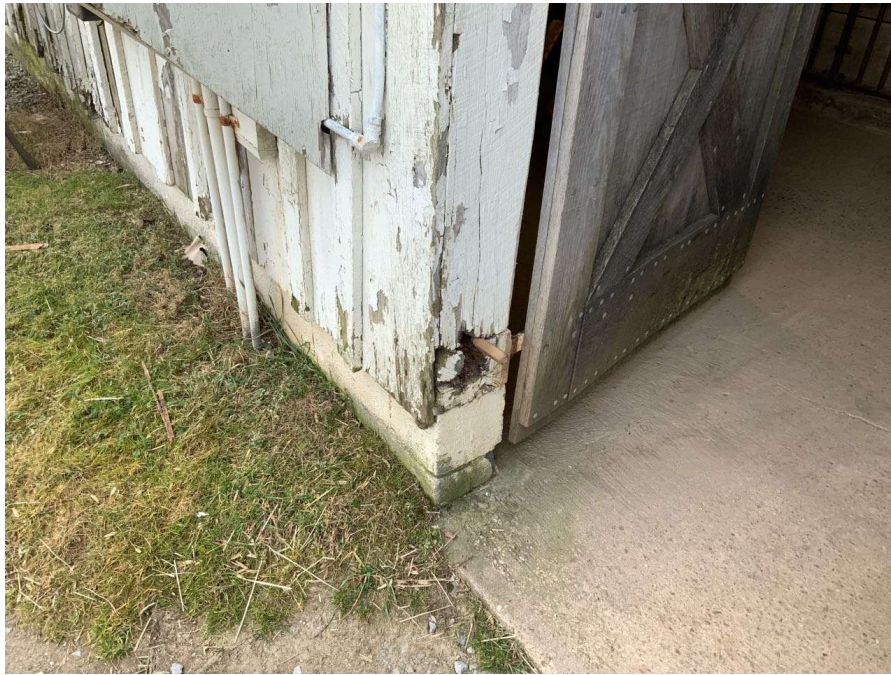
Photo S-147: Rot with full icepick penetration in the sill plate below east jamb near Gridline K/1 at grade level.

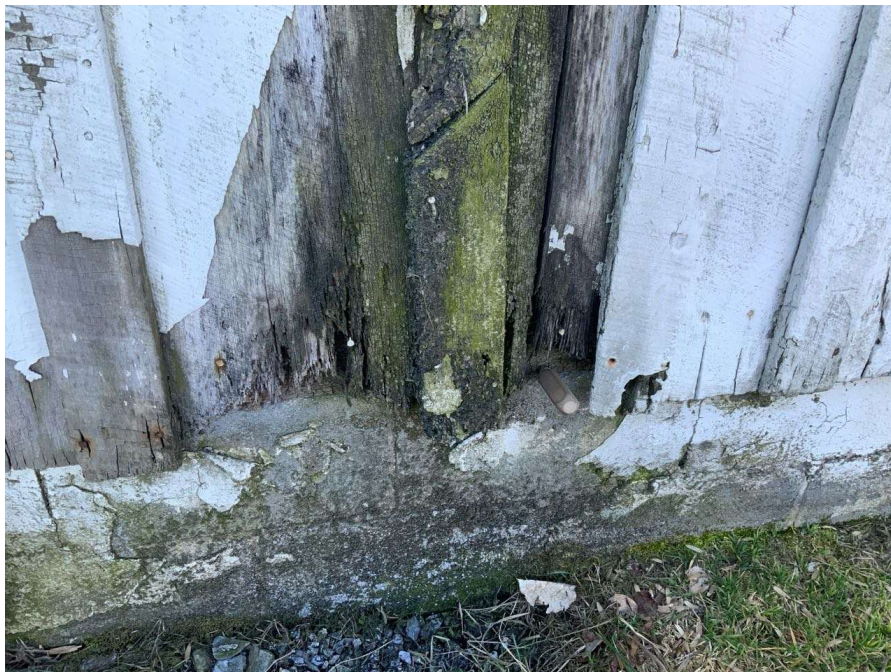
Photo S-148: Rot with full icepick penetration in the sill plate adjacent to Column P/1 at grade level.

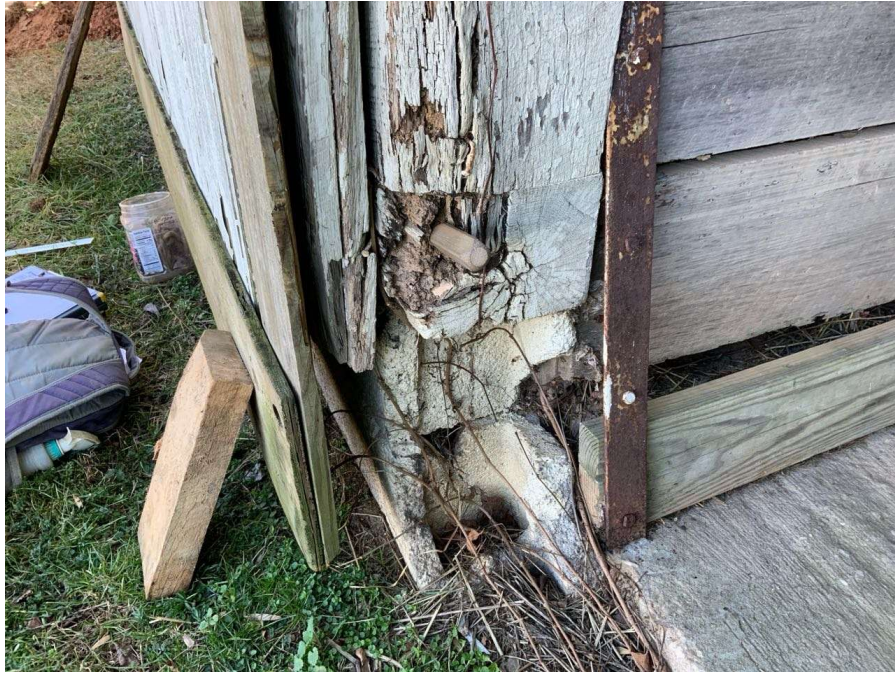
Photo S-149: Rot with full icepick penetration in the sill plate below Column S/1. Note the CMU wall is chipped out at this location indicating that this door is likely not part of the original construction.

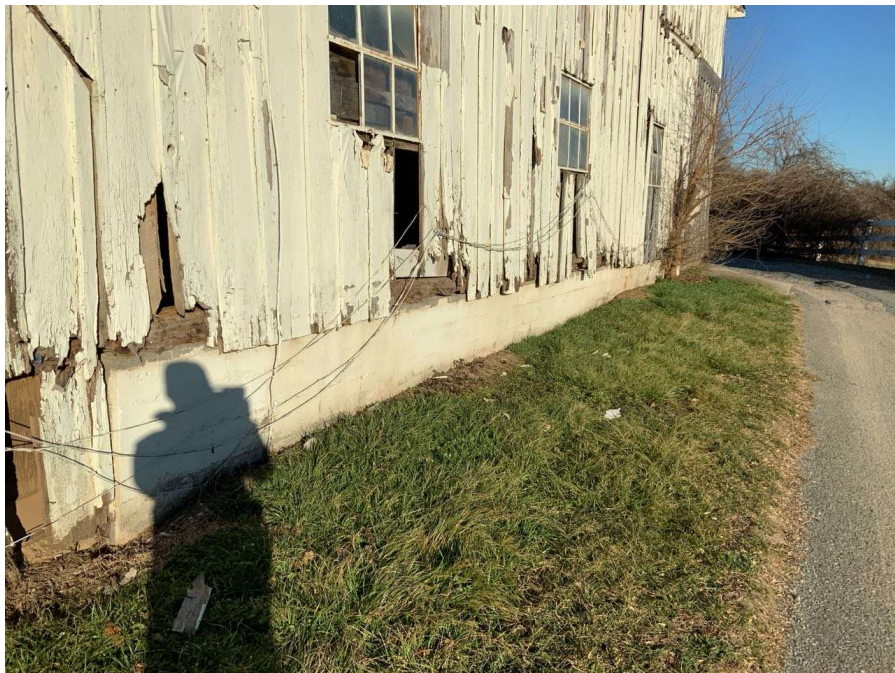
Photo S-150: Siding along east elevation is broken or missing exposing the sill plate along Gridline T to the external environment. The sill plate is rotting.

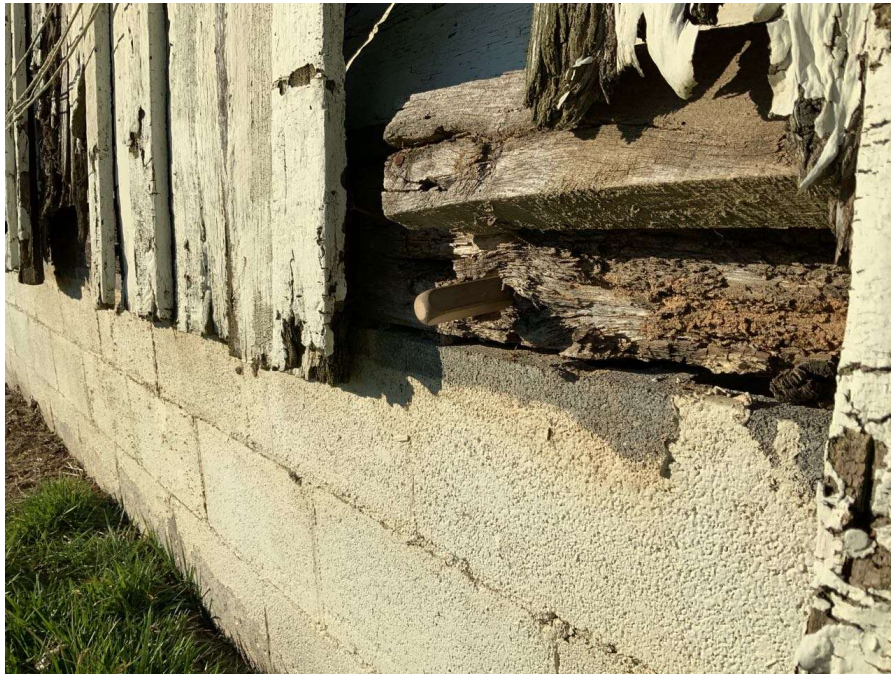
Photo S-151: The sill plate along Gridline T is rotting with up to full icepick penetration.

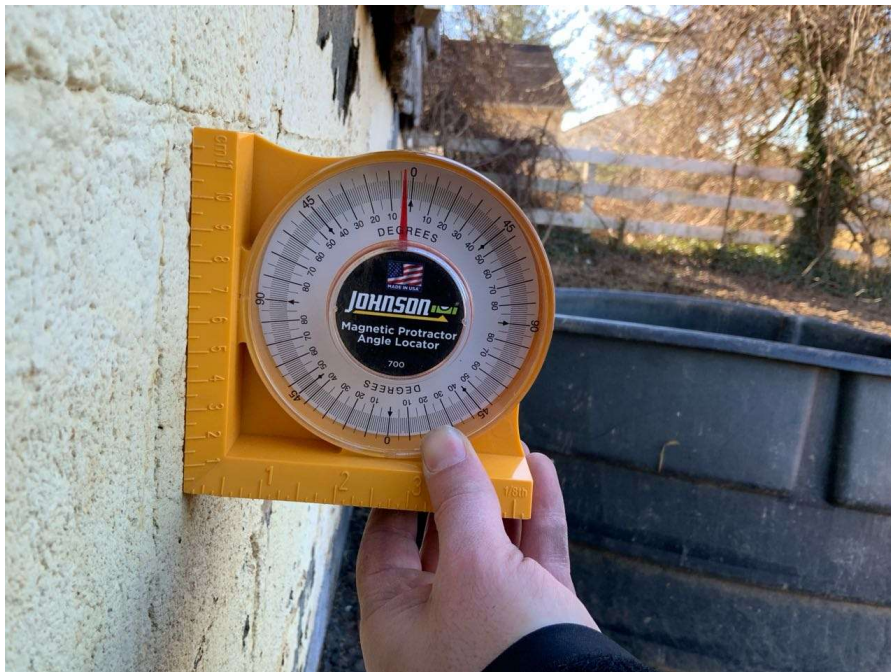
Photo S-152: Tilt in west elevation CMU foundation wall (looking south).

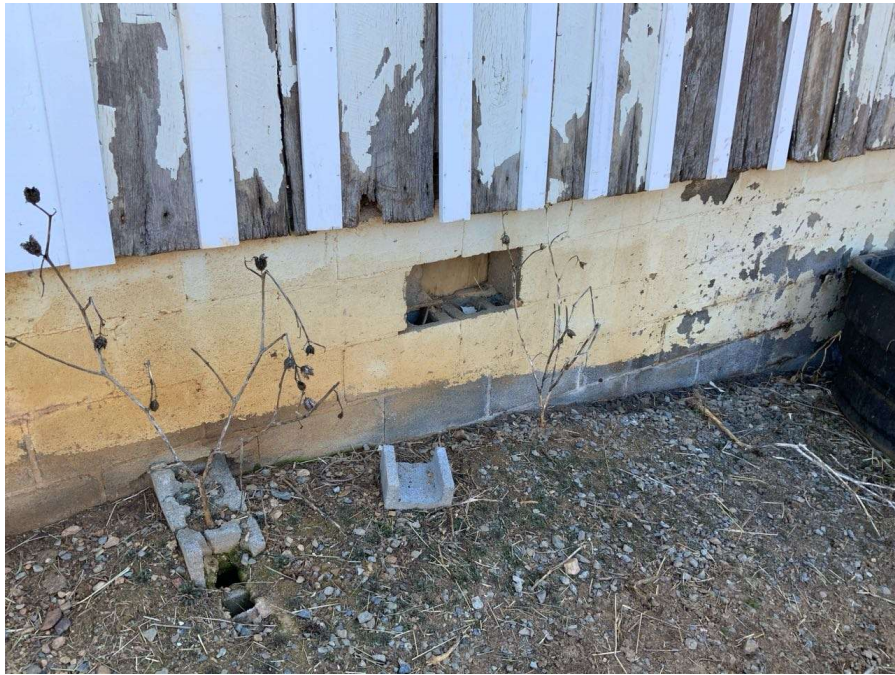
Photo S-153: Missing block in CMU foundation wall at the west elevation (looking southeast).

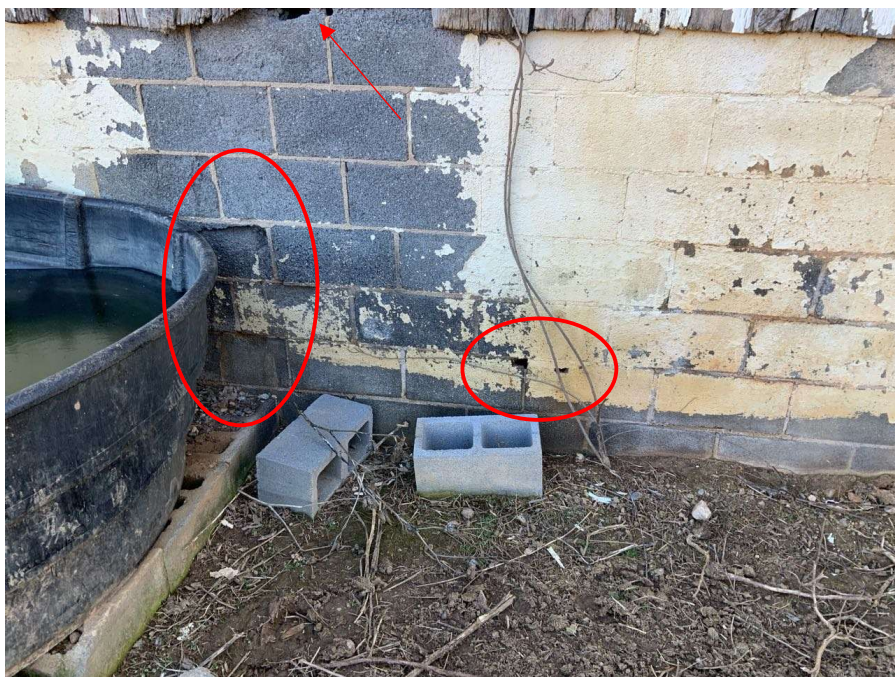
Photo S-154: Typical chips in exterior faces of the cells of the CMU foundation wall blocks at the west elevation.
