EQUESTRIAN BARN AT AVENEL

CONDITION ASSESSMENT REPORT

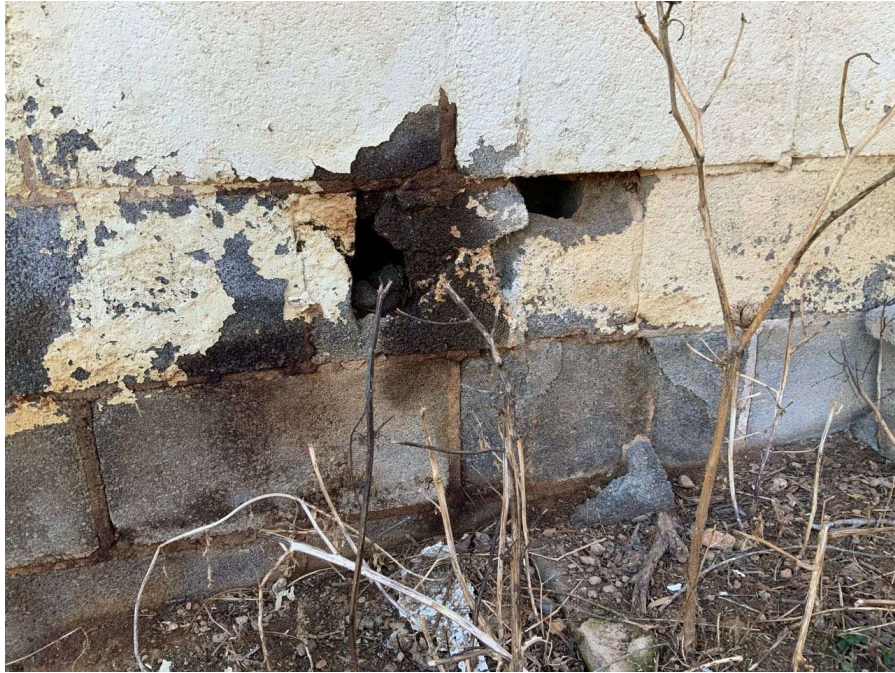
Photo S-155: Typical chips in exterior faces of the cells of the CMU foundation wall blocks at the west elevation.

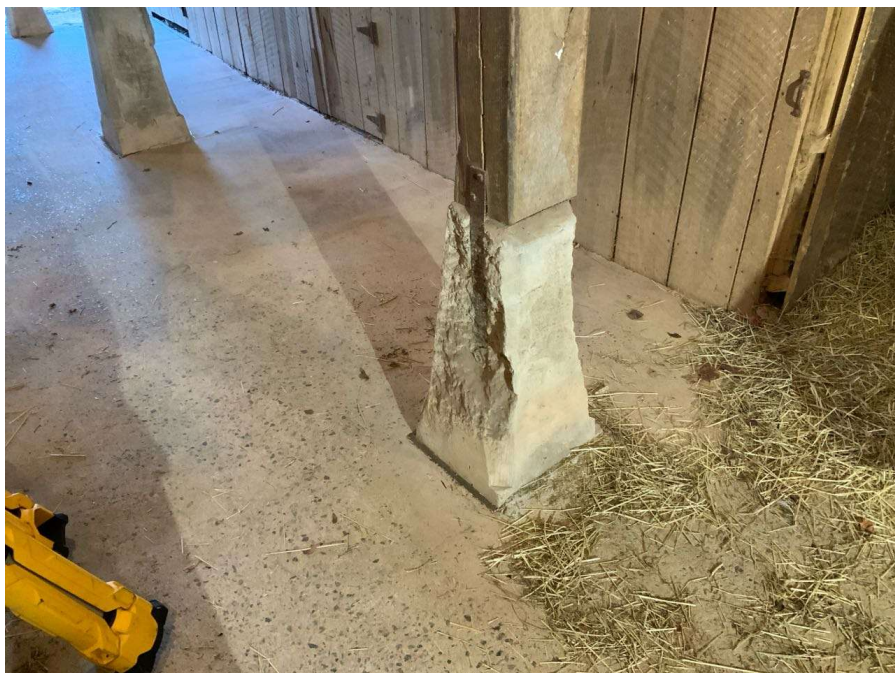
Photo S-156: Typical pedestal with spalled faces exposing the embedded steel straps. Column O/2.5 shown.

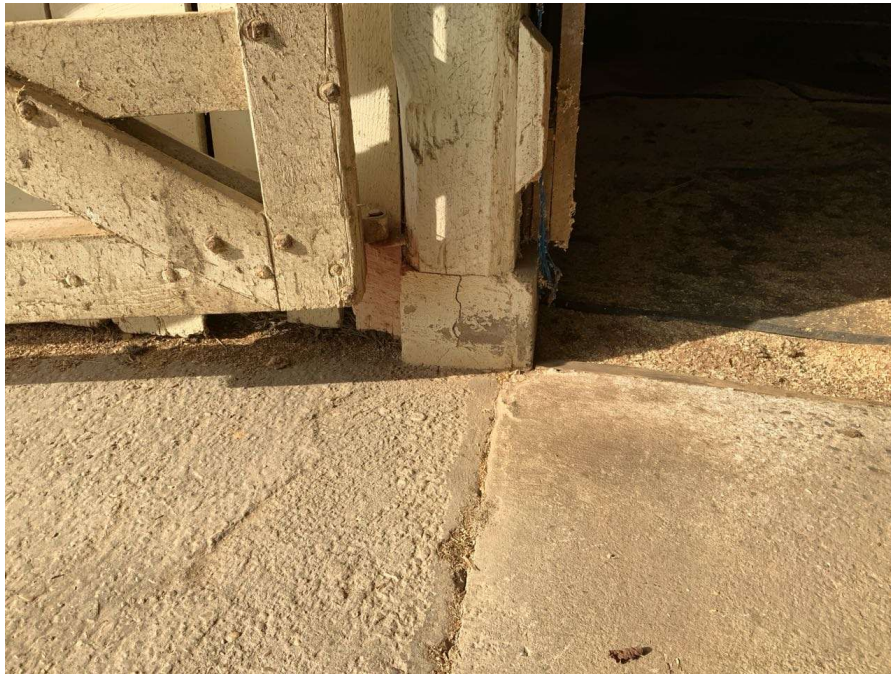
Photo S-157: Vertical crack in east face of the concrete curb supporting Column L/7 at grade level. Note that the column does not appear to be positively attached to the concrete curb.

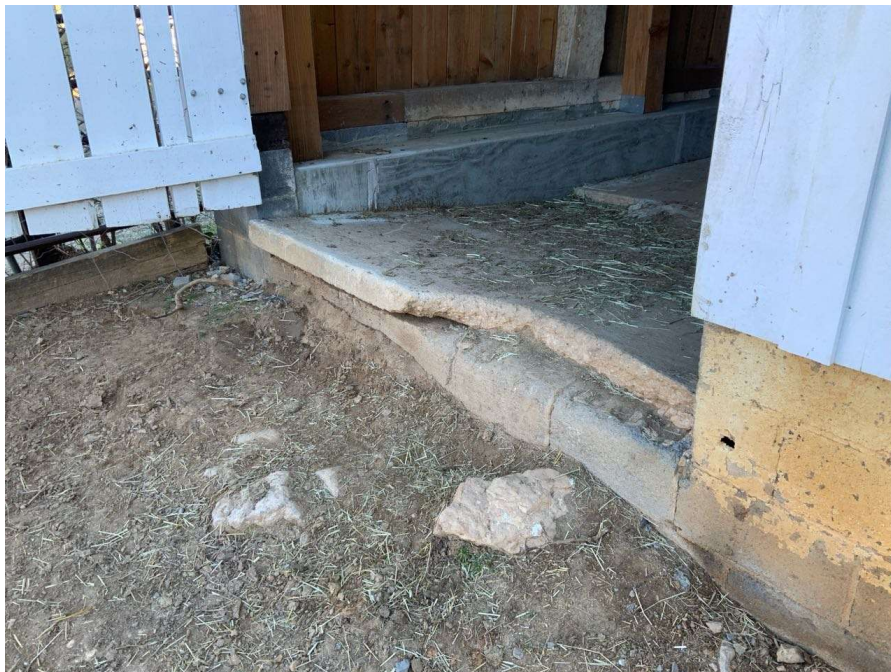
Photo S-158: Settled walkway slab at northwest corner of building.

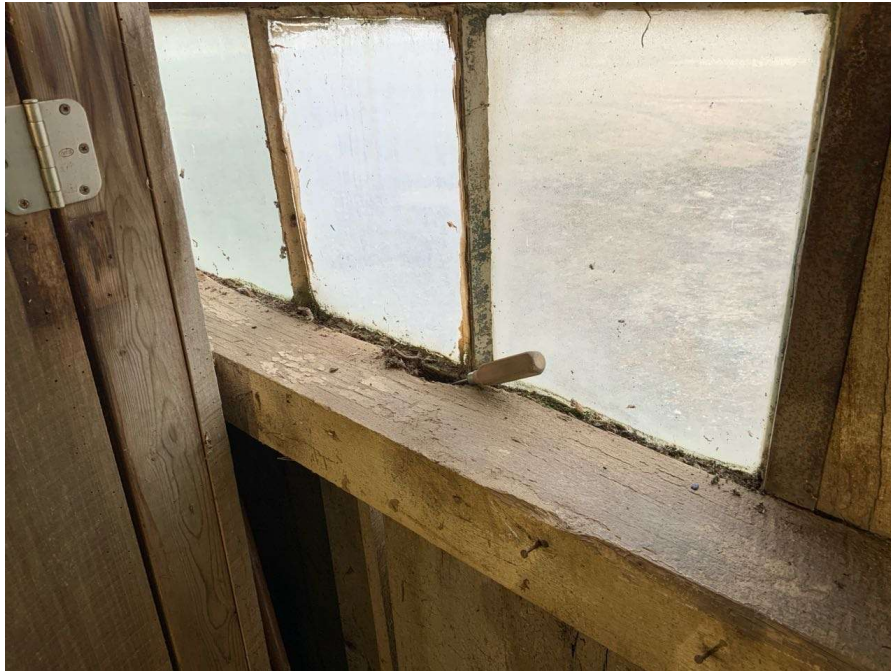
Photo S-167: Typical area of rot in the wind girt under the window opening. Wind girt between Columns M/1 and N/1 at grade level shown.

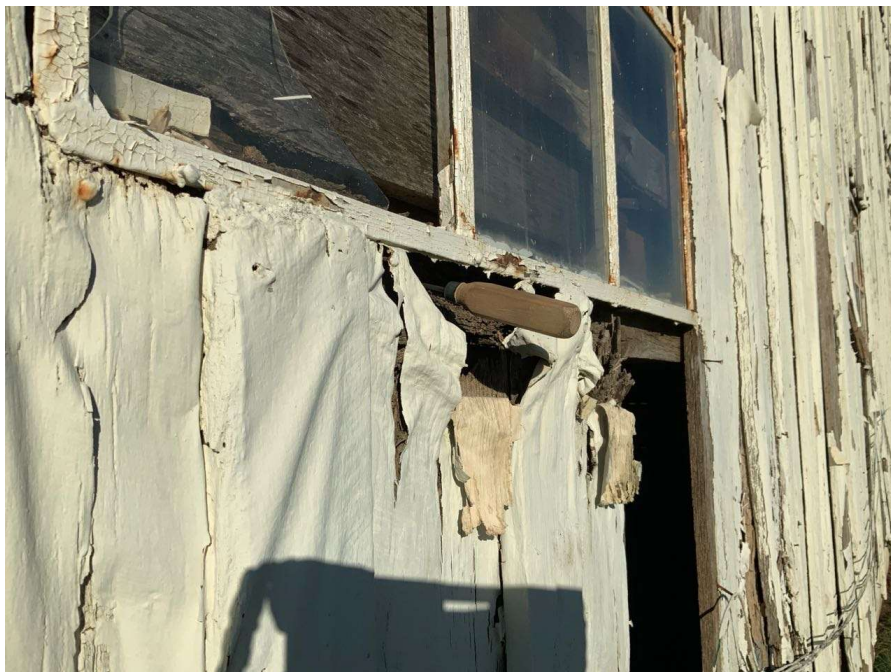
Photo S-168: Typical area of rot in the wind girt under the window opening. Girt between Columns T/3 and T/4 at grade level shown. Icepick penetration at this area is up to 3.5" deep.

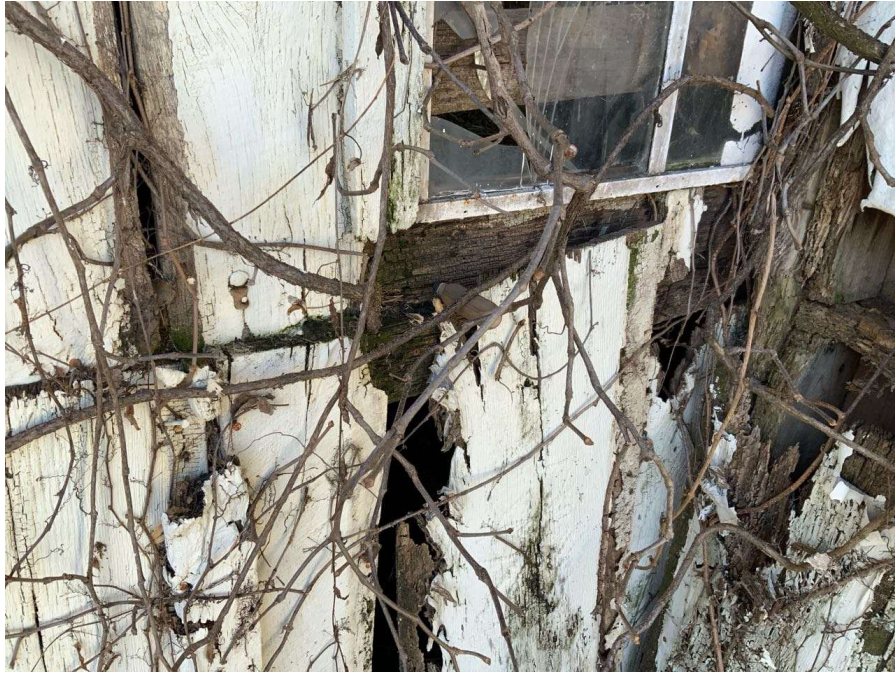
Photo S-169: Typical area of rot in the wind girt under the window opening. Wind girt between Columns N/4 and N/5 at grade level shown. There is up to full icepick penetration at this location.

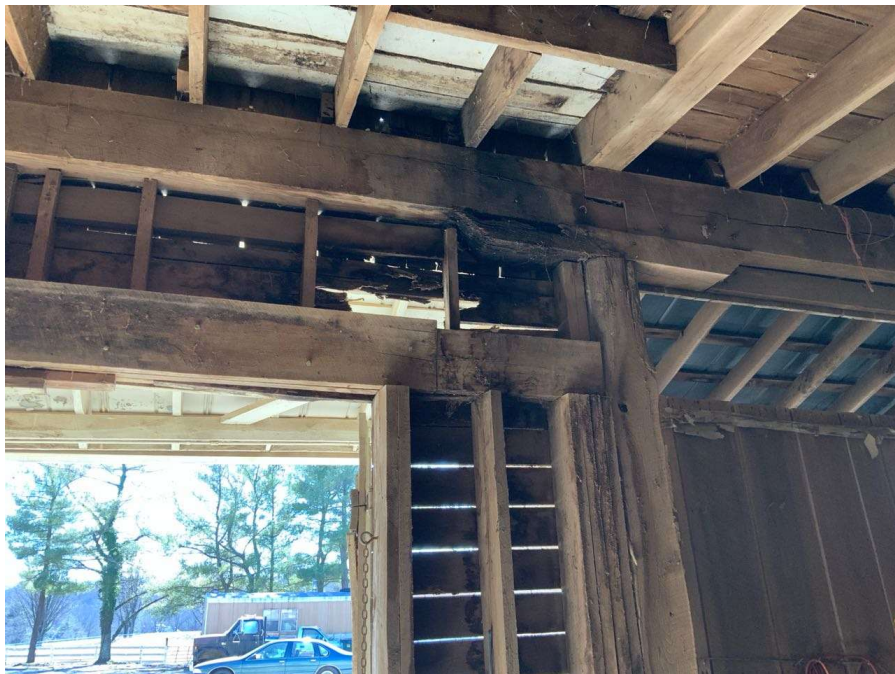
Photo S-170: A new member has been sistered to the original rotting header at the door between Columns F/4 and G/4.

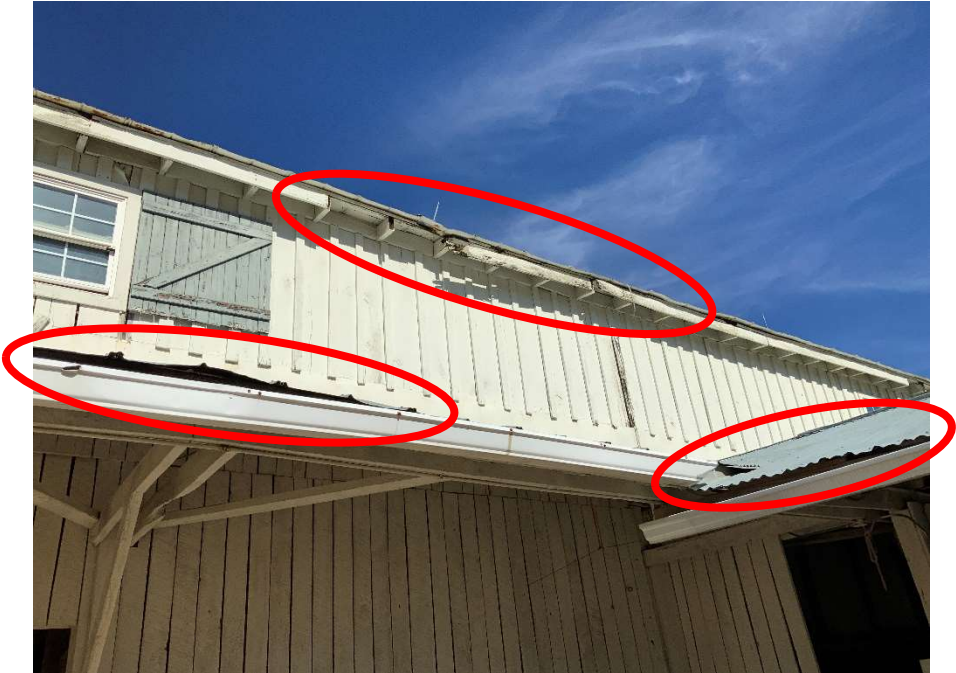
Photo A-3: Sections of lifted metal roof panels and deteriorated/missing fascia boards.

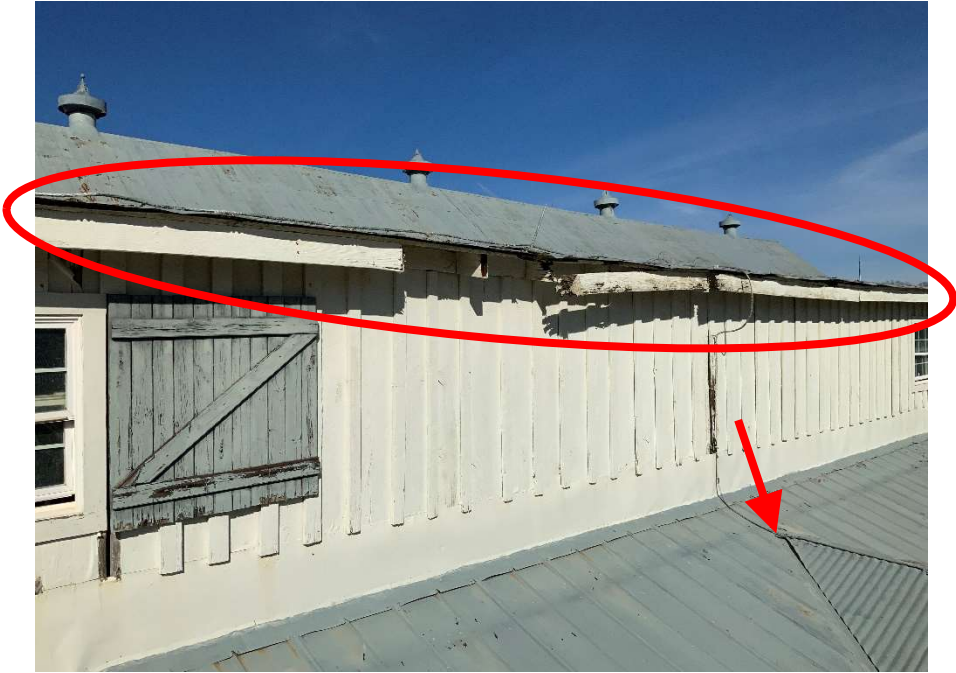
Photo A-4: Deteriorating roof edge and inadequate waterproofing at corrugated roof.

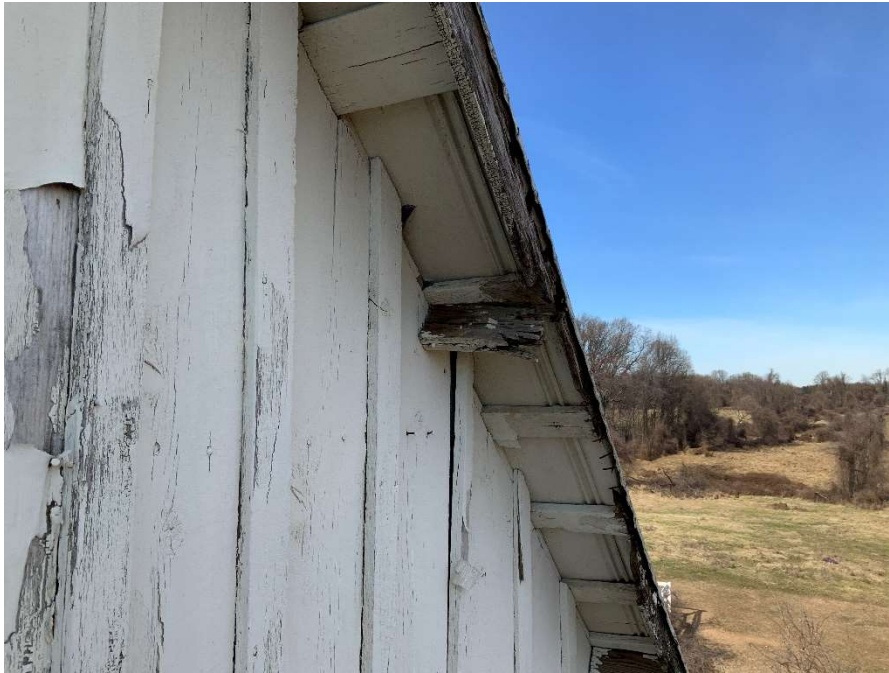
Photo A-5: Close-up view of deteriorated/missing fascia board and lack of edge flashing.

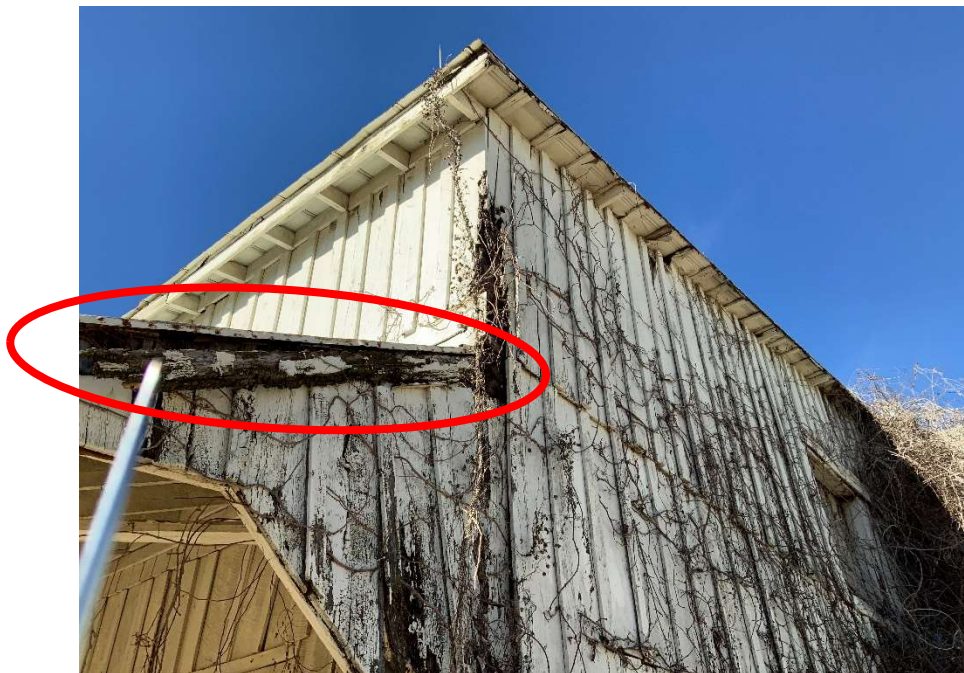
Photo A-6: Lack of edge coverage and wood deterioration.

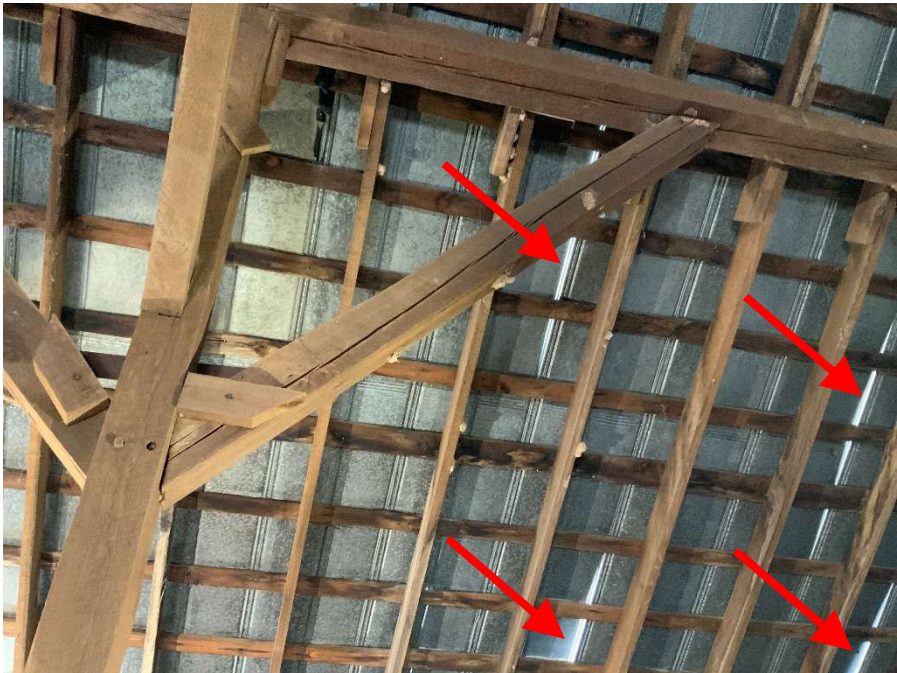
Photo A-7: Underside of metal roof panels with separated seams.

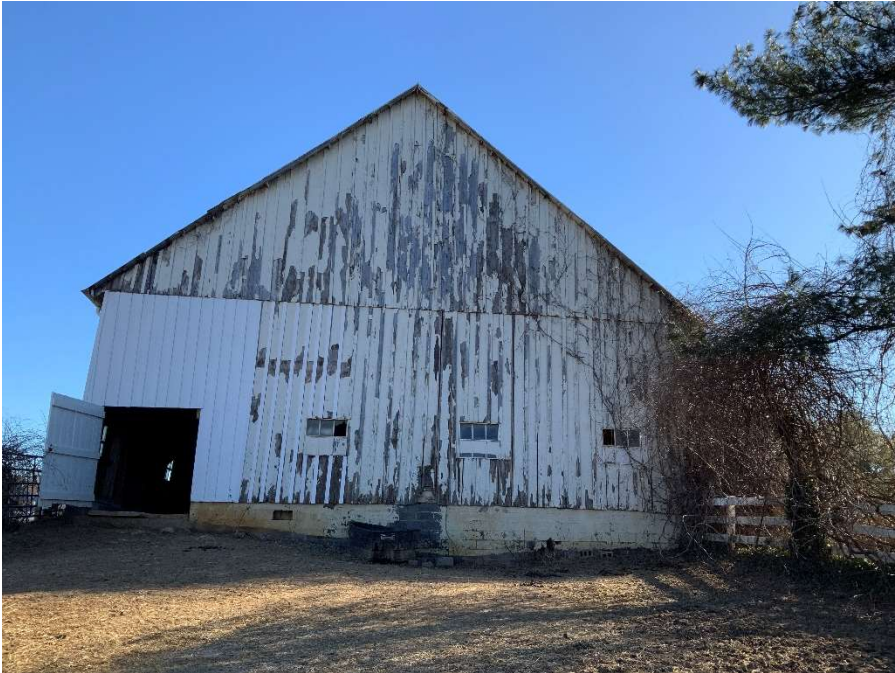
Photo A-9: General exterior photo of paint peeling and deteriorated siding.

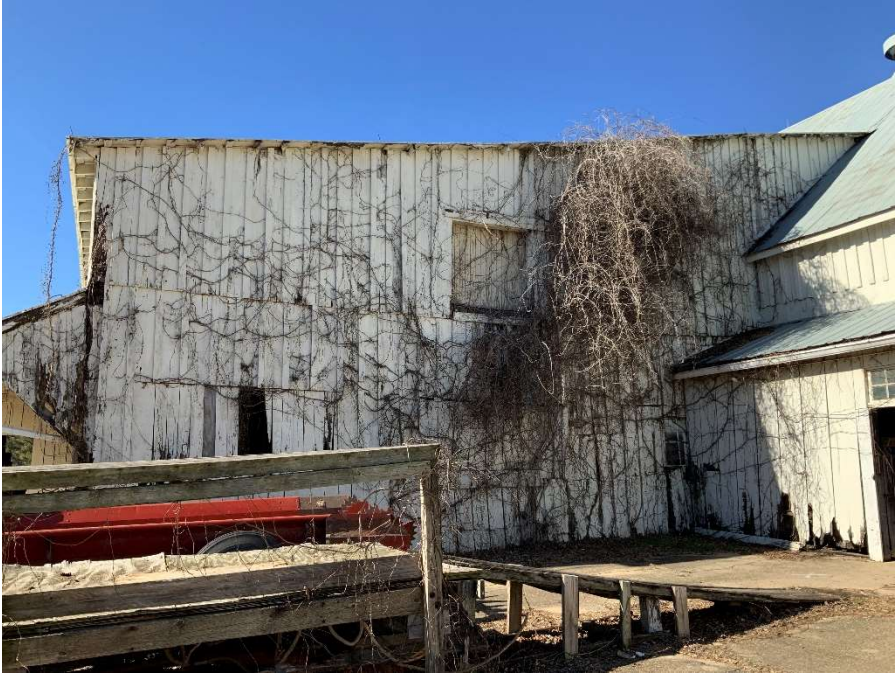
Photo A-10: General exterior photo of wood decay and overgrowth.

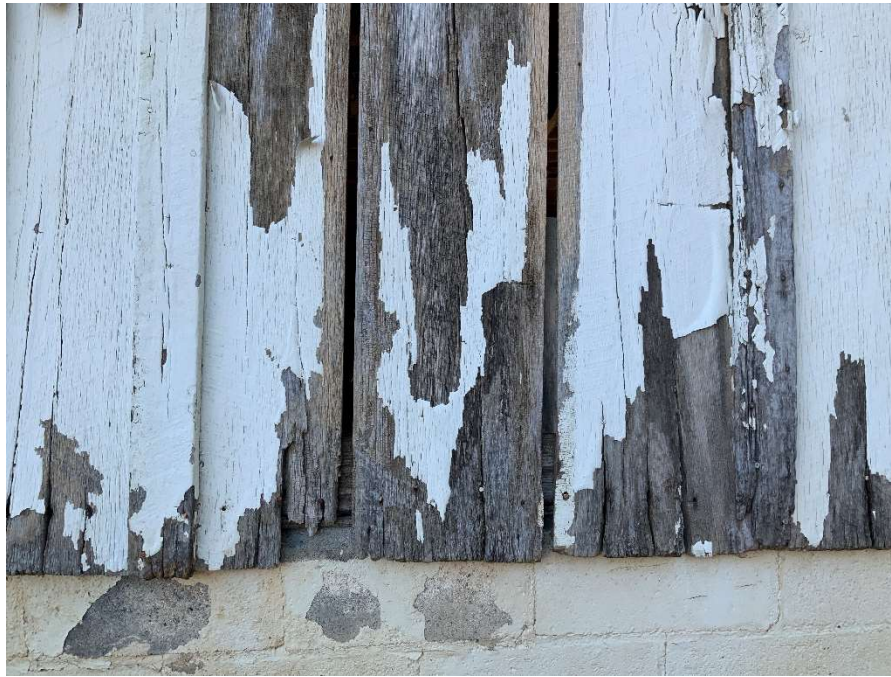
Photo A-11: Paint peel, missing battens, and exposed wood joints.

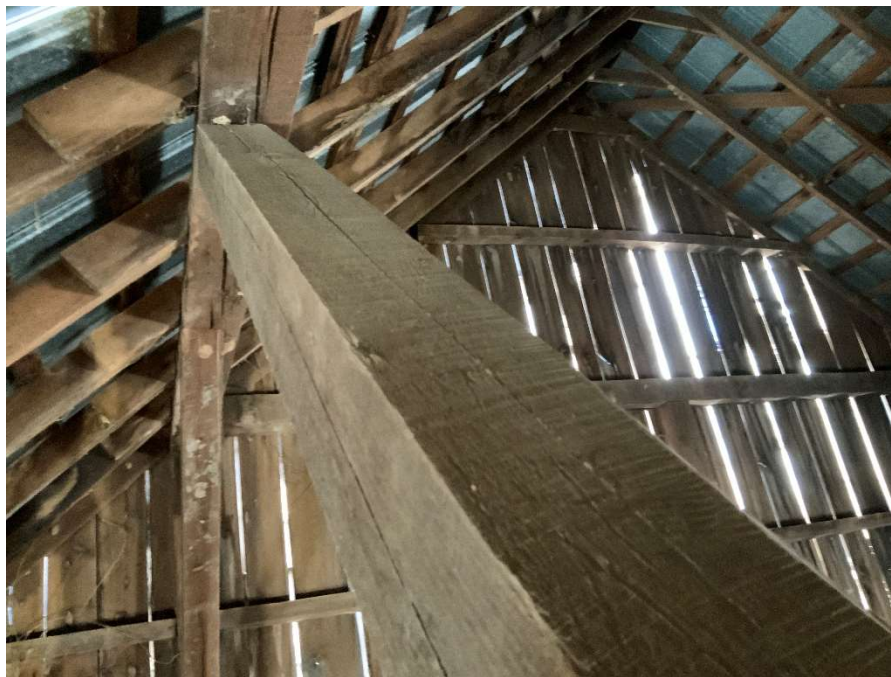
Photo A-12: Interior photo of unprotected wood siding joints.

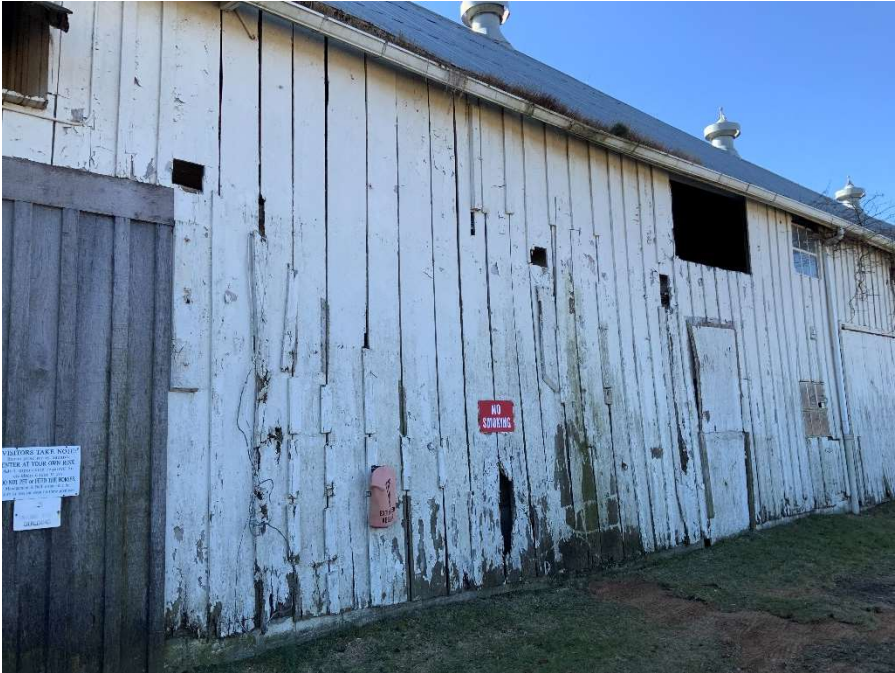
Photo A-13: General exterior photo of deteriorated and decaying boards.

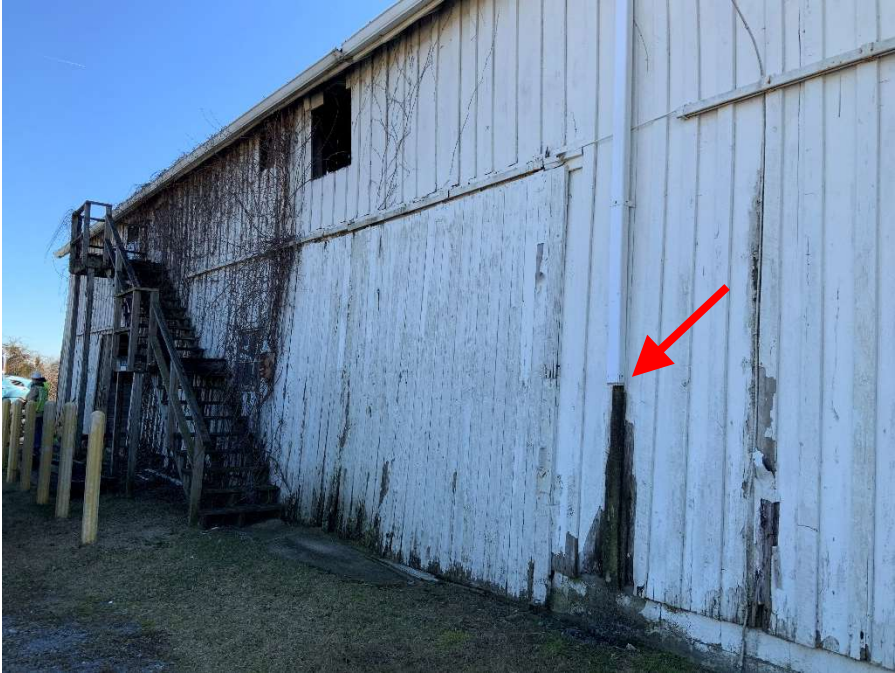
Photo A-14: Deteriorated boards and a discontinuous rain leader.

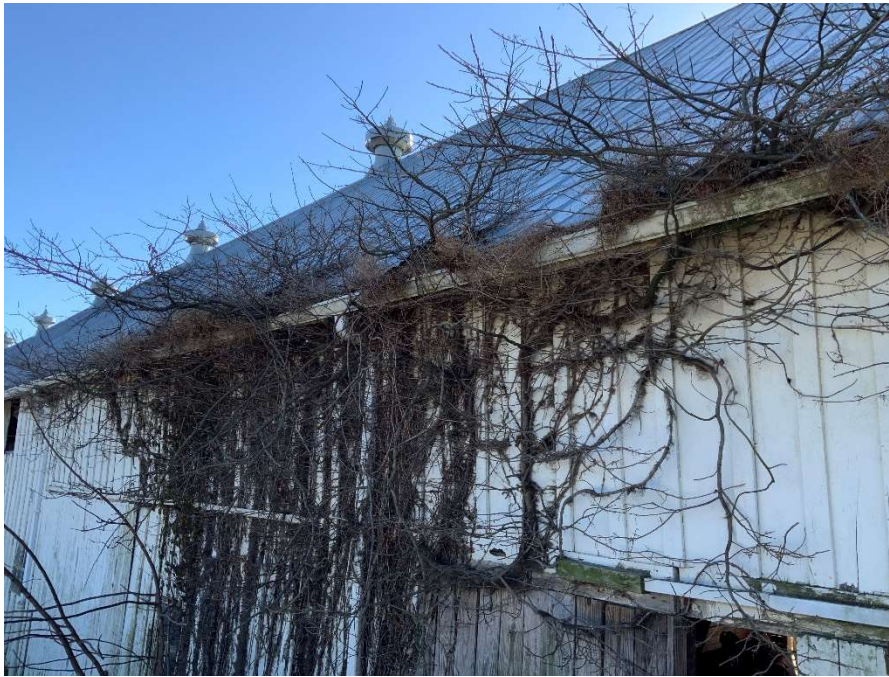
Photo A-15: General exterior photo of vegetation overgrowth and clogged gutters.

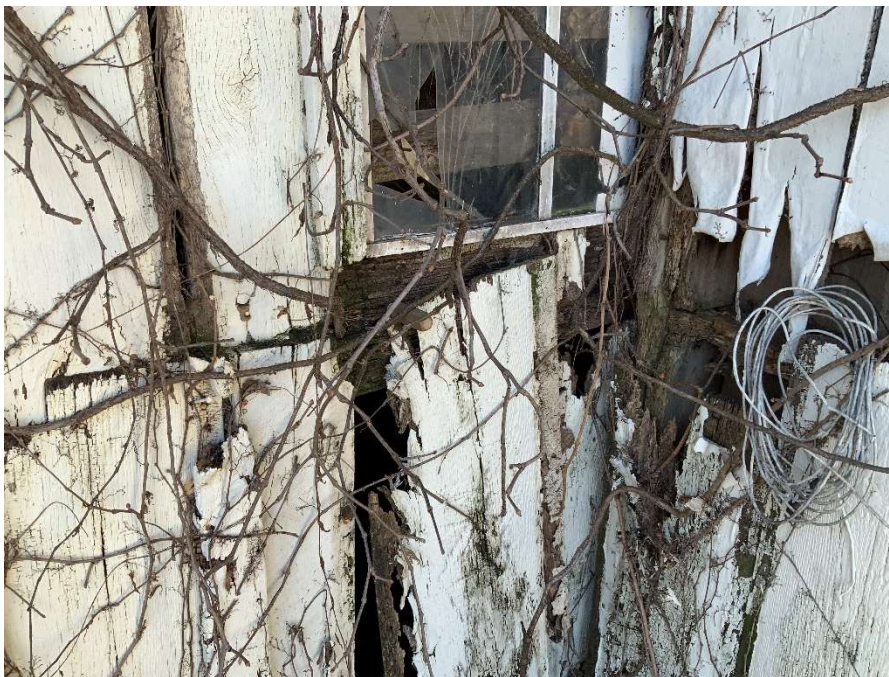
Photo A-16: Close-up photo of wood deterioration and overgrowth.

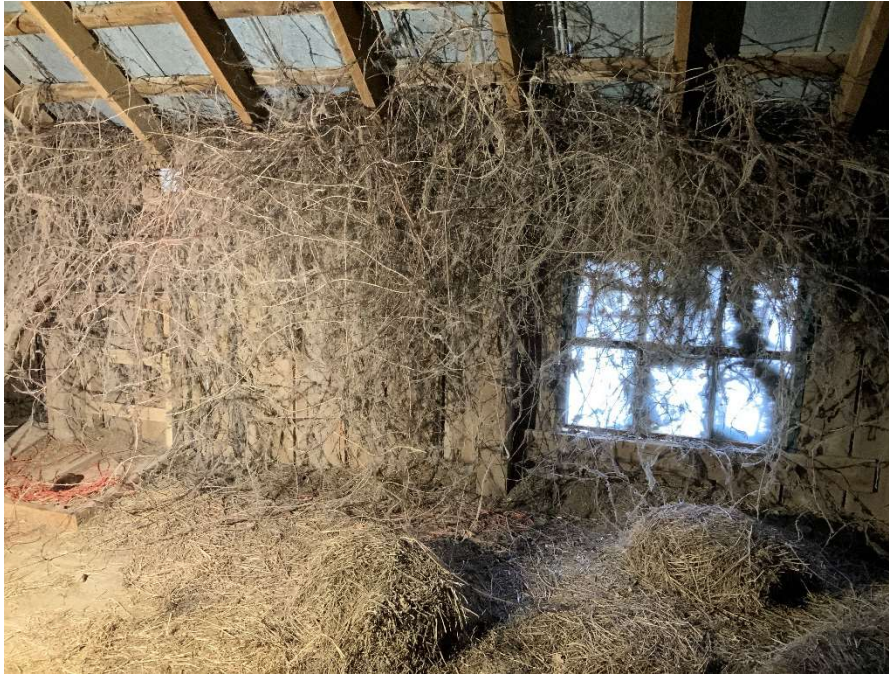
Photo A-17: Interior photo of vegetation overgrowth compromising the building envelope.

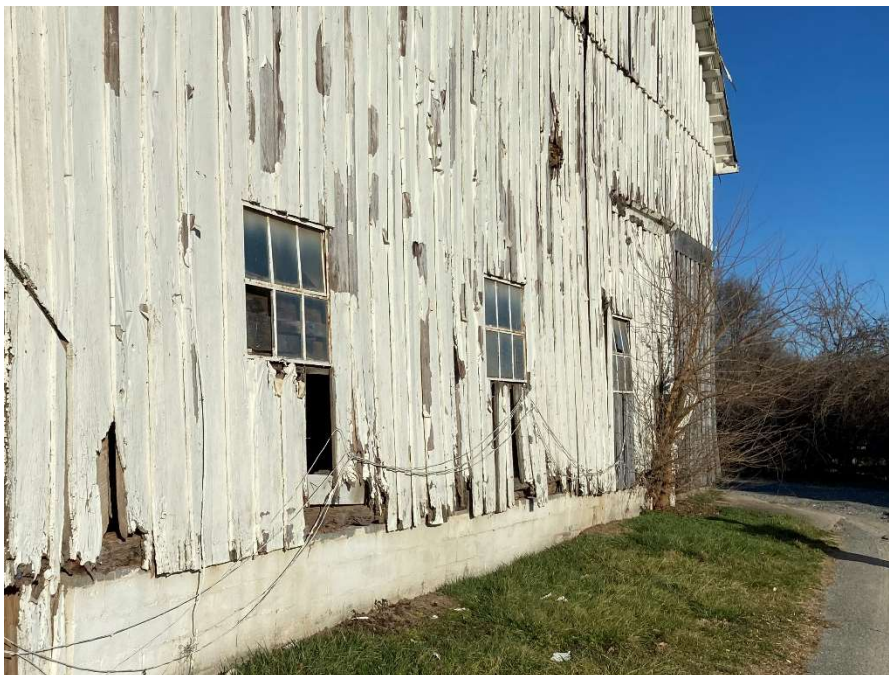
Photo A-18: General exterior photo of window damage and localized deterioration.

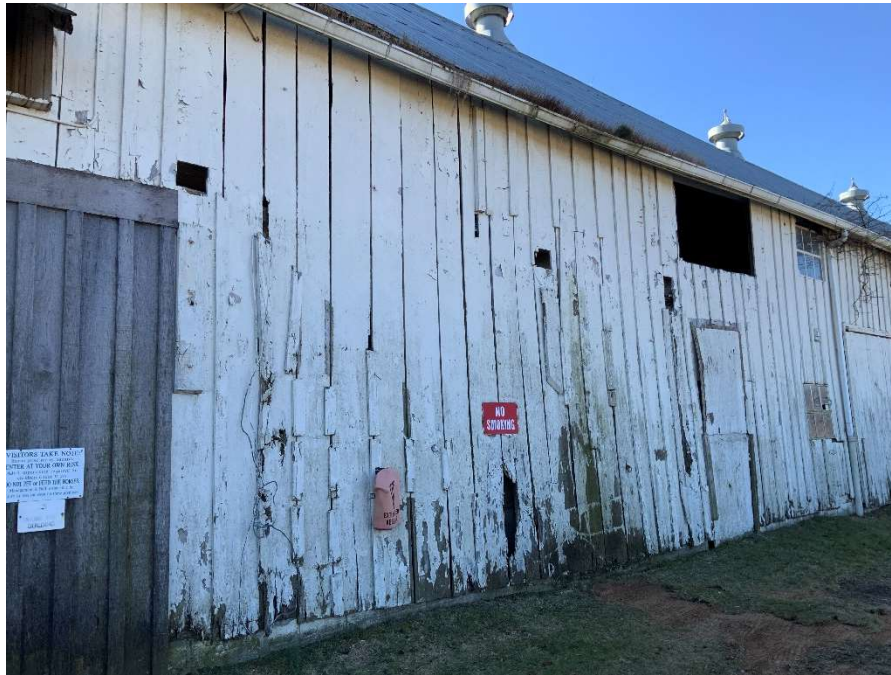
Photo A-19: General exterior photo of unprotected window openings.

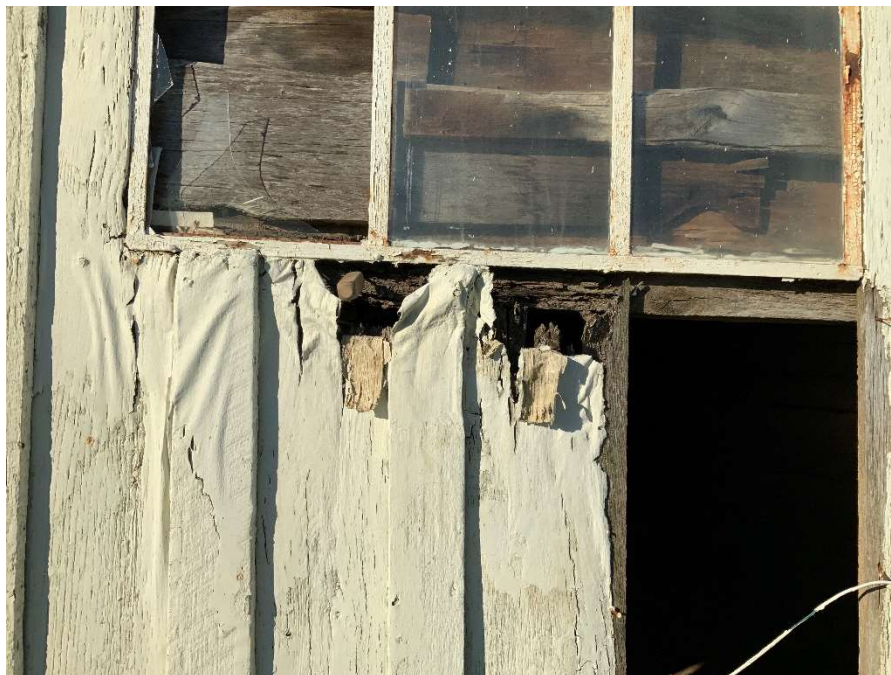
Photo A-20: Window damage and deterioration at sill.

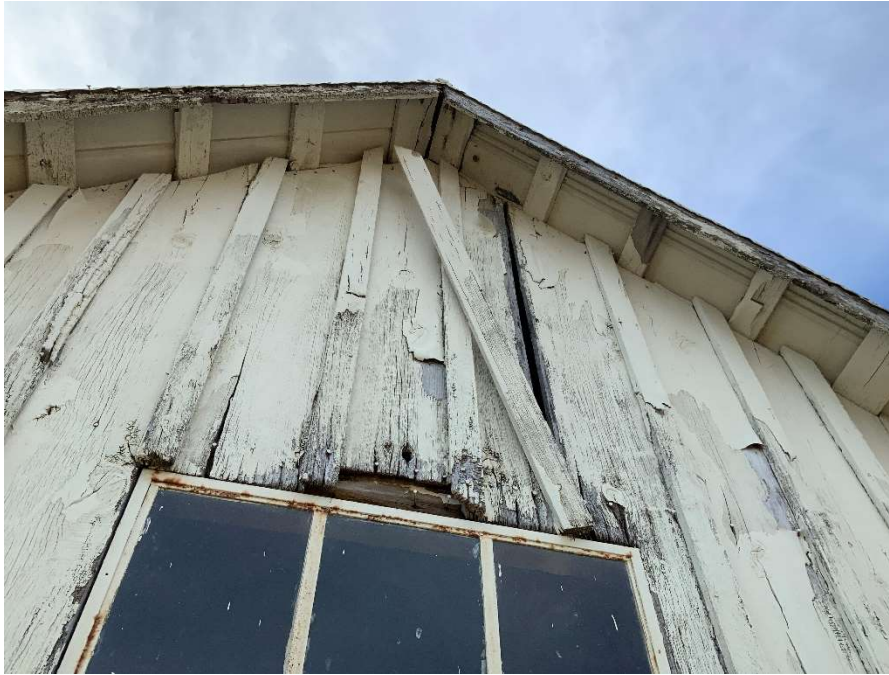
Photo A-21: Window damage and deterioration at head.

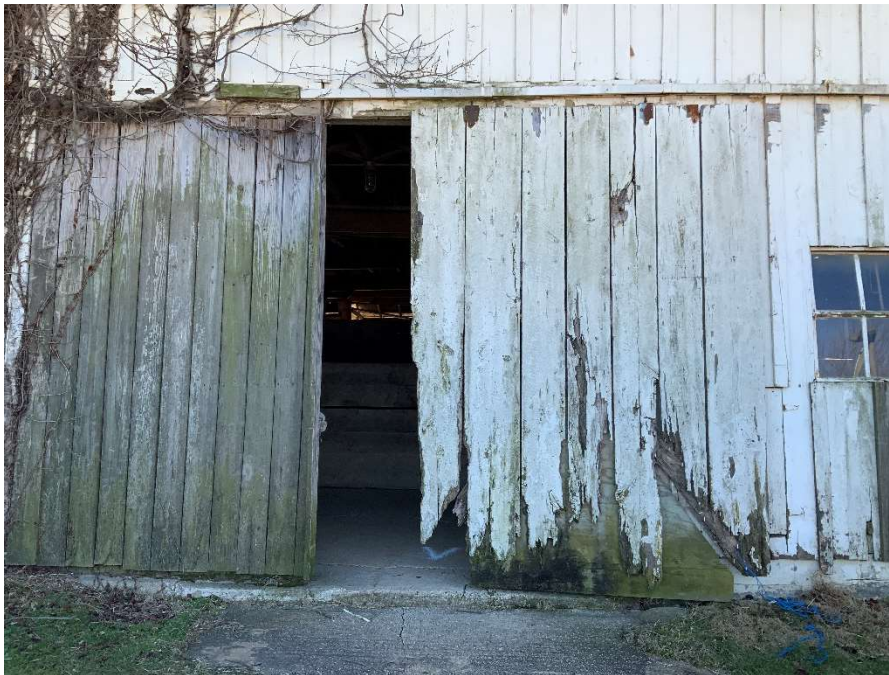
Photo A-22: General exterior photo of sliding door deterioration and decay.

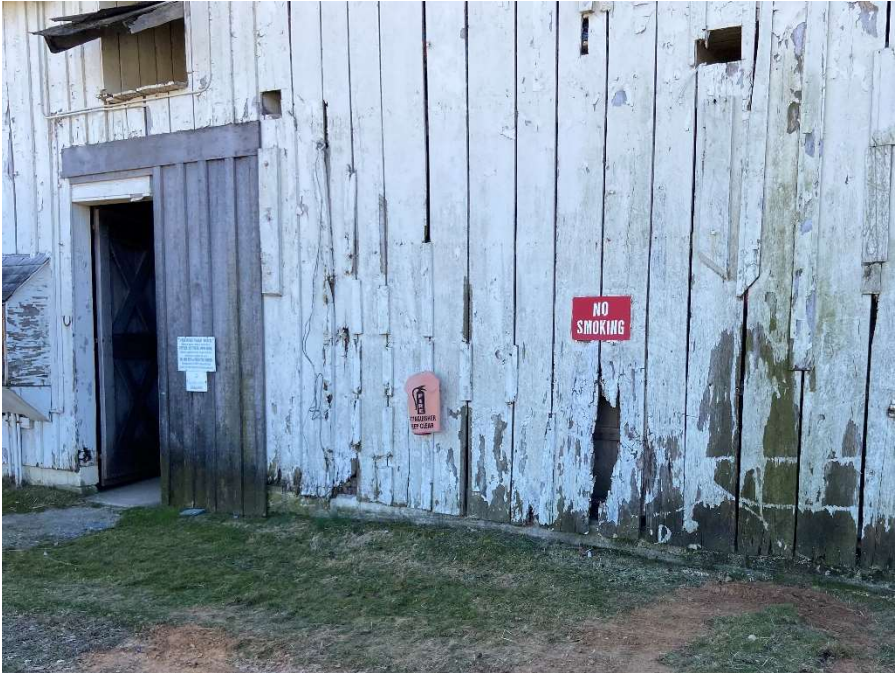
Photo A-23: General exterior photo of unpainted door.

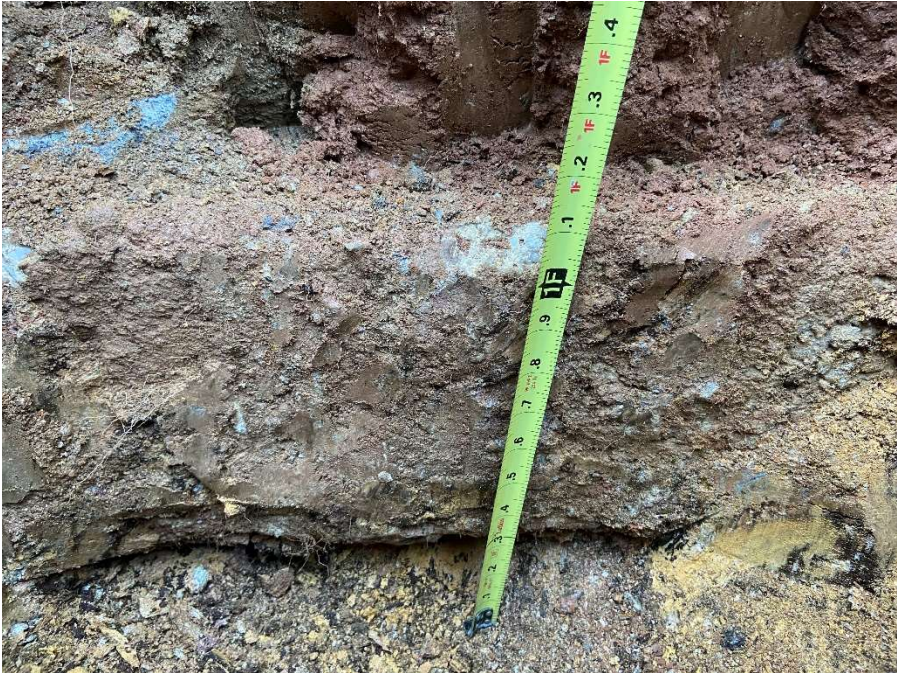
Photo GT-4: Exposed concrete foundation at TP-1 measuring 0.9 feet thick.

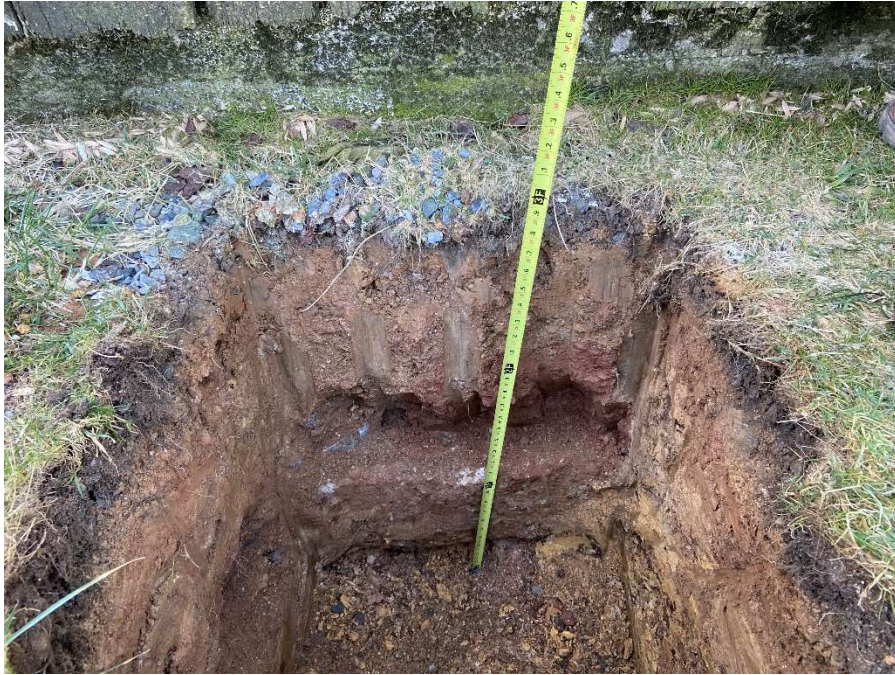
Photo GT-5: Exposed foundation at TP-1 with top of footing measuring 1.9 feet BGS and bottom of footing at 2.8 feet BGS.

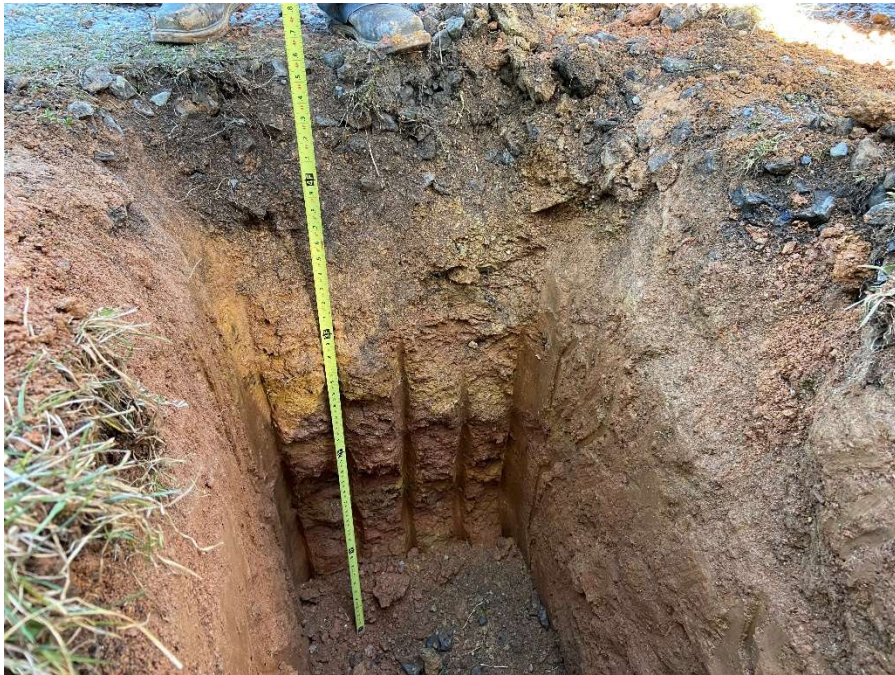
Photo GT-6: TP-2 soil profile (0.0 feet to 4.6 feet).

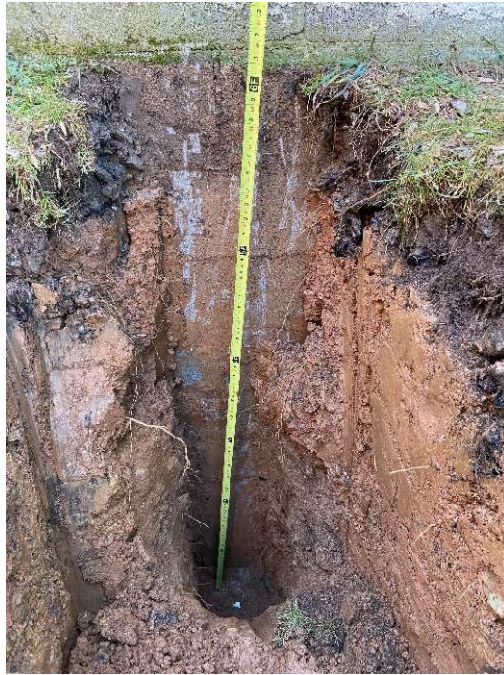
Photo GT-7: Top of concrete footing at TP-2 measuring 6.0 feet BGS with CMU foundation wall extending full depth and resting on top of spread footing.

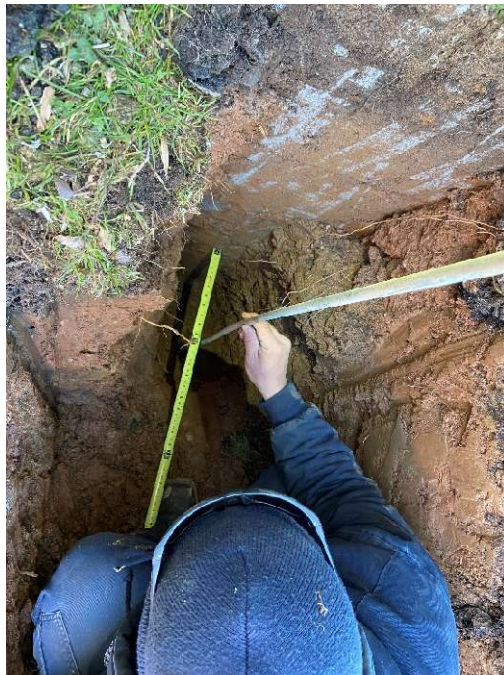
Photo GT-8: Sounding rod used at TP-2 to locate edge of spread footing foundation. Foundation protrudes 1.0 foot from exterior foundation wall.

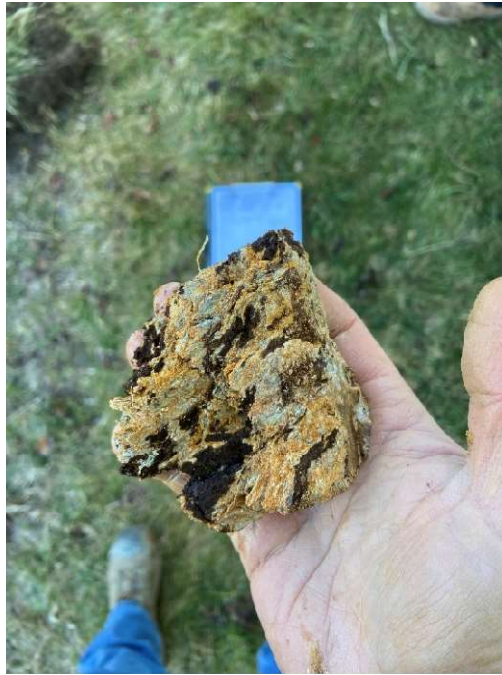
Photo GT-9: Soil from TP-1. Likely residual soil part of the Glenelg silt loam soil unit.

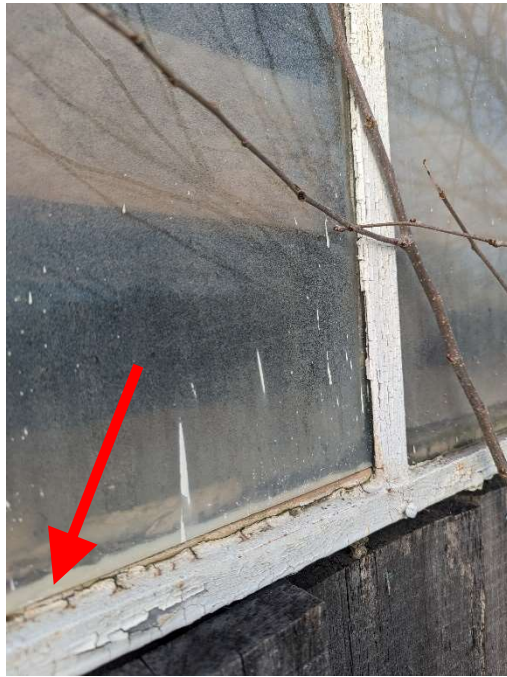
Photo E-1: Tan/white caulk associated with the barn's exterior windows. Identified as potential ACM. Windows are present in all exterior walls.

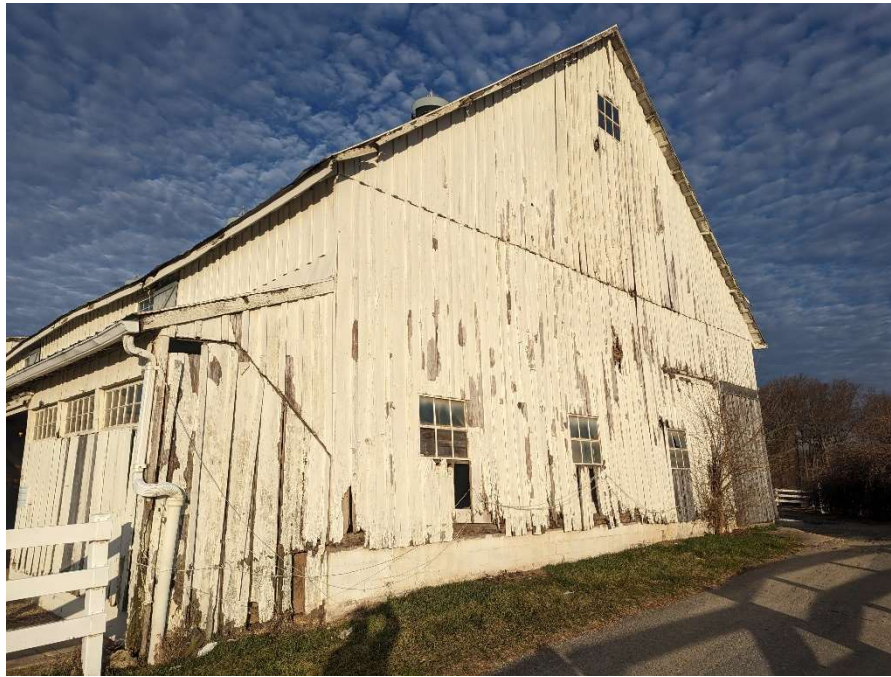
Photo E-3: Cracking/peeling white paint along barn exterior walls and fascia boards. Identified as potential lead-based paint.

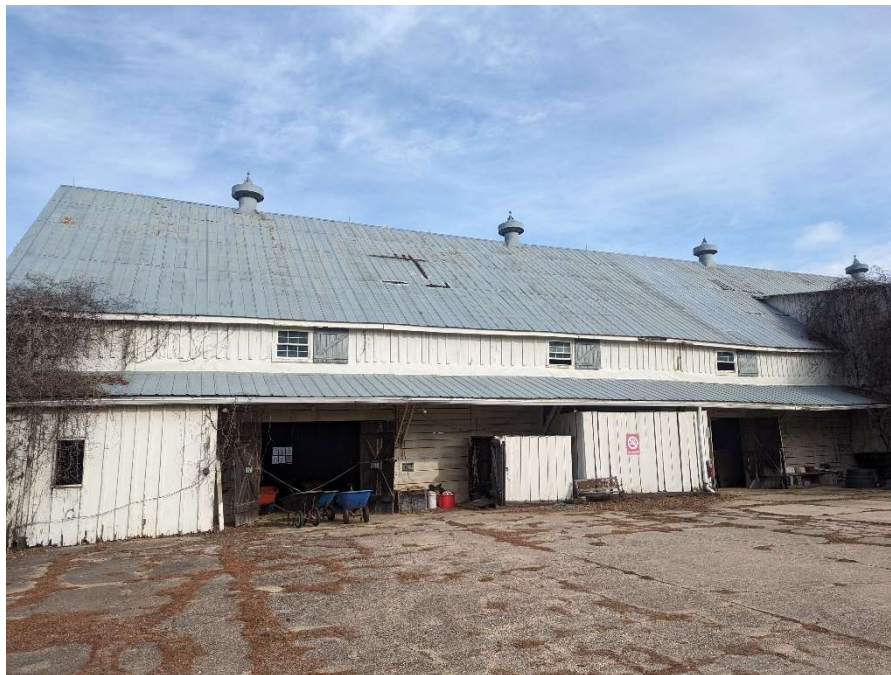
Photo E-4: Peeling/blistering gray paint on metal roof and roof vents/cupolas. Identified as potential lead-based paint.

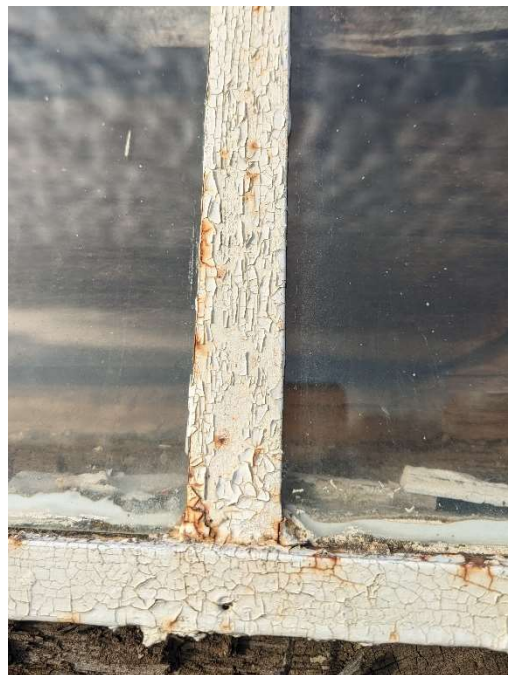
Photo E-6: "Alligator texture" cracking observed on white paint on exterior window frames. Identified as potential lead-based paint.

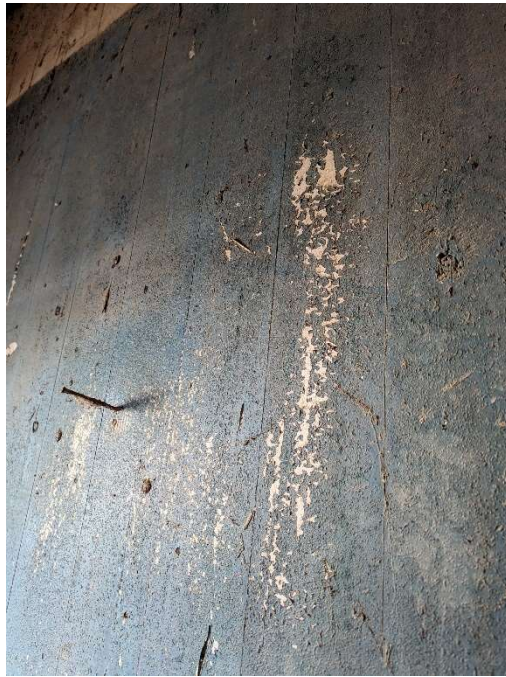
Photo E-7: "Alligator texture" cracking on green interior paint located throughout barn. Identified as potential lead-based paint.
