EQUESTRIAN BARN AT AVENEL

CONDITION ASSESSMENT REPORT

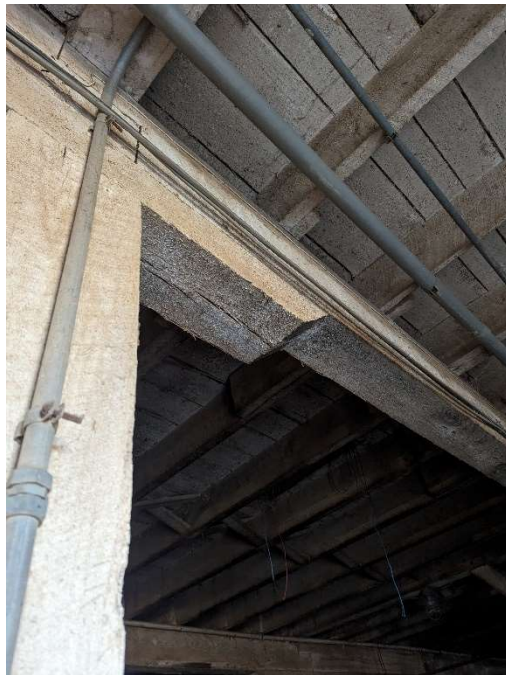
Photo E-8: Flaking white paint on interior walls and timbers. Identified as potential lead-based paint.

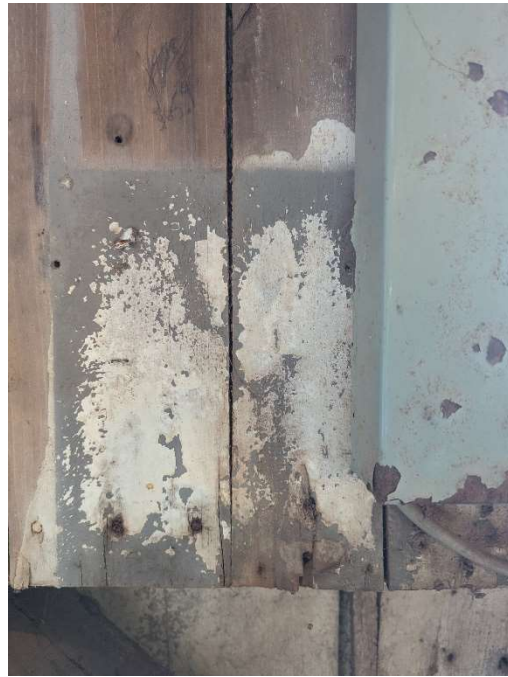
Photo E-9: Cracking gray paint behind apparent former interior electrical panel area on north barn interior wall. Identified as potential lead-based paint.

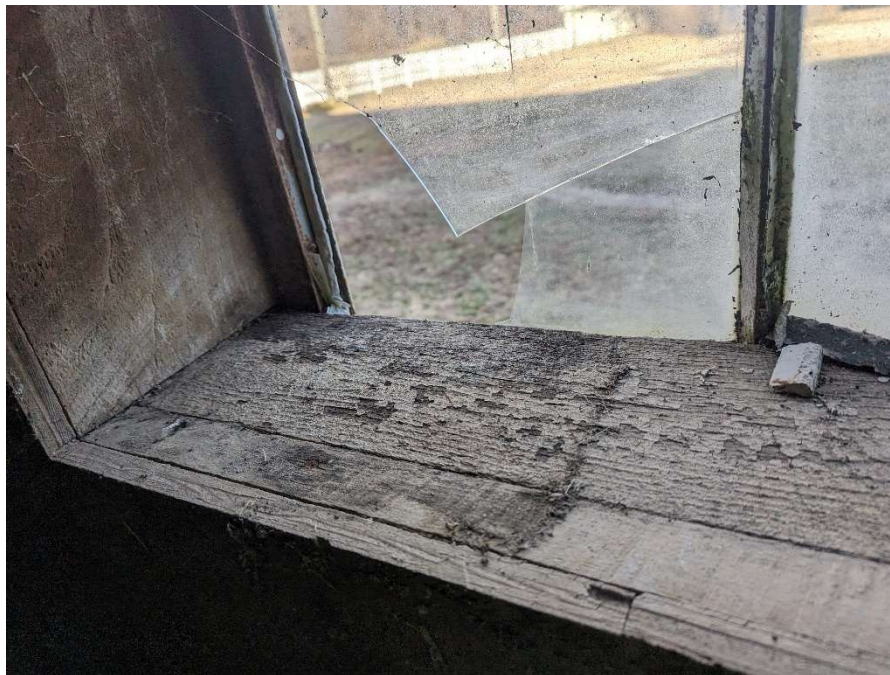
Photo E-10: Cracking/flaking white paint on interior wooden window sills throughout barn. Identified as potential lead-based paint.

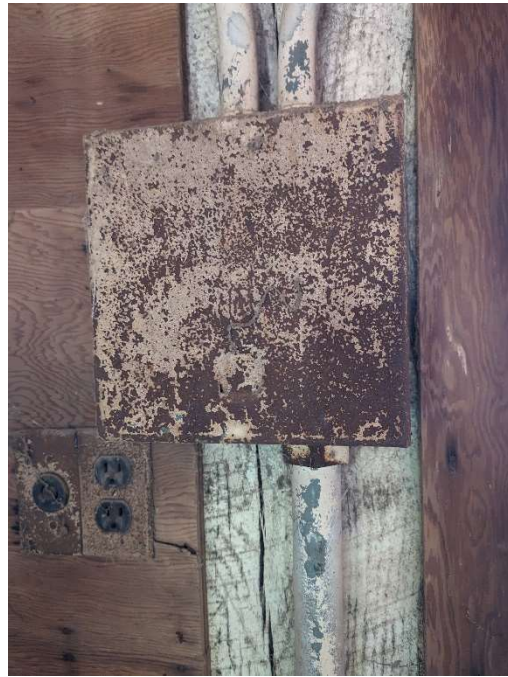
Photo E-11: Cracking/flaking white paint on conduit and junction box located on north barn interior wall. Identified as potential lead-based paint.

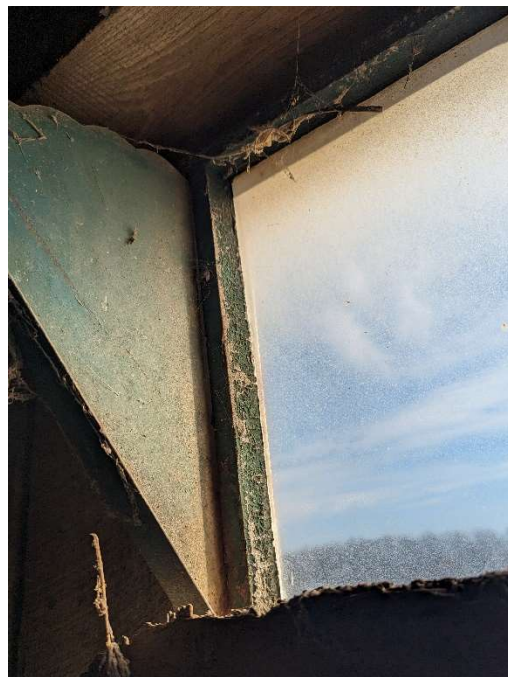
Photo E-12: "Alligator texture" cracking green paint on exterior window frames. Numerous windows are present in barn exterior walls. Identified as potential lead-based paint.

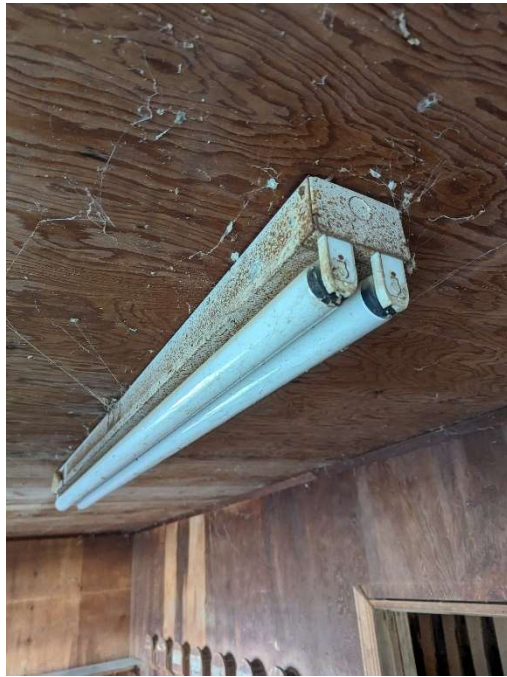
Photo E-13: Fluorescent light fixture in barn interior room along northern building wall. Ballast identified as potentially containing PCBs. Fixture was not opened for inspection due to its condition.

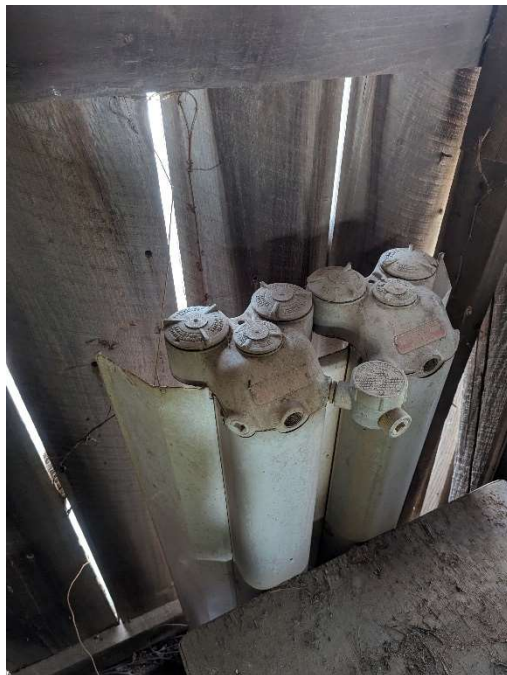
Photo E-14: Fluorescent light fixture in garage/outbuilding south of the barn. Fixture could not be opened to allow inspection of the ballast due to its location. Identified as potentially containing PCBs.

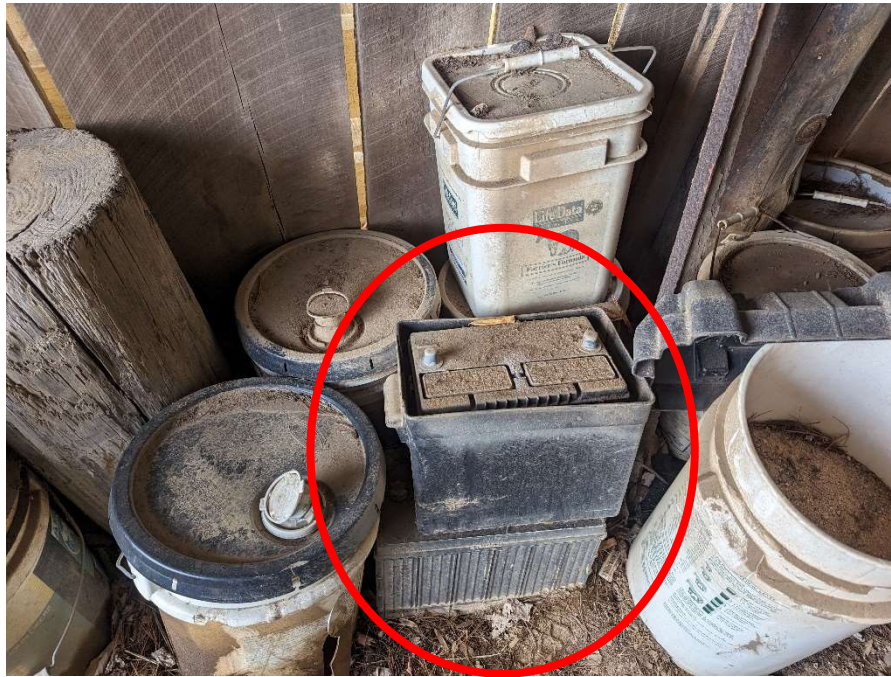
Photo E-15: Lead-acid batteries in plastic battery boxes. Located in garage/outbuilding south of the barn. No leaks were evident.

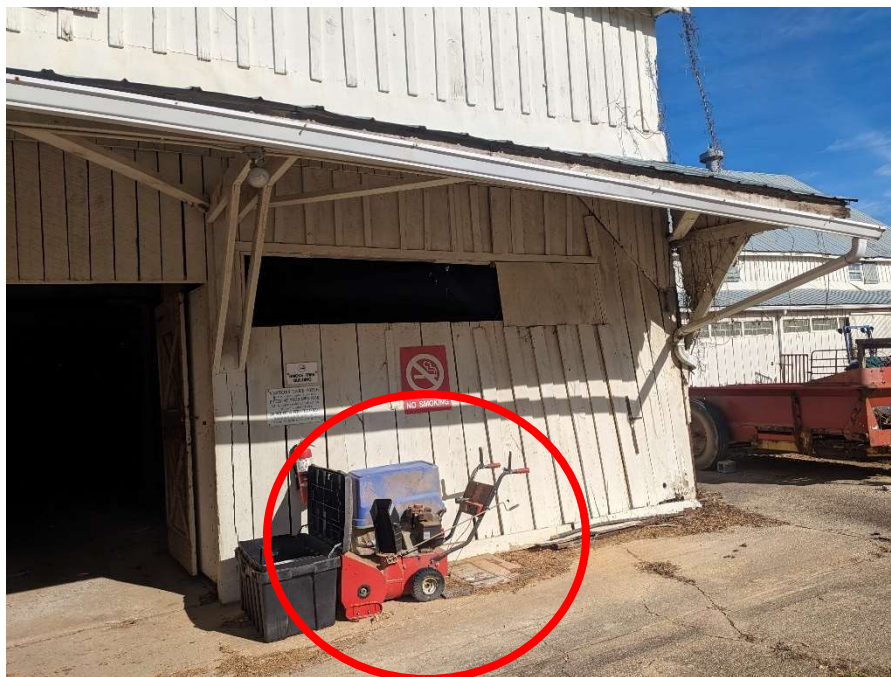
Photo E-16: Gasoline-powered snow blower along barn's south exterior wall. Identified as oil-containing equipment.

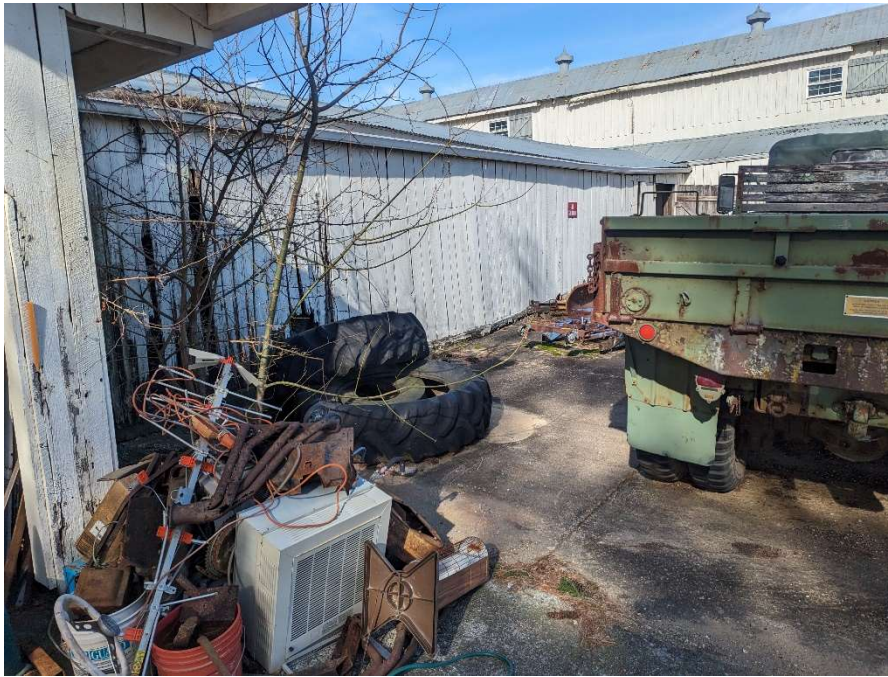
Photo E-29: Tires, heating and air conditioning/mechanical equipment stored at the northeast corner of the garage/outbuilding.

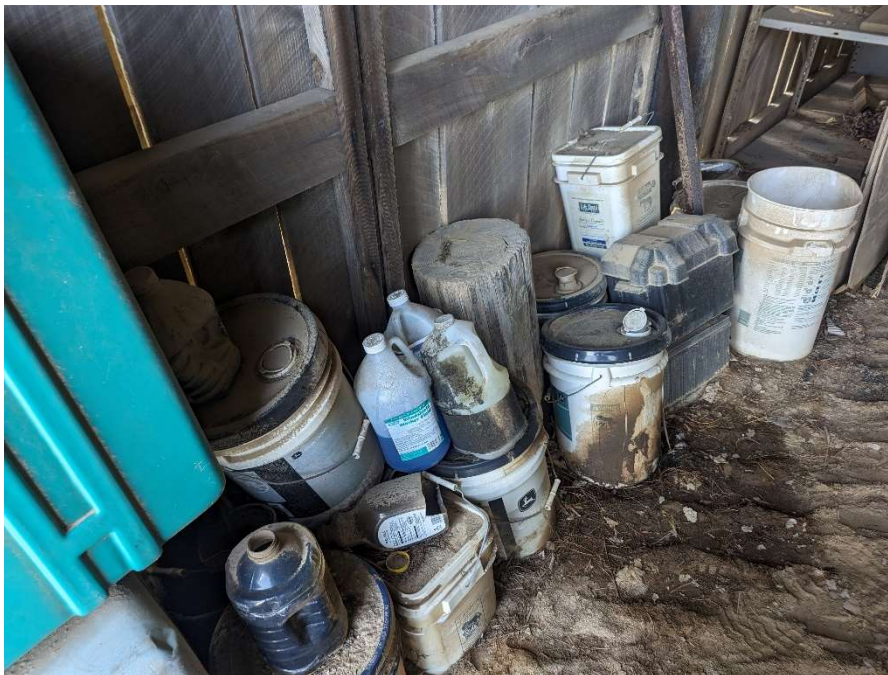
Photo E-30: Hydraulic/transmission oil containers, windshield washer fluid, and car batteries located inside the garage/outbuilding, along south interior wall. Stained soils were evident.

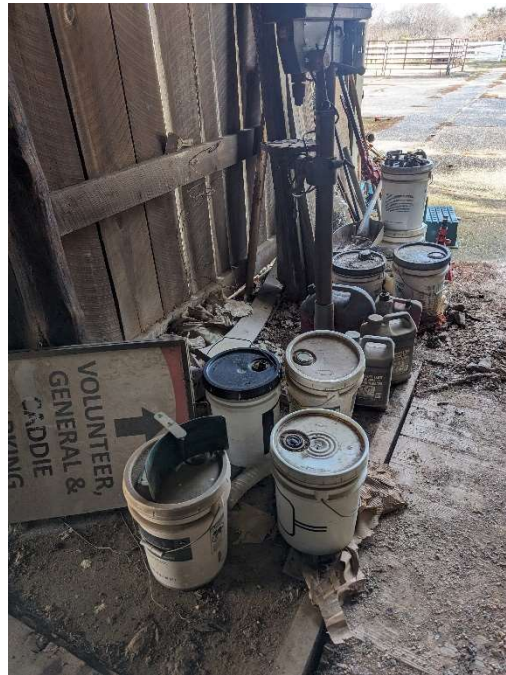
Photo E-31: Hydraulic/transmission/gear oil containers and plastic gasoline cans located inside the garage/outbuilding, along north interior wall.

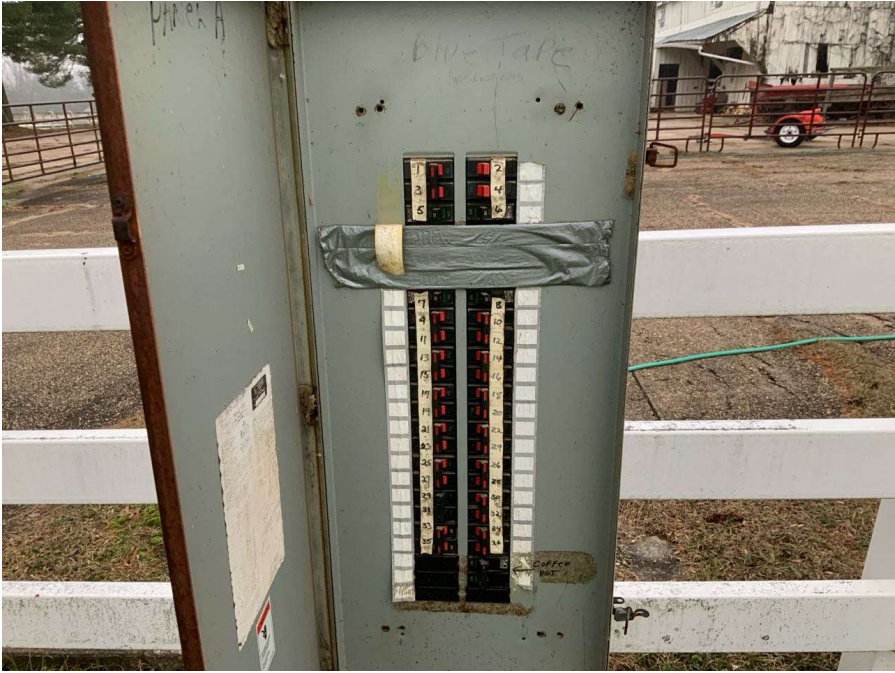
Photo EL-2: Site mounted panelboards are missing circuit breaker knockouts.

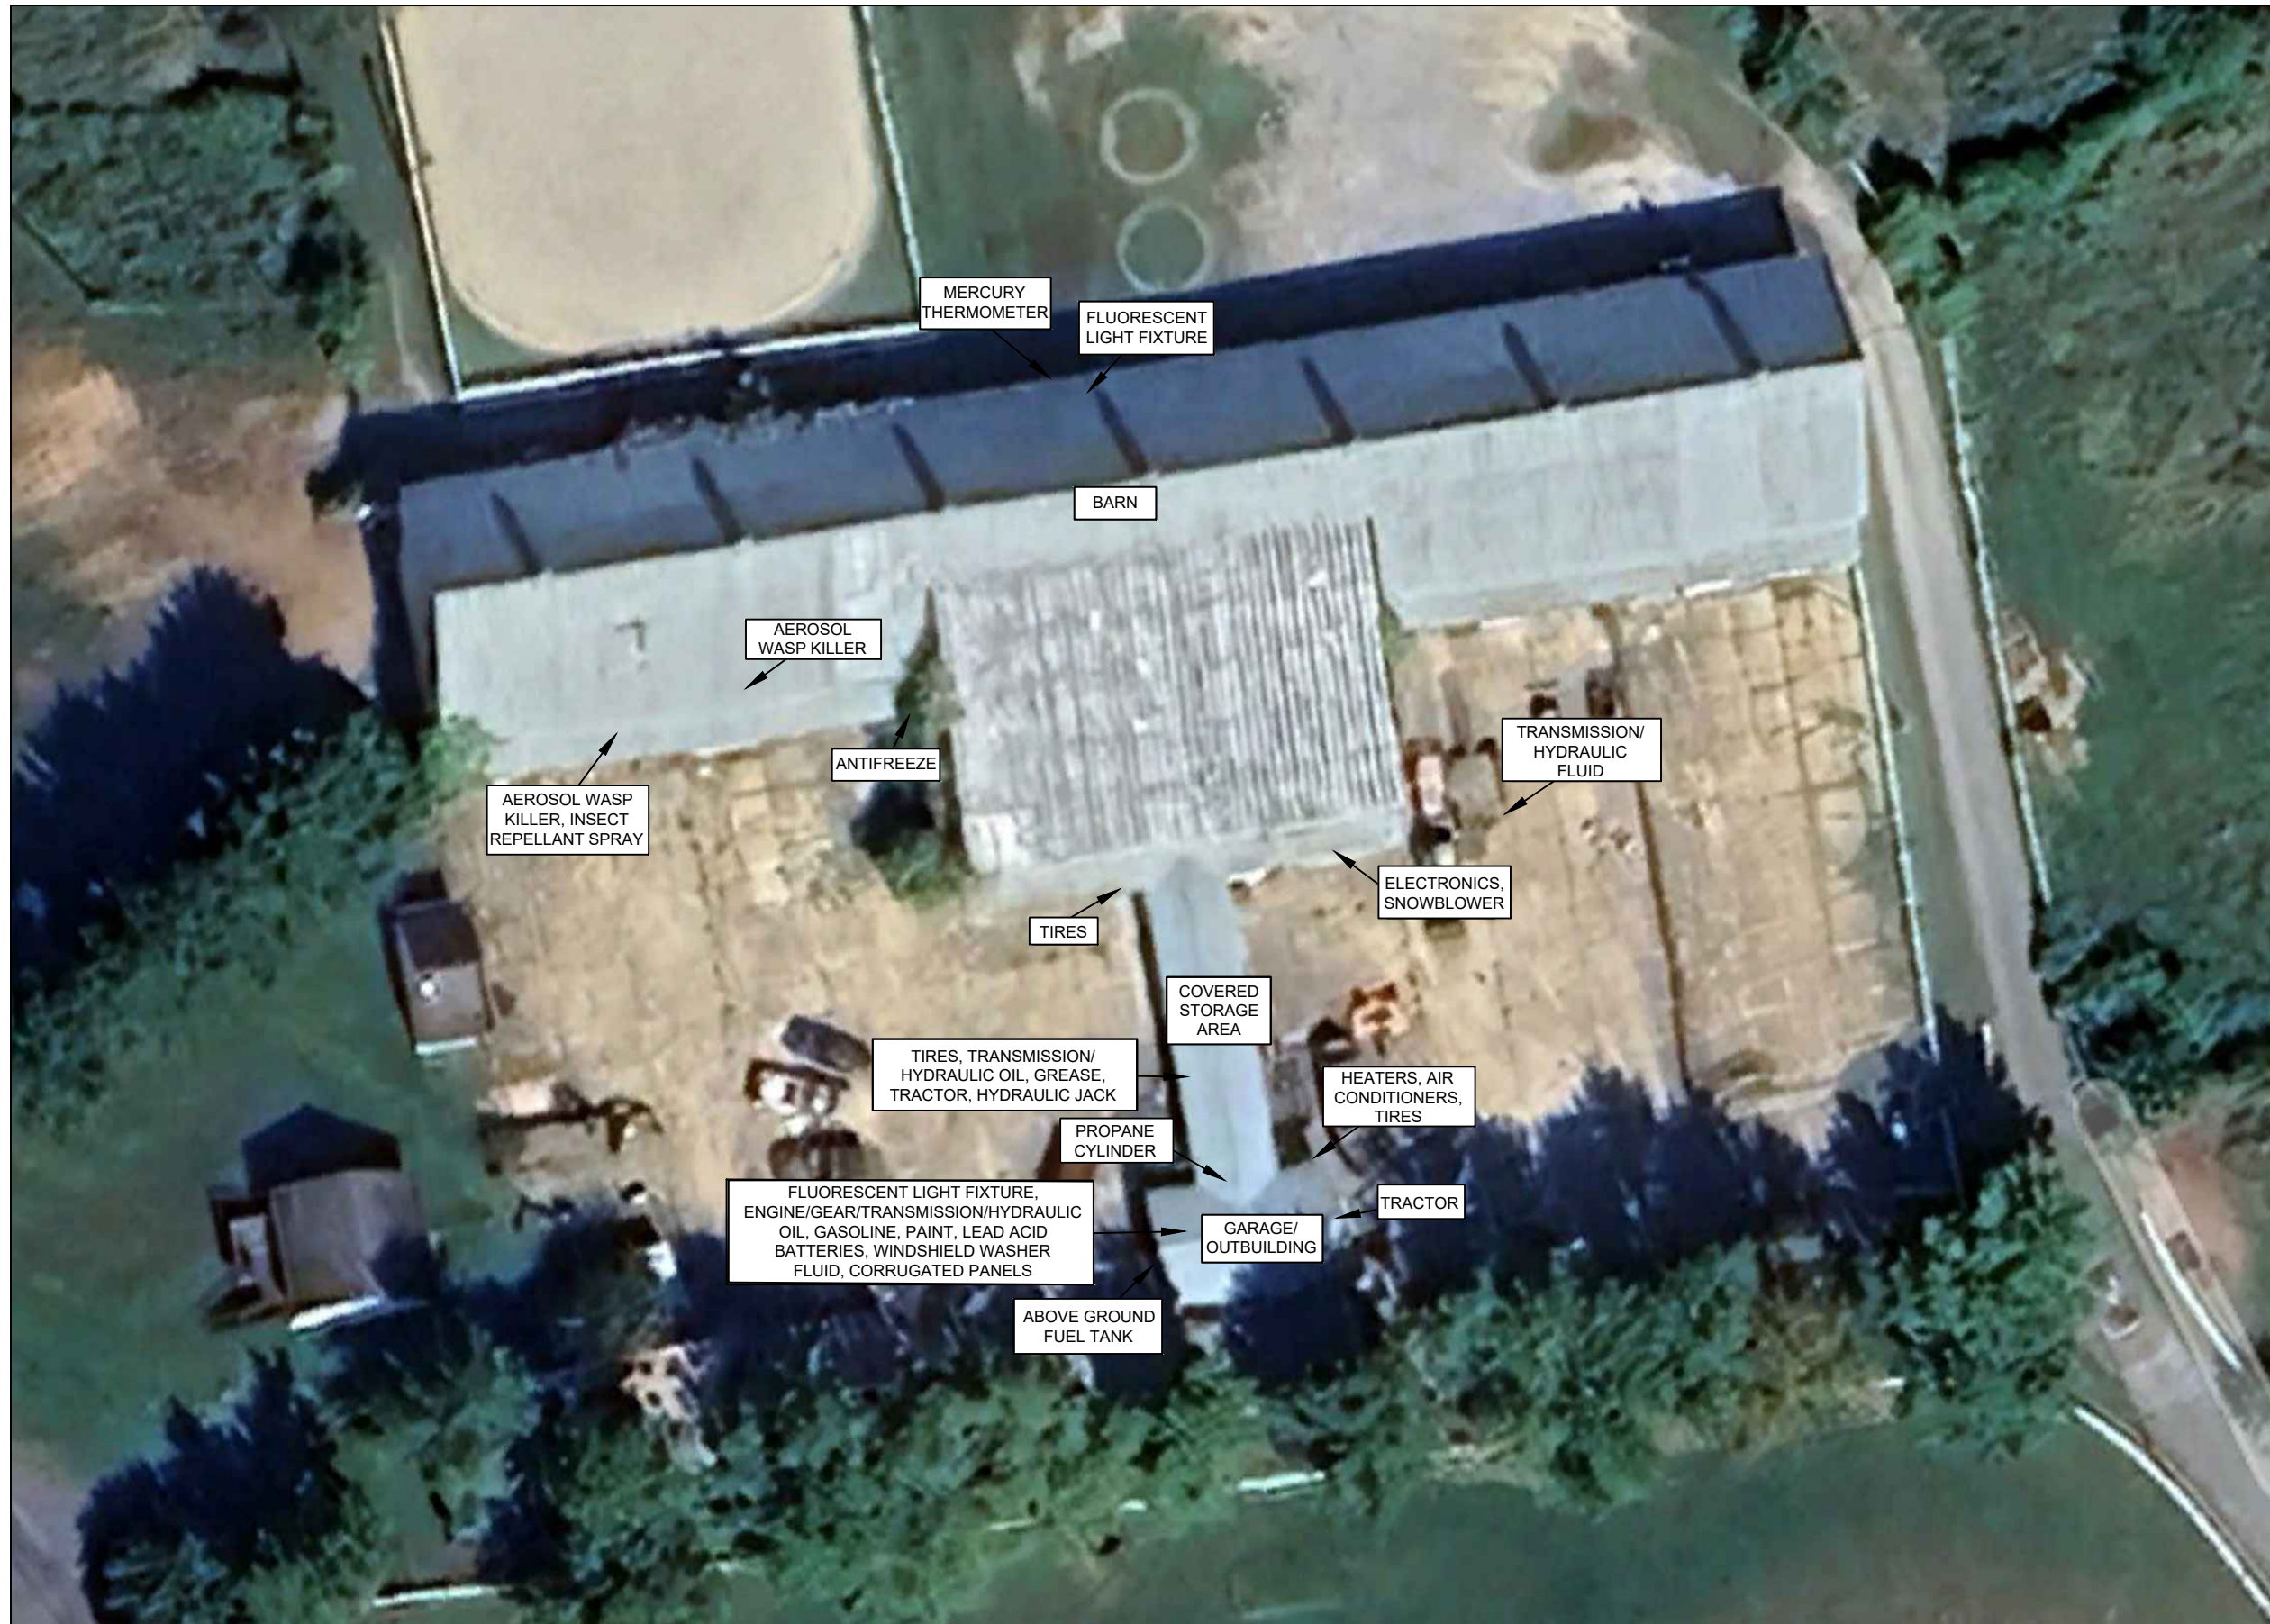
Hazardous and Regulated Materials Identified
during Visual Assessment (February 8, 2024)

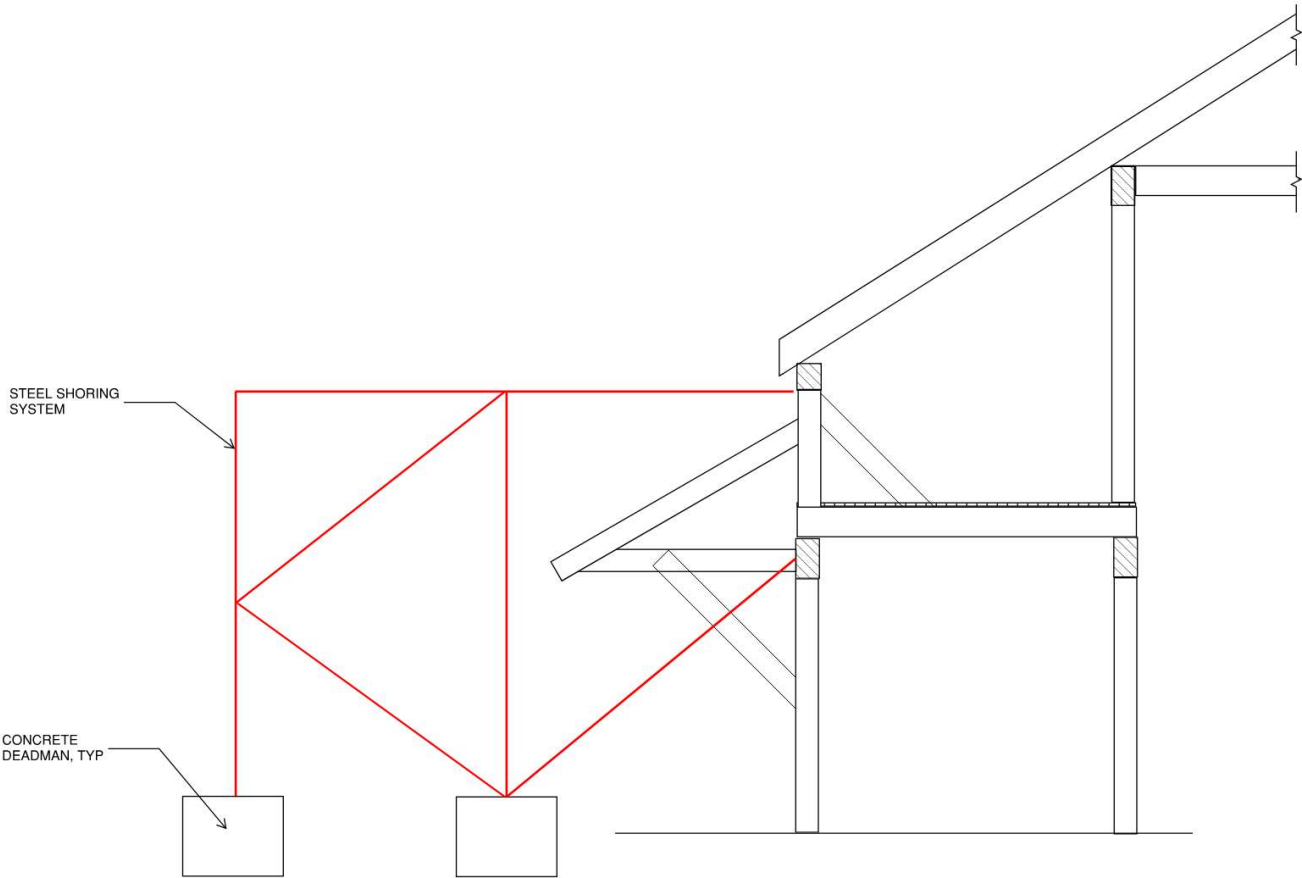
Detail-1: Building Shoring/Bracing

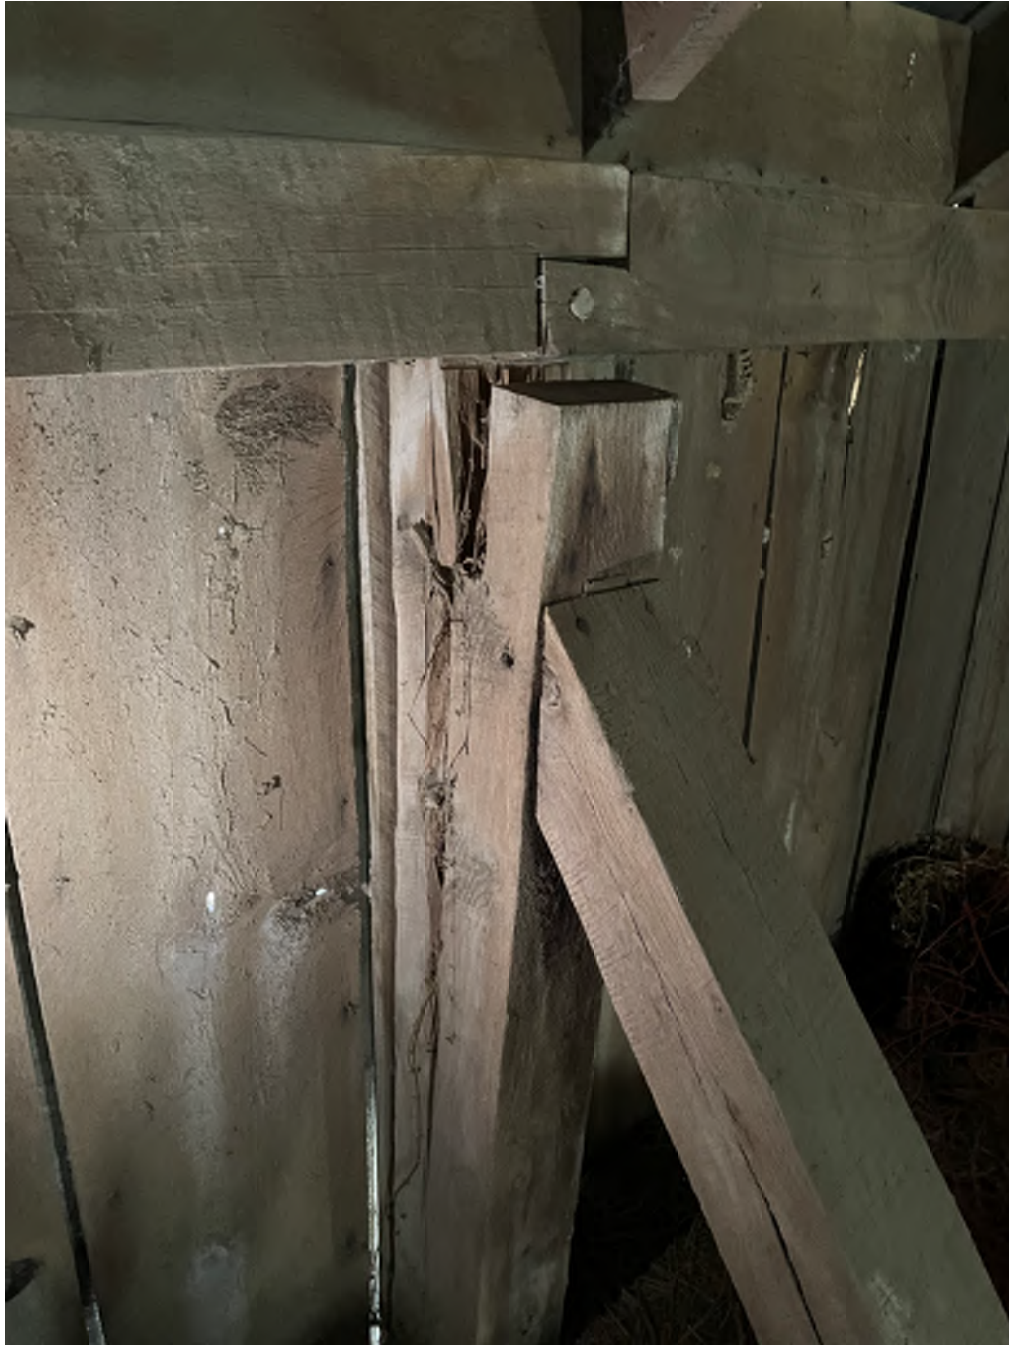
Damaged post in loft

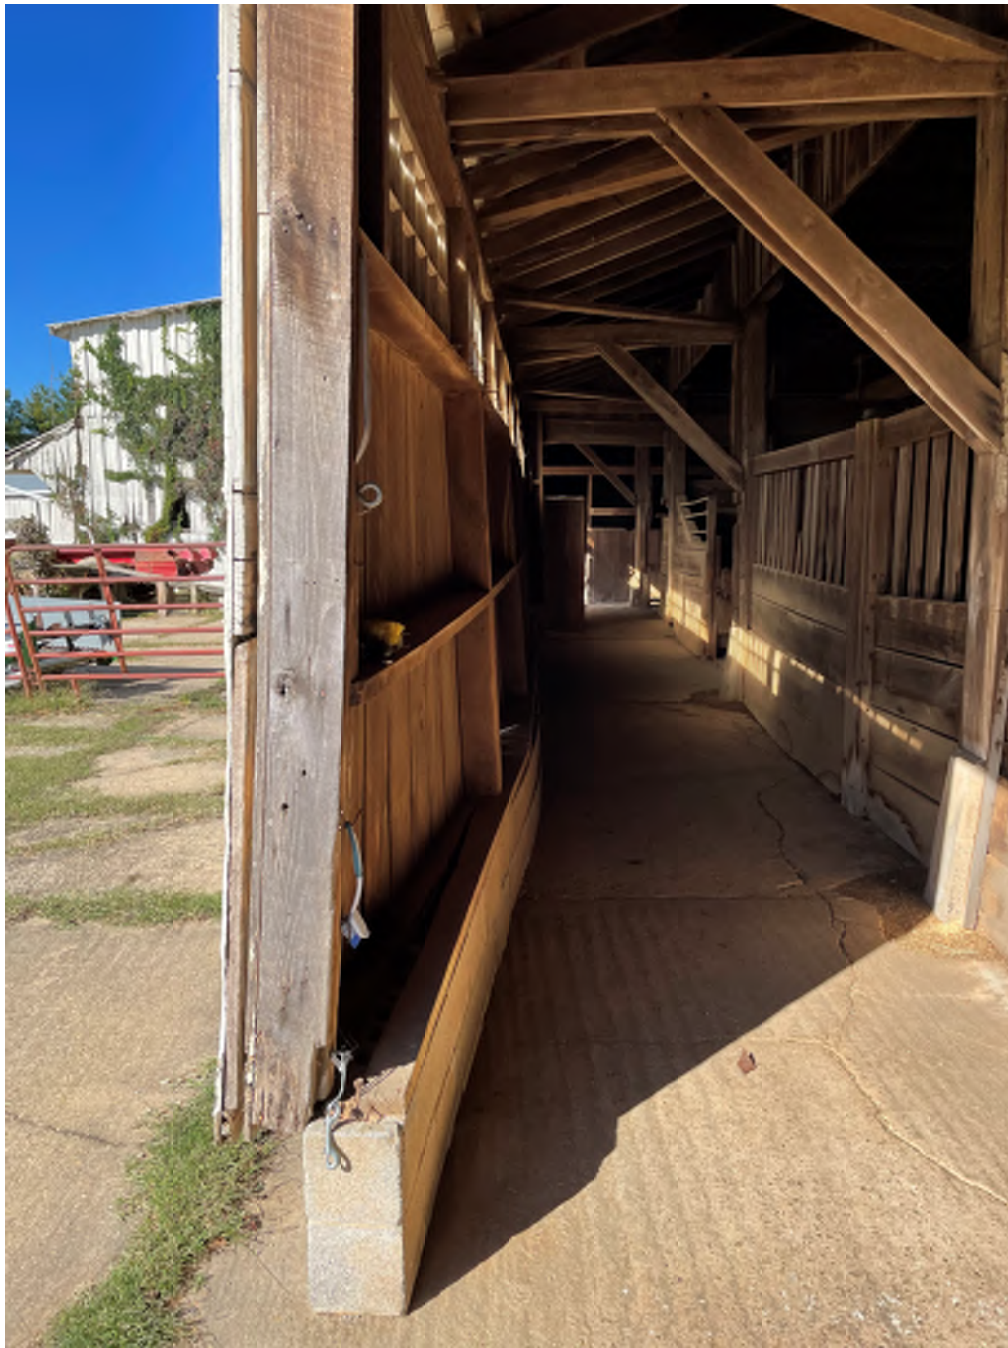
South west foundation wall out of place.

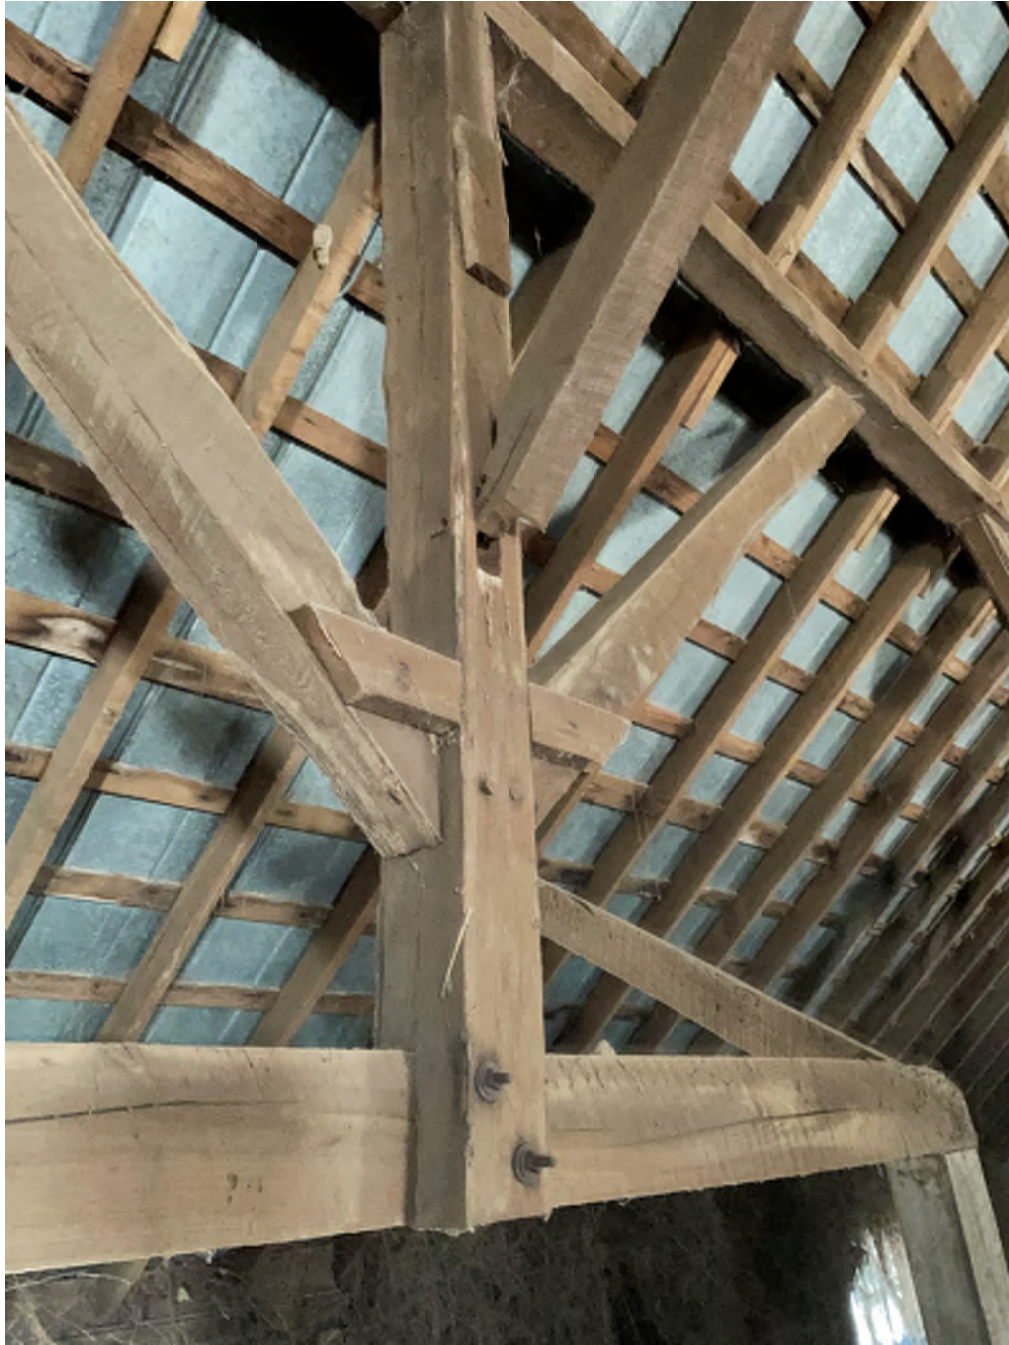
Transferred post to be stabilized.
