EQUESTRIAN BARN AT AVENEL

CONDITION ASSESSMENT REPORT

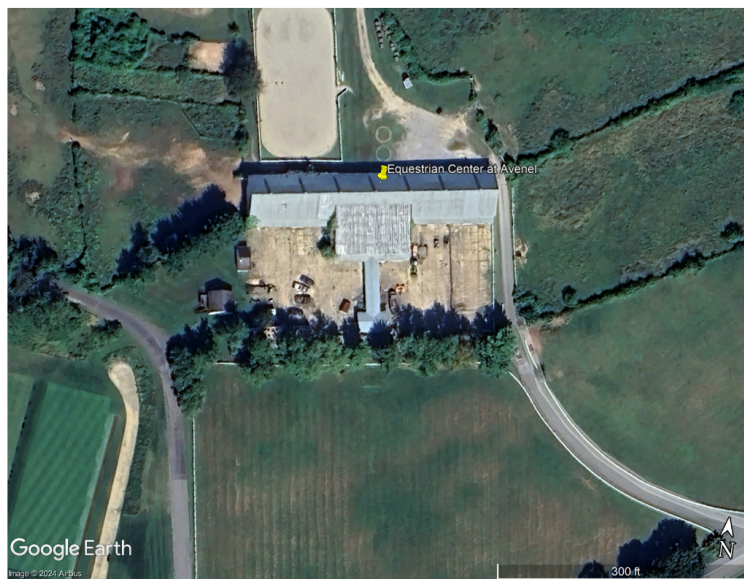
ES Figure 1 – Google Earth Image of Barn

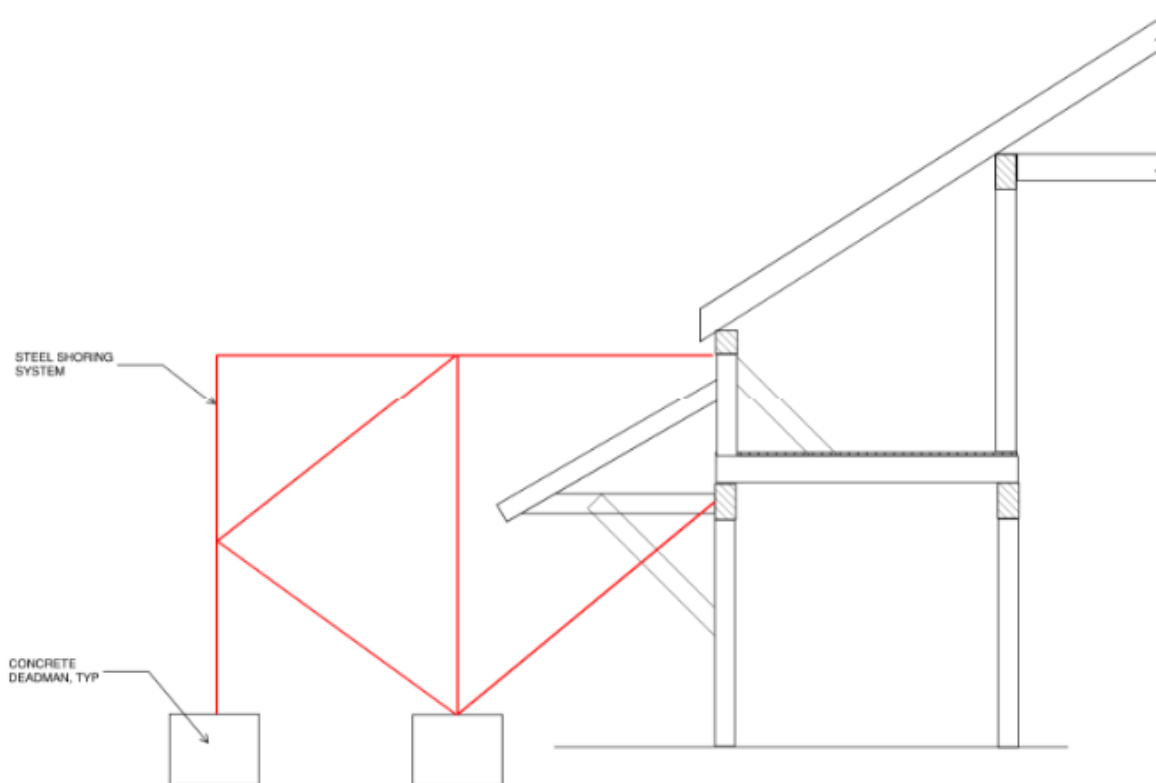
ES Figure 2 – Conceptual Exterior Building Bracing Scheme (cross section)

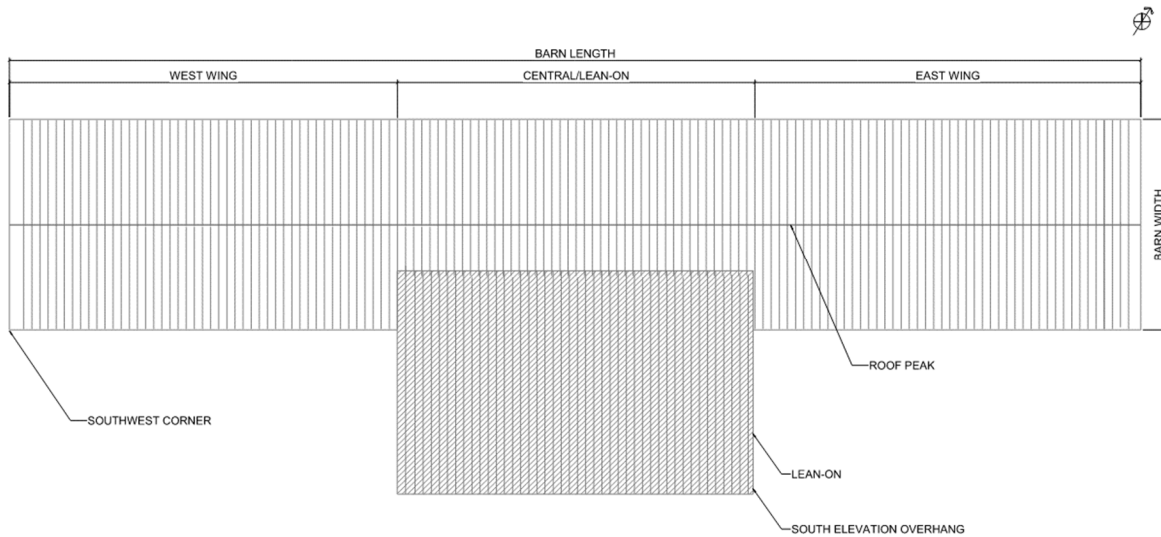
ES Figure 4 is a reference plan of the barn.

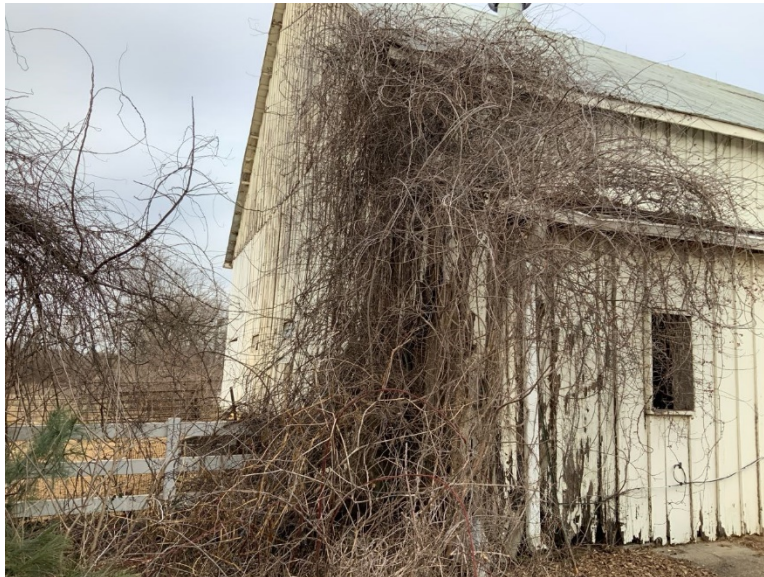
ES Photo 2: Heavy Vegetation pushing up roof deck along southwest corner (REF Photo S113)

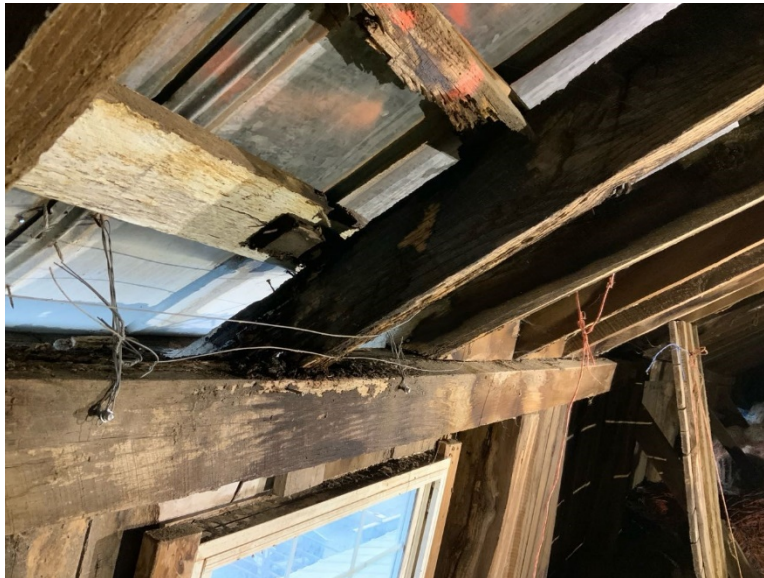
ES Photo 3 Rotting rafters (REF Photo S10 – Appendix B2)

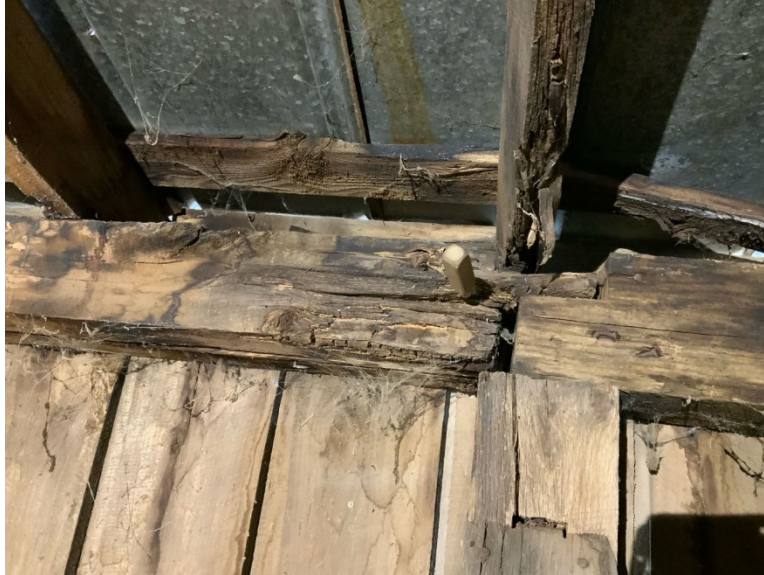
ES Photo 4 – Perimeter Roof Rot (REF Photo S21 – Appendix B2)

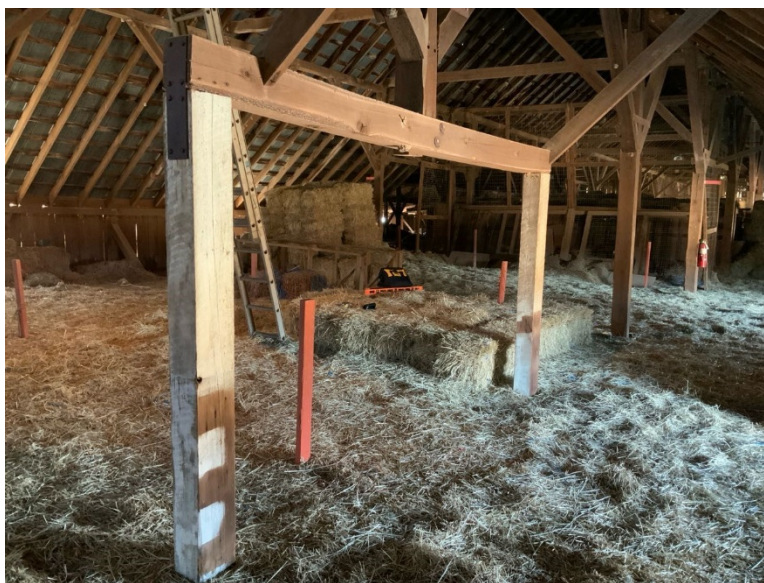
ES Photo 5 – General view of the load spreader beam structures in hayloft (REF Photo G10 – Appendix B1)

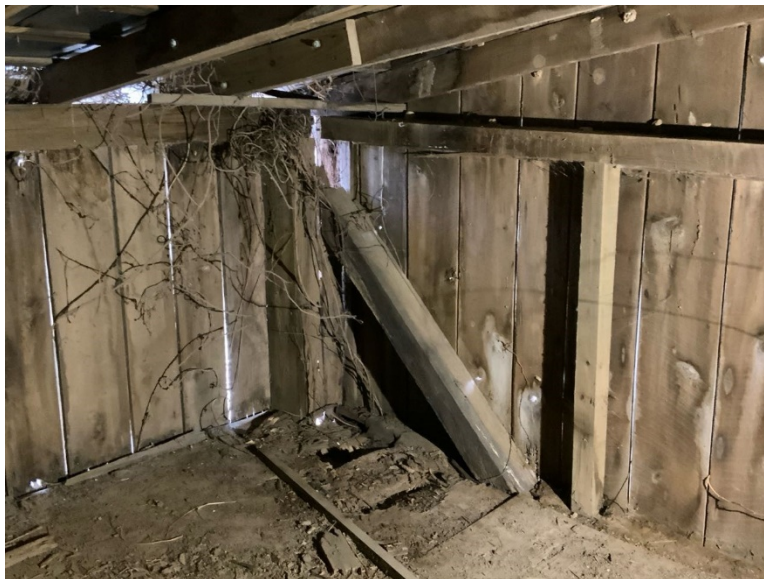
ES Photo 6 – Hayloft looking southwest – post has been added to east existing column., north brace and wind girt are not connected to the post and the east brace is missing. The floorboards adjacent to the column are rotting. (REF Photo S42- Appendix B2)

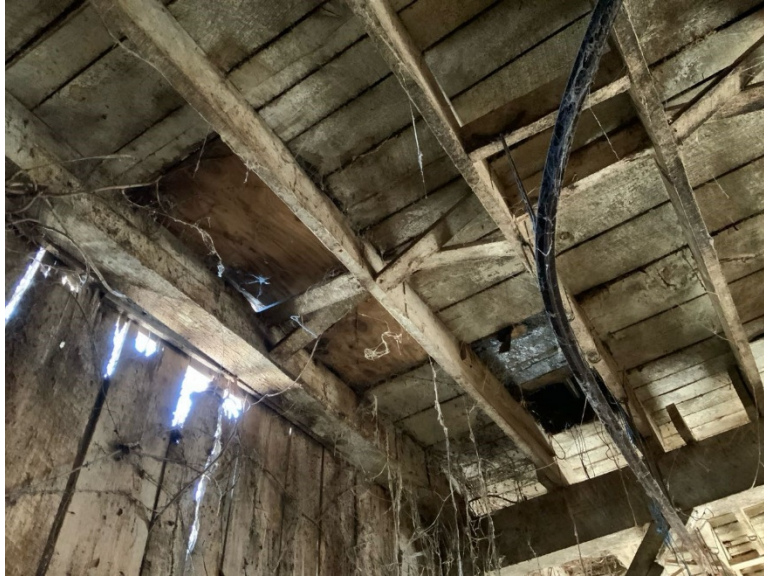
ES Photo 7 – Hayloft from below – typical rotting/broken/missing floorboards – Lean on structure (REF Photo S68 – Appendix B2)

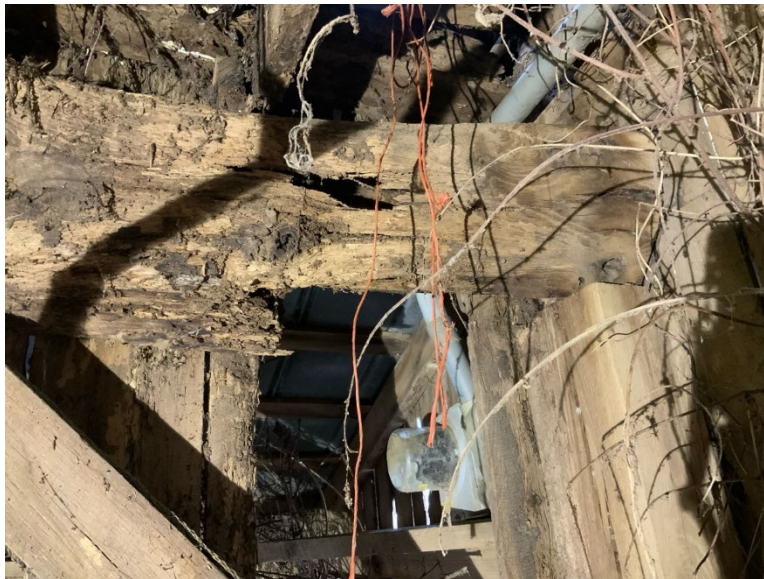
ES Photo 8 – Critical finding at hayloft floor beam – west end of beam has approximately 90% section loss – (REF Photo S81 – Appendix B2)

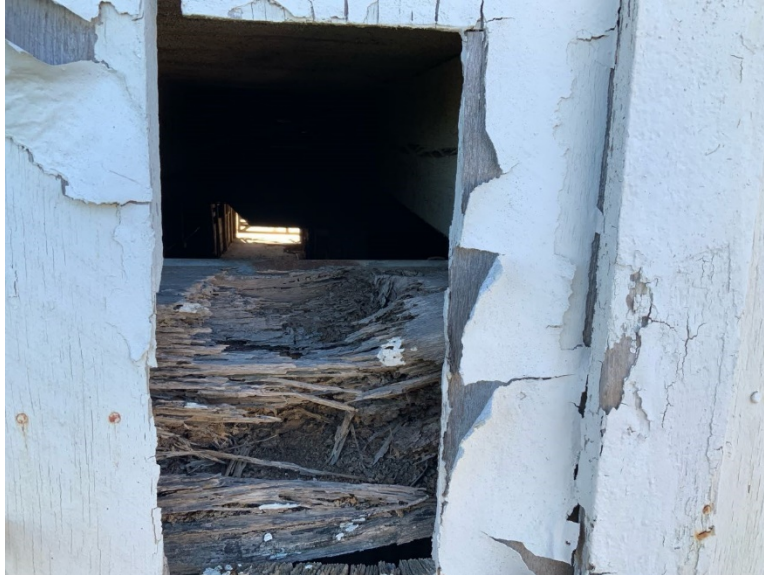
ES Photo 9 – Severe rot at floor beam – west end has significant section loss – (REF Photo S82 – Appendix B2)

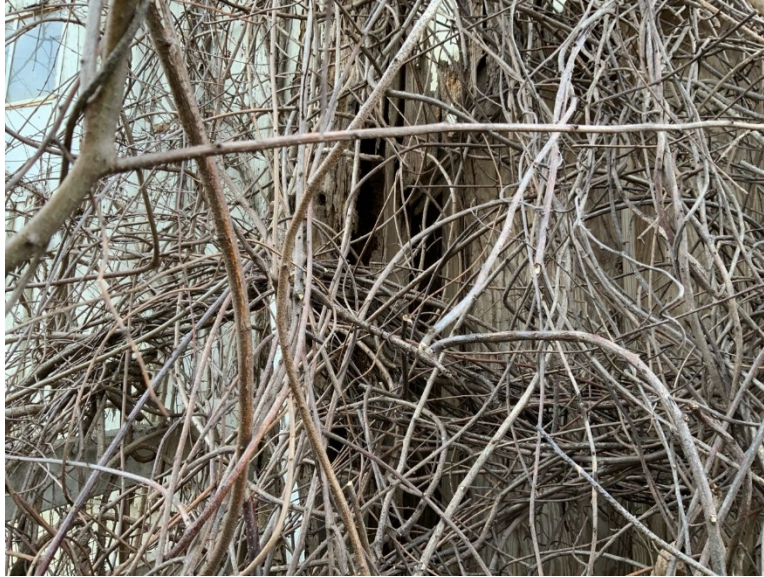
ES Photo 10 – Siding at southwest corner has holes – column appears to be rotting throughout its height – heavy vegetation (REF Photo S114 – Appendix B2).

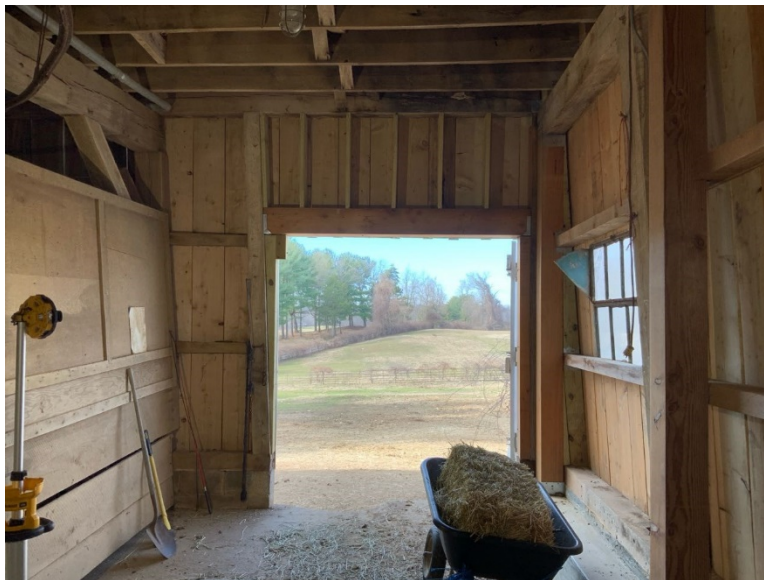
ES Photo 11 – New repairs on Northwest corner (REF Photo S100 - Appendix B2)

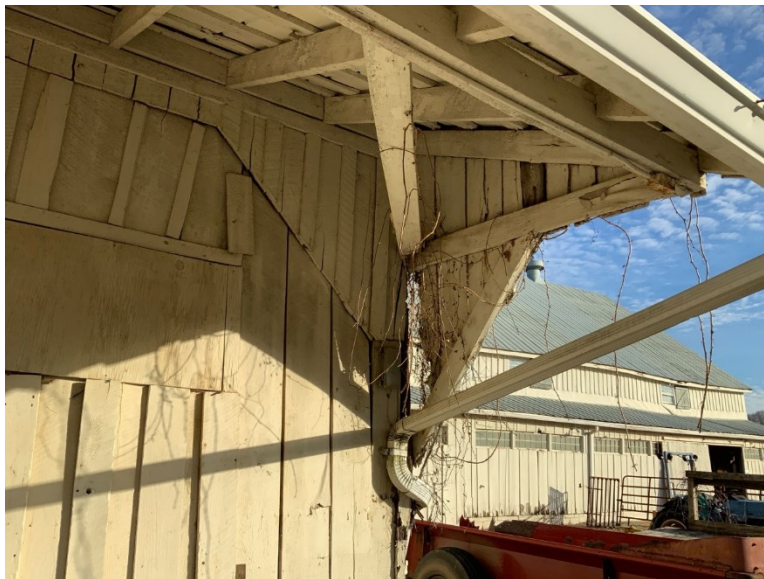
ES Photo 12 – Overhead support diagonal is disconnected at the base and overhang is leaning (REF Photo S140 Appendix B2)

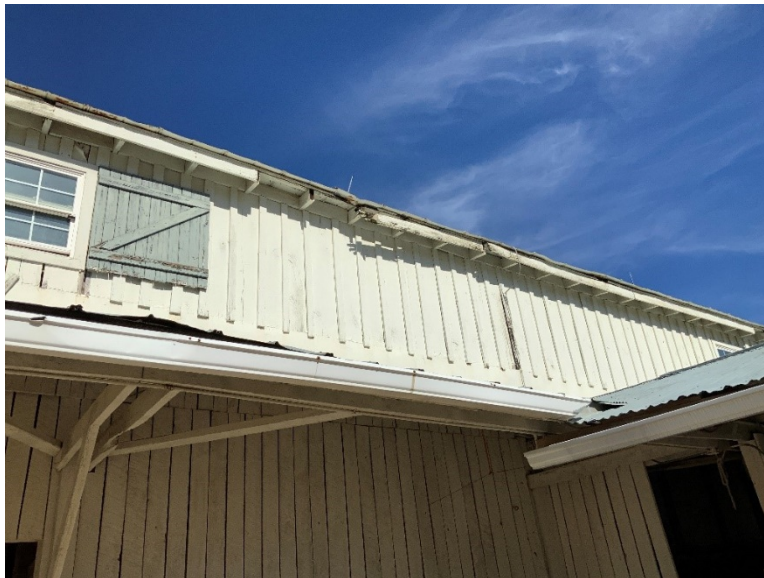
ES Photo 13 – Sections of lifted metal roof panels and missing fascia boards (REF Photo A3- Appendix B3)

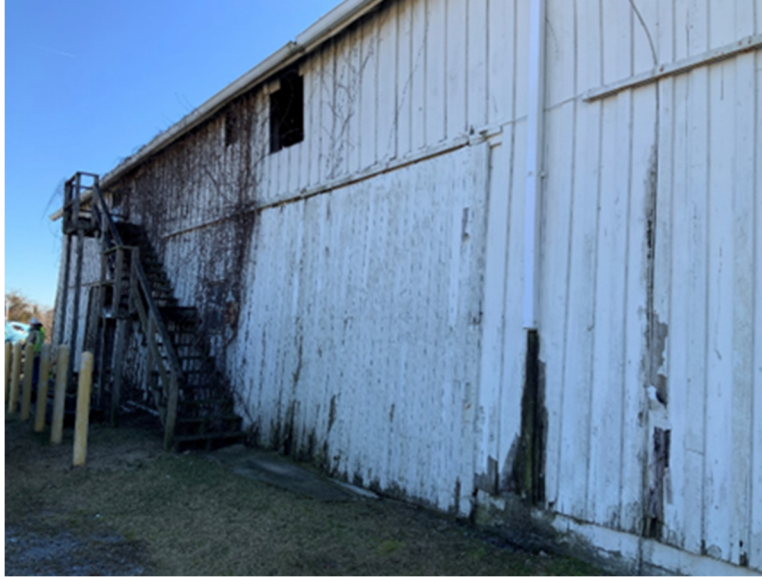
ES Photo 14 – Gutter clogged with vegetation, deteriorated boards and discontinuous rain leader (REF Photo A14 – Appendix B3)
