Avenel Community Meeting

David McDonough, Deputy General Manager

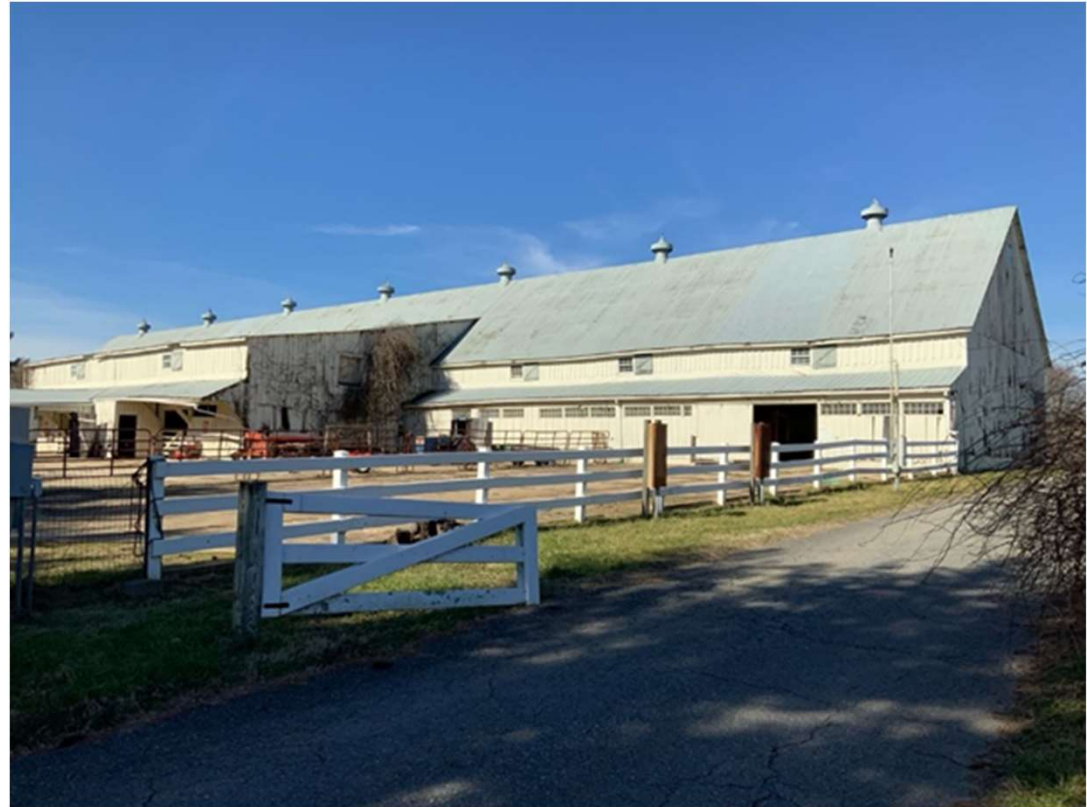
- GF team members
 - Architectural
 - Structural
 - Electrical
 - Geotechnical
 - Hazardous Materials
 - Cost Estimating
 - Construction Management – Lidar Scan
- Inspection performed January/February 2024
- WSSC Water – Drone photos

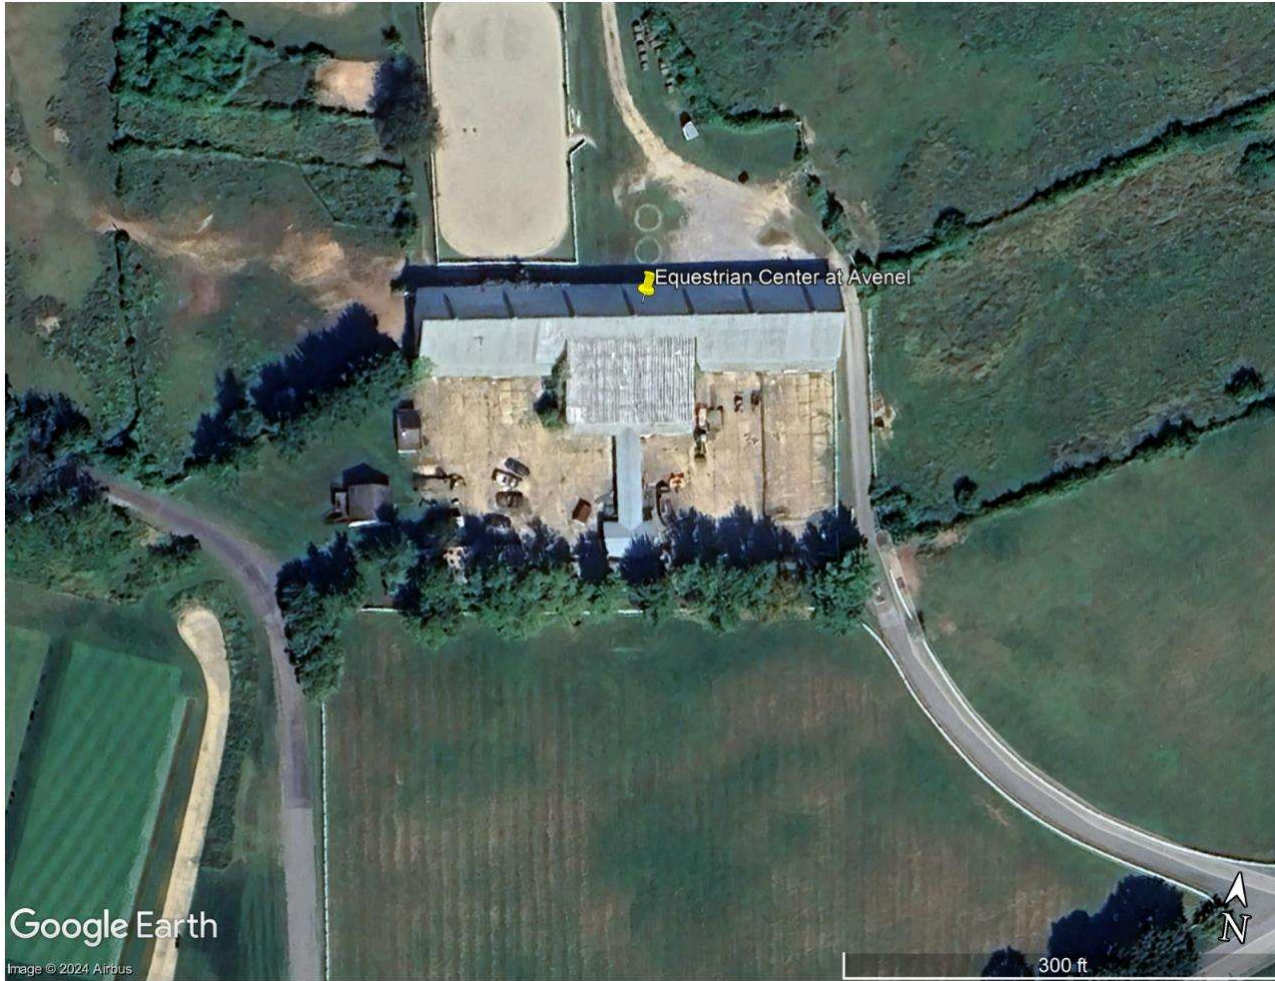
Equestrian Center at
Avenel – Google Earth
Image

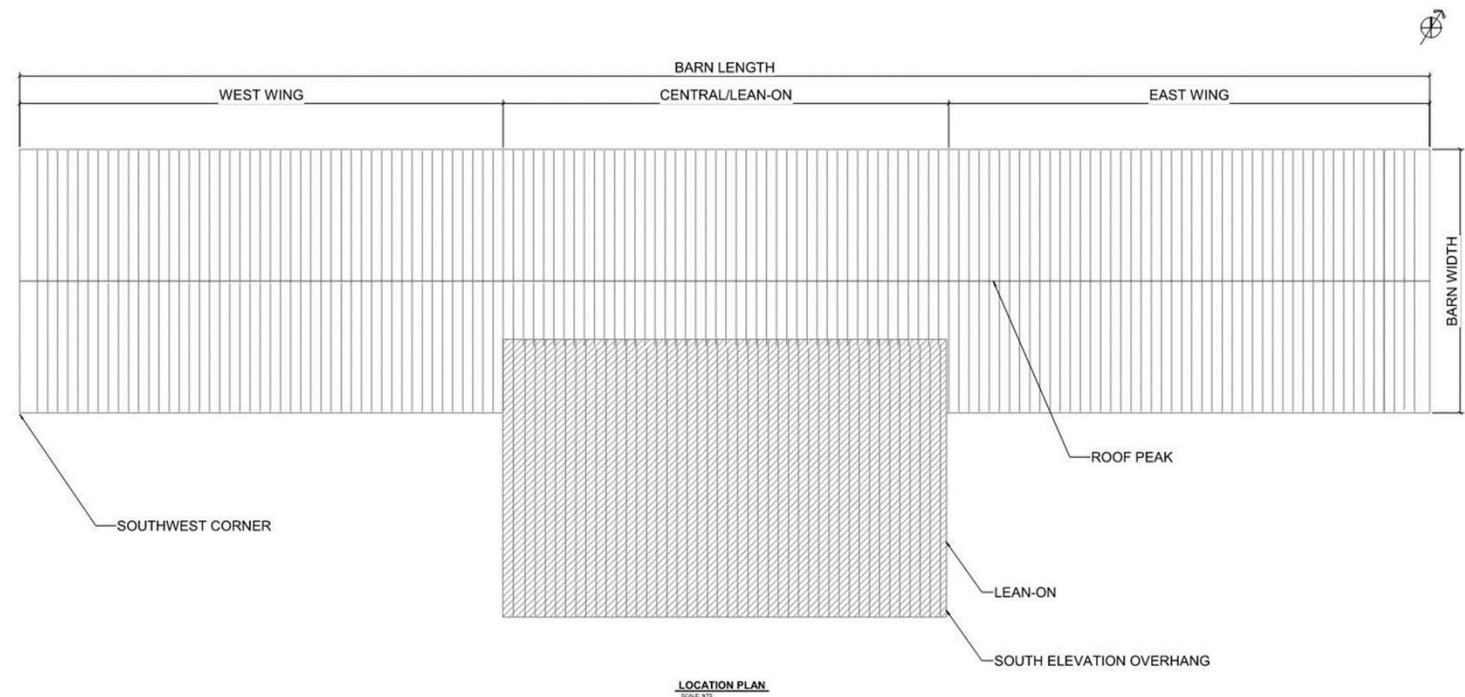
Overall Barn Condition

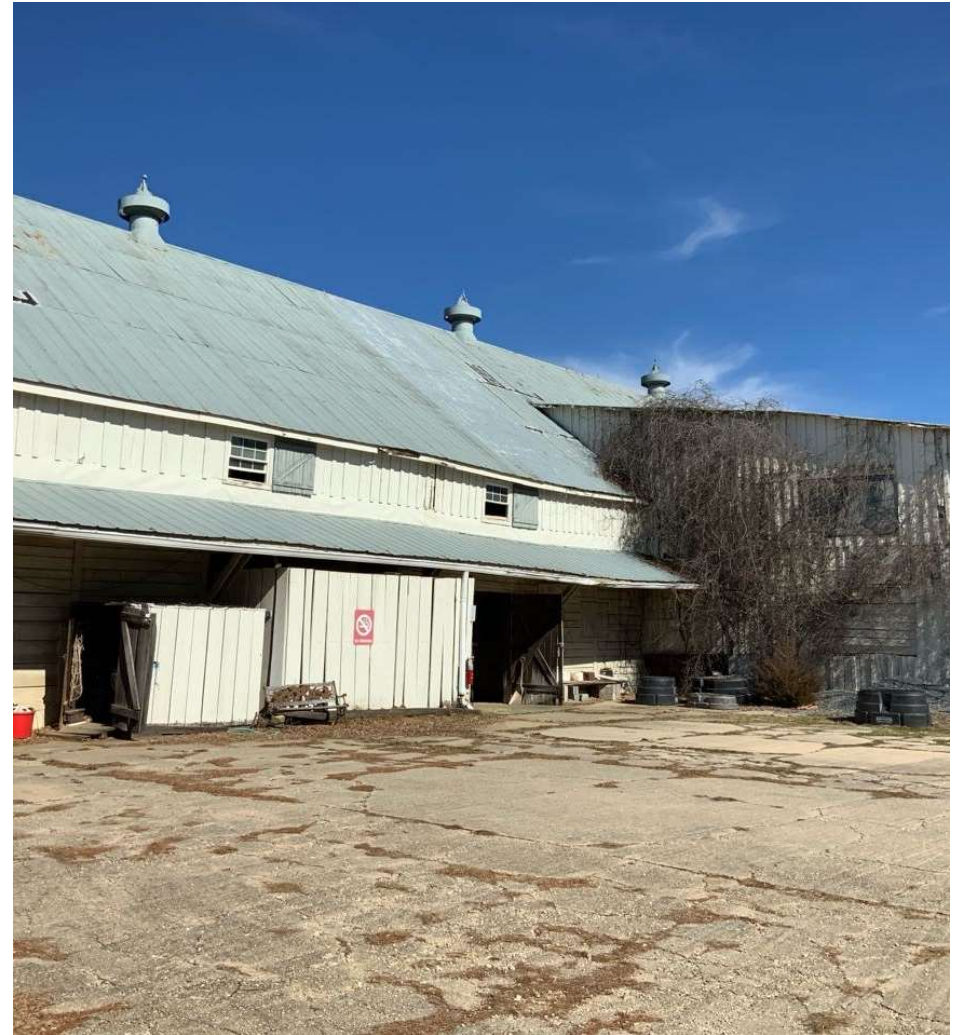
General view of Barn (looking northeast); west wing and lean-on structure are visible

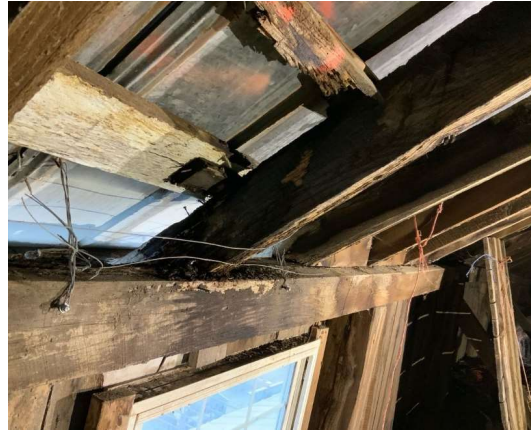
Rotting rafters (REF Photo S10)

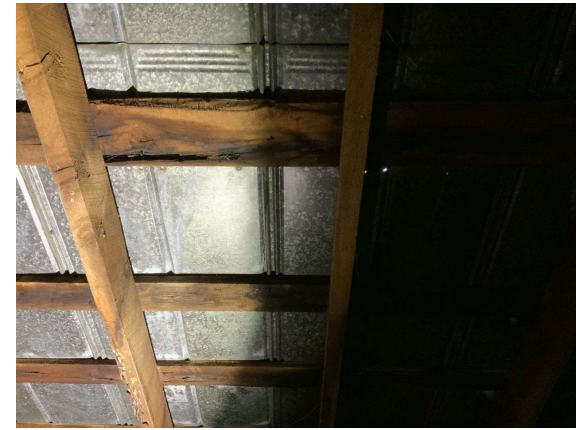
Typical pinhole leak in roof metal deck (REF Photo S1)

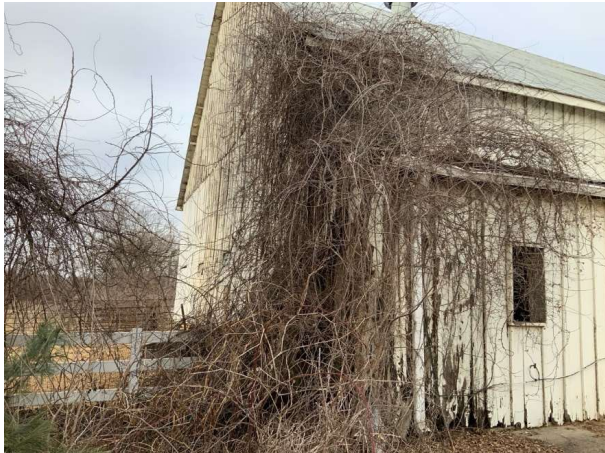
Heavy vegetation pushing up roof deck along southwest corner (REF Photo S113)

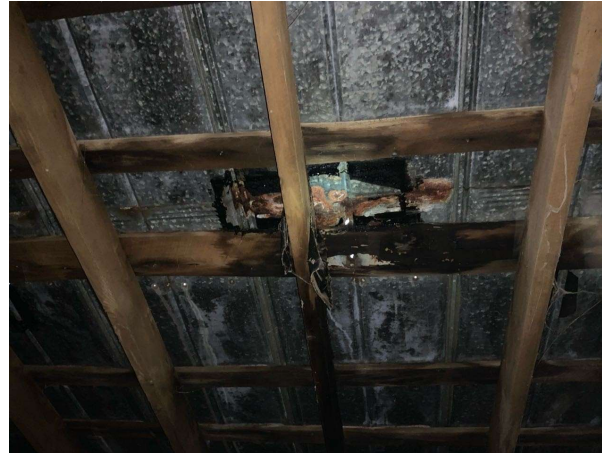
Typical area of rusted roof deck and failing patch (REF Photo S2)

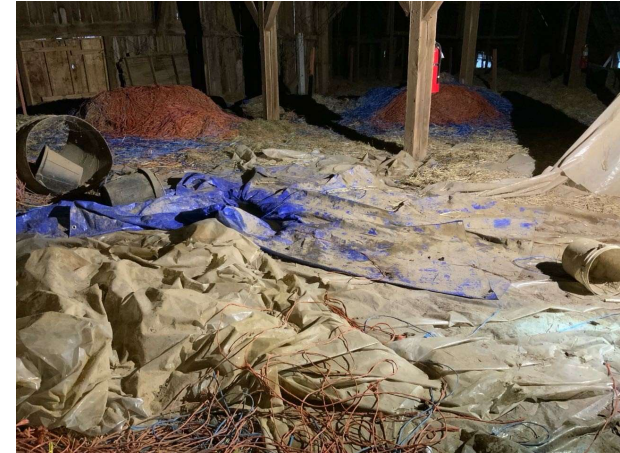
Tarps with standing water on hayloft flooring underneath lean-on region of structure. Floor shown looking northwest along gridline 6. (REF Photo S2)

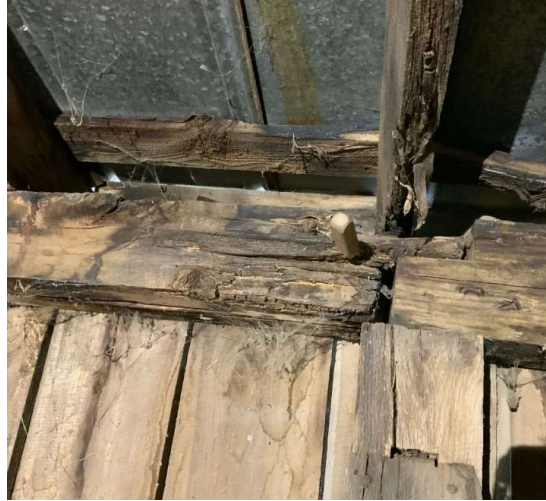
Perimeter roof rot (REF Photo S21)

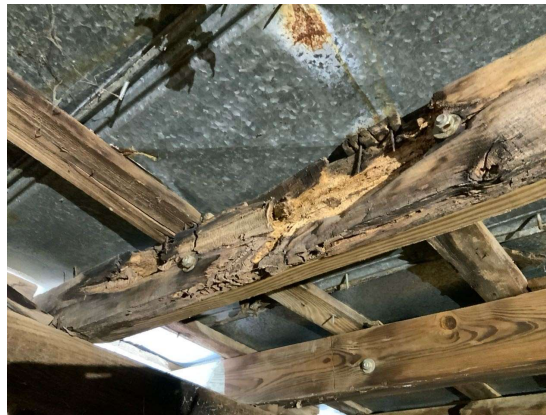
Previously sistered roof rafter along Gridline 7 between Gridlines I and J. Note the bolts are only through the rotted portion of the rafter. (REF Photo S12)

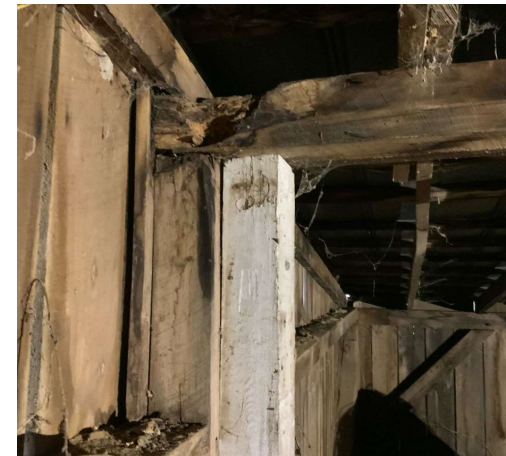
Beam between Column M/6 and N/6 exhibits rot with full pick penetration at east bearing. A 5.25" x 5.25" post has been added to west side of column to help support beam. REF Photo S30

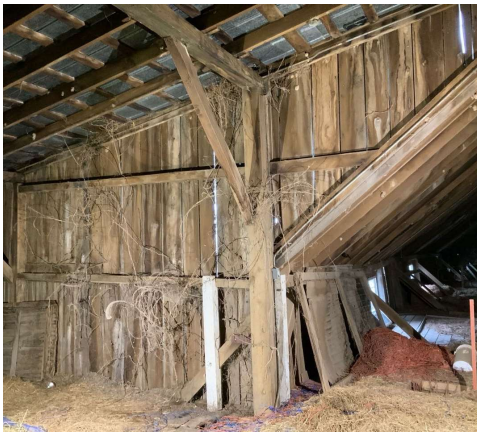
New column and posts supporting wind girt and roof beam at Column H/4 in hayloft (looking southwest). Note the south brace is connected with ineffective strap to new column. REF Photo S40

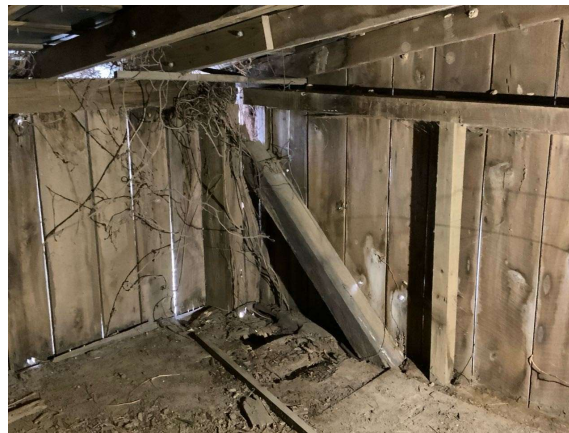
Severe rot at top of original Column H/7 in hayloft (looking southwest). A new post has been installed to the east of the existing column. The north brace and wind girt are not connected to the new post and east brace is missing. The floorboards adjacent to column are rotting. REF Photo S42

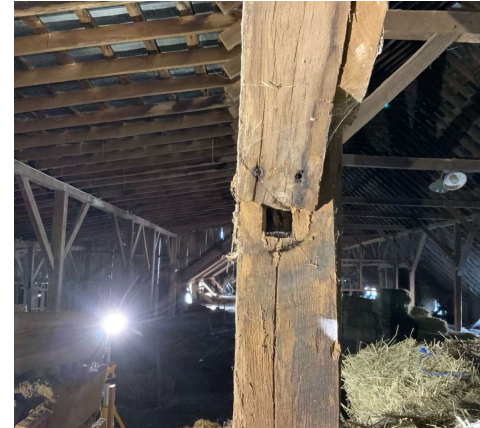
Disconnected and twisted east brace at Column M/3 in hayloft (looking west) REF Photo S47

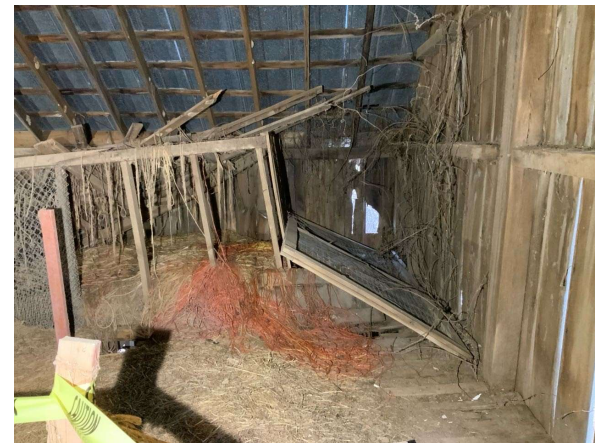
The east brace at Column B/4 in hayloft appears to be missing based on similar geometry in other portions of the building (looking south). REF Photo S51

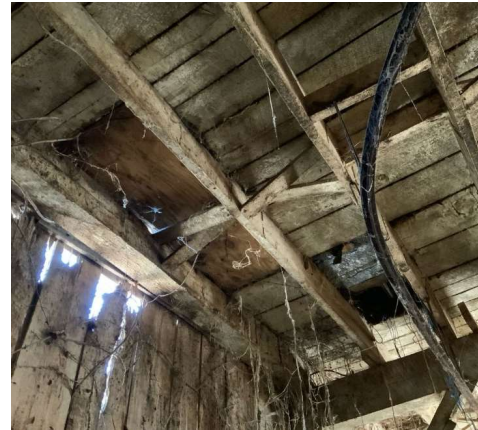
Hayloft from below – typical rotting/broken/missing floorboards – Lean-on structure (REF Photo S68)

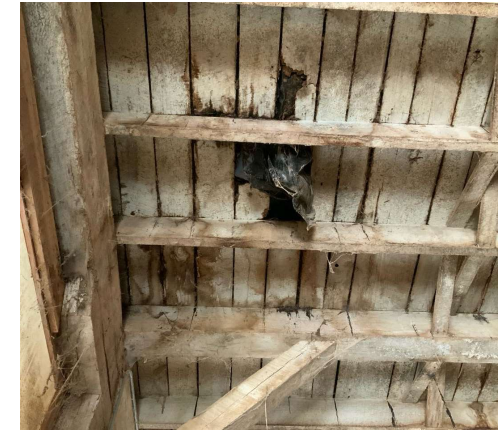
Typical rotting/broken/missing floorboards. Lean-on portion of structure near Gridline 7 shown looking west. (REF Photo S67)

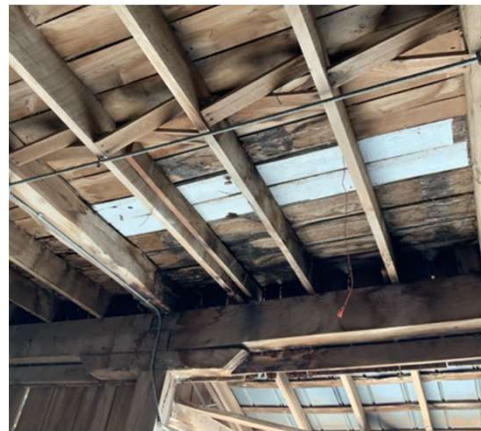
Typical rotting floorboards. East wing near Gridline 4 shown looking south (REF Photo S66).

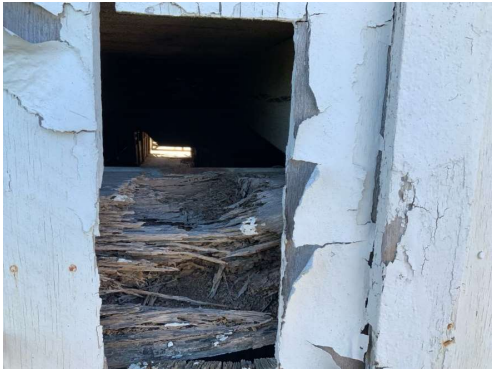
Severe rot at floor beam – west end has significant section loss (REF Photo S82)

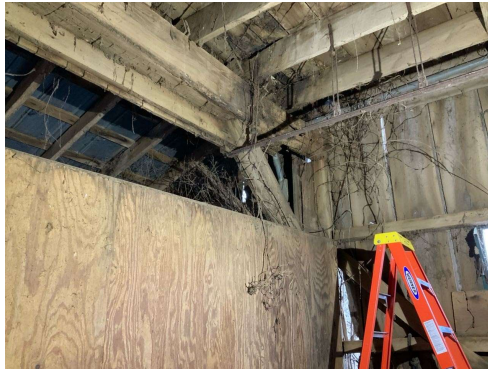
Critical finding at floor beam between Columns B/4 and C/4. West end of beam has approximately 90% section loss (REF Photo S80)

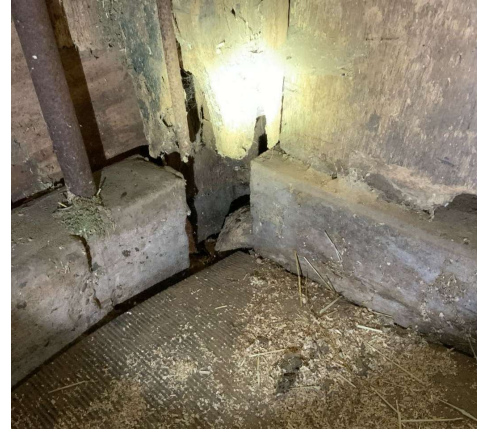
Bearing loss at Column M/2.5 at grade level (looking northwest)
(REF Photo S107)

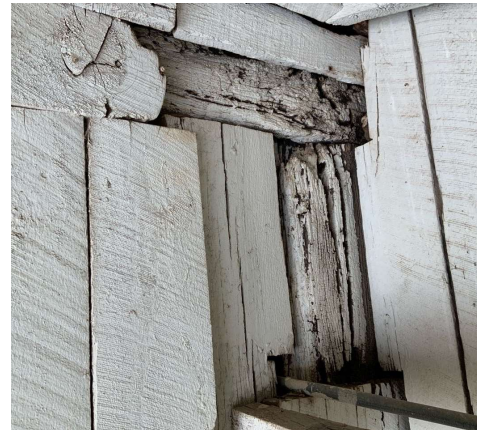
South face of the at-grade column cap at Column K/7 is exposed to exterior and has soft rot (REF Photo S97)

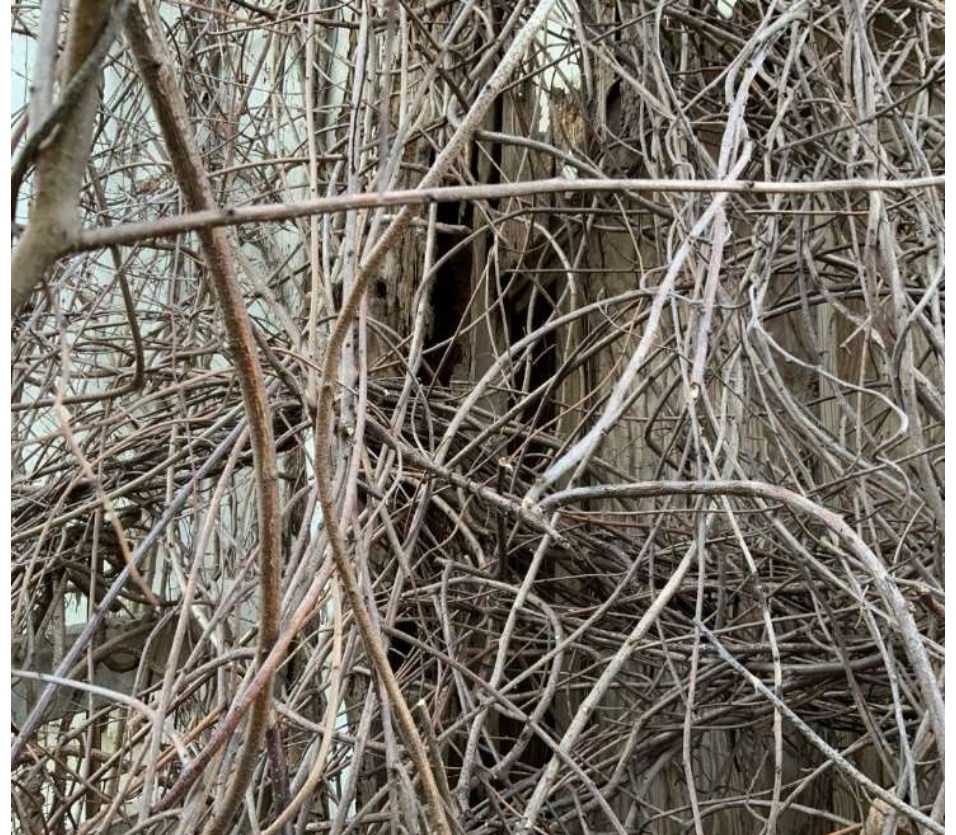
- Siding at southwest corner has holes – column appears to be rotting throughout its height – heavy vegetation (REF S114)

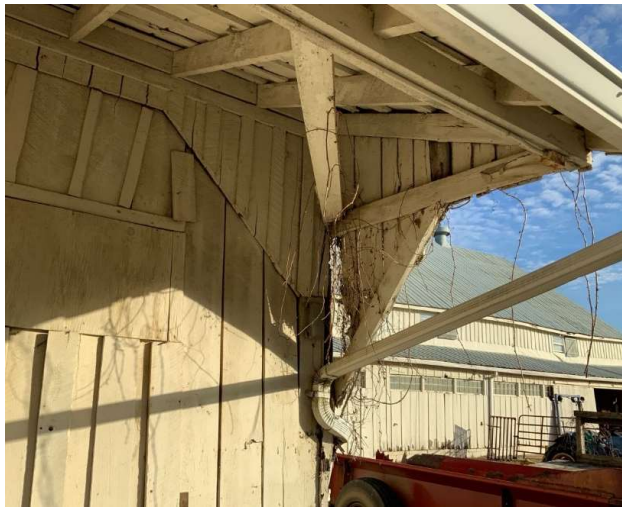
Overhead support diagonal is disconnected at the base and overhang is leaning (REF Photo S140)

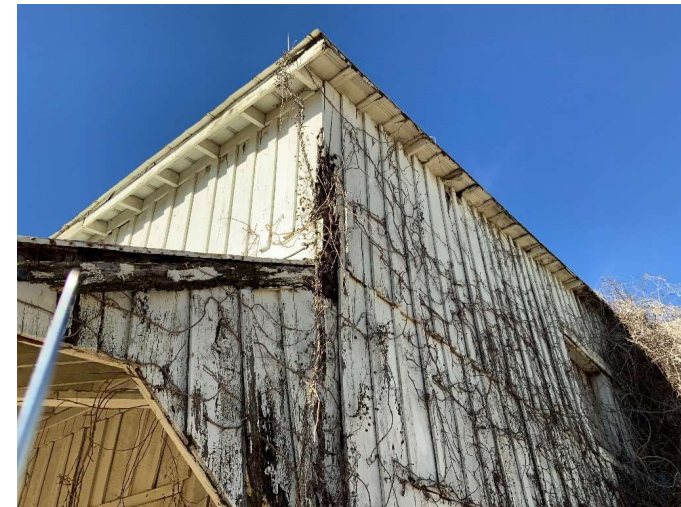
Southeast view of South Elevation overhang deterioration (REF Photo A6)

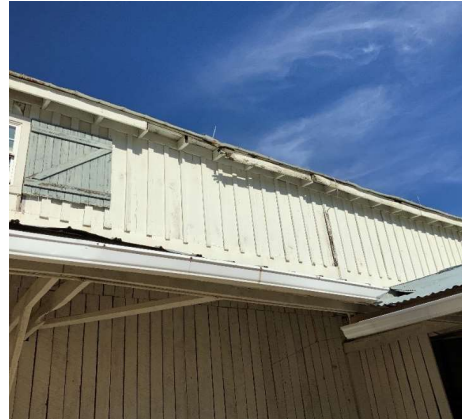
Sections of lifted metal roof panels and missing fascia boards (REF Photo A3)

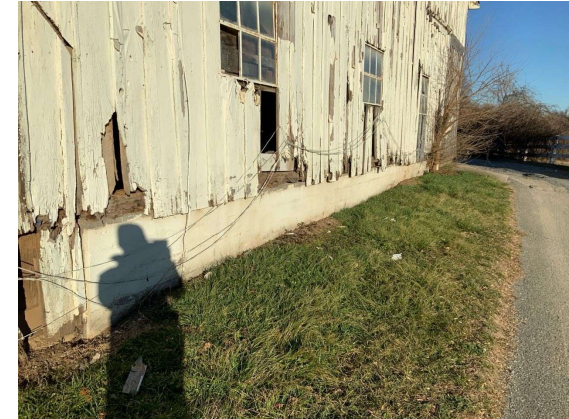
Siding along east elevation is broken or missing exposing the sill plate along Gridline T to the external environment. The sill plate is rotting. (REF Photo S150)

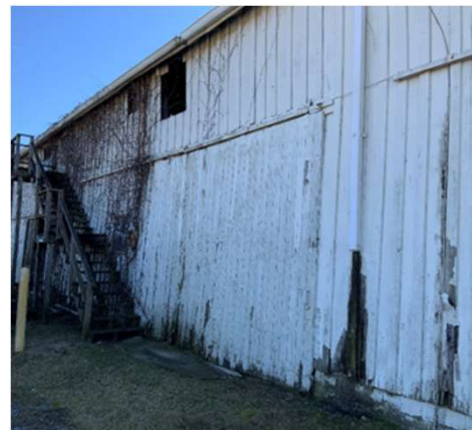
Gutter clogged with vegetation, deteriorated boards and discontinuous rain leader (REF Photo A14)

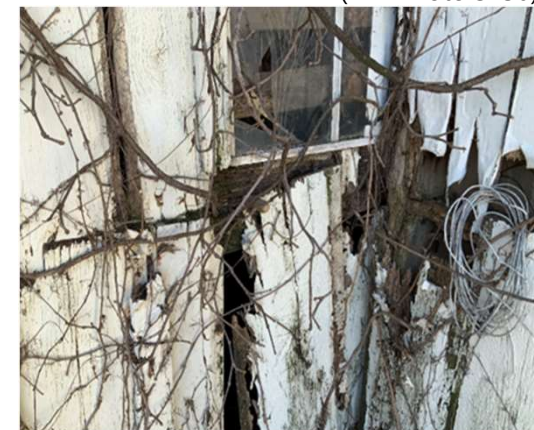
Rot and deterioration and over-growth at grade (REF Photo A16)

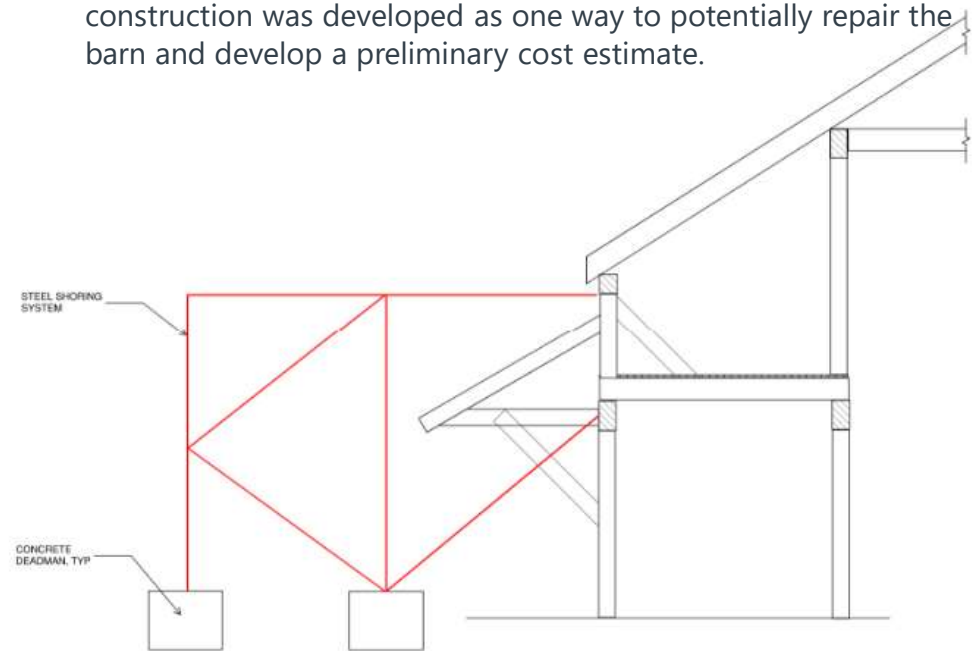
Conceptual Exterior Building Bracing Scheme (cross section)
(REF Appendix E Conceptual Details)

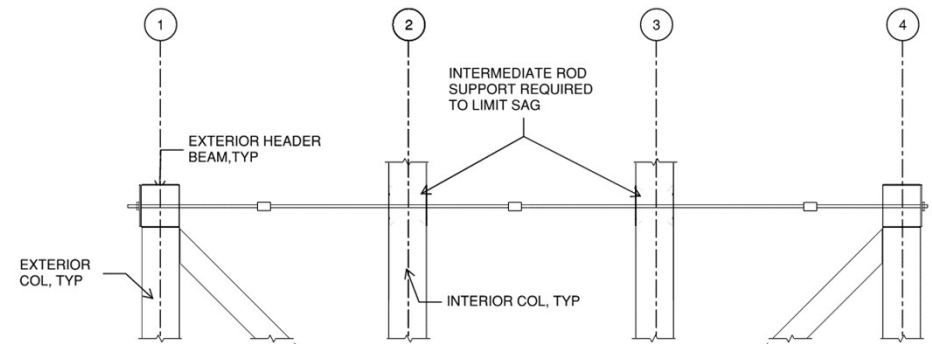
Roof/Hayloft Tension Ties (REF Detail 2 – Appendix E)

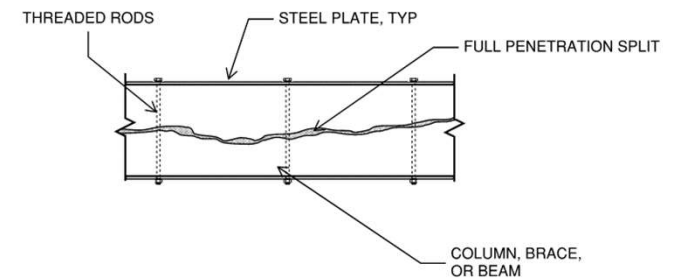
Proposed Split member repair detail.
(REF Detail 3 – Appendix E)

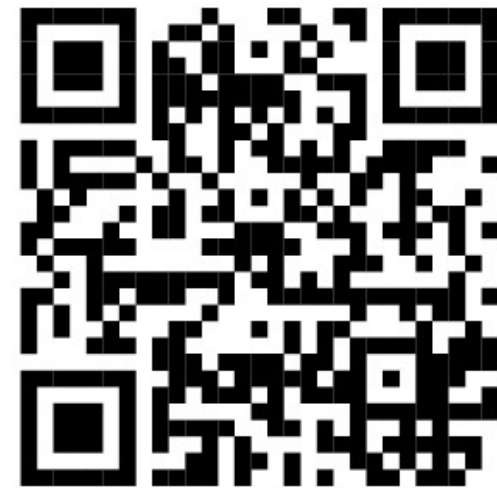
What Do You Need to Know?

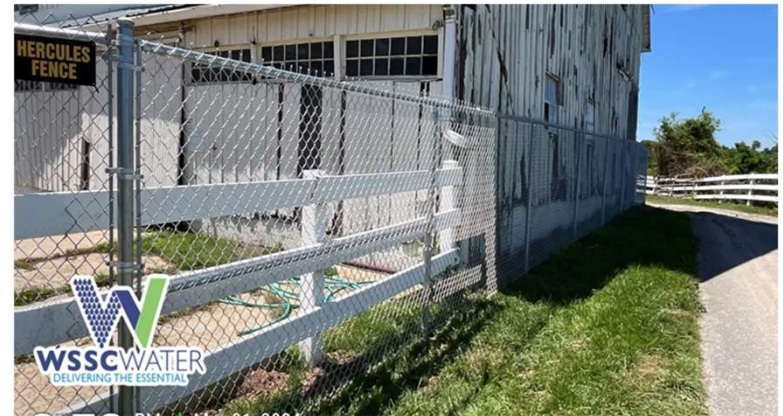
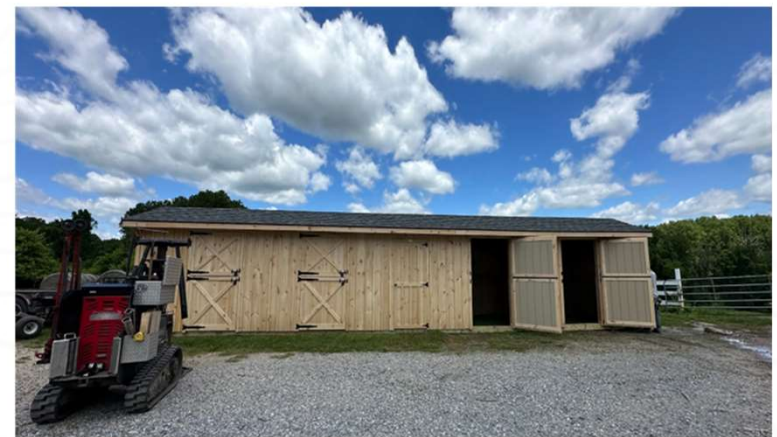
- At Gannett Fleming's recommendation, access to the barn has been restricted and we have placed fencing around its perimeter to ensure public safety
- Installed four-stall barn and hay storage container on site to accommodate Ms. Evans' horses
- Extended License Agreement with Ms. Evans through December 1, 2024, free-of-charge
